**Monitoring Report No. 187**

**Ardglass Harbour,  
Ardglass,  
Co. Down.**

**AE/07/237**

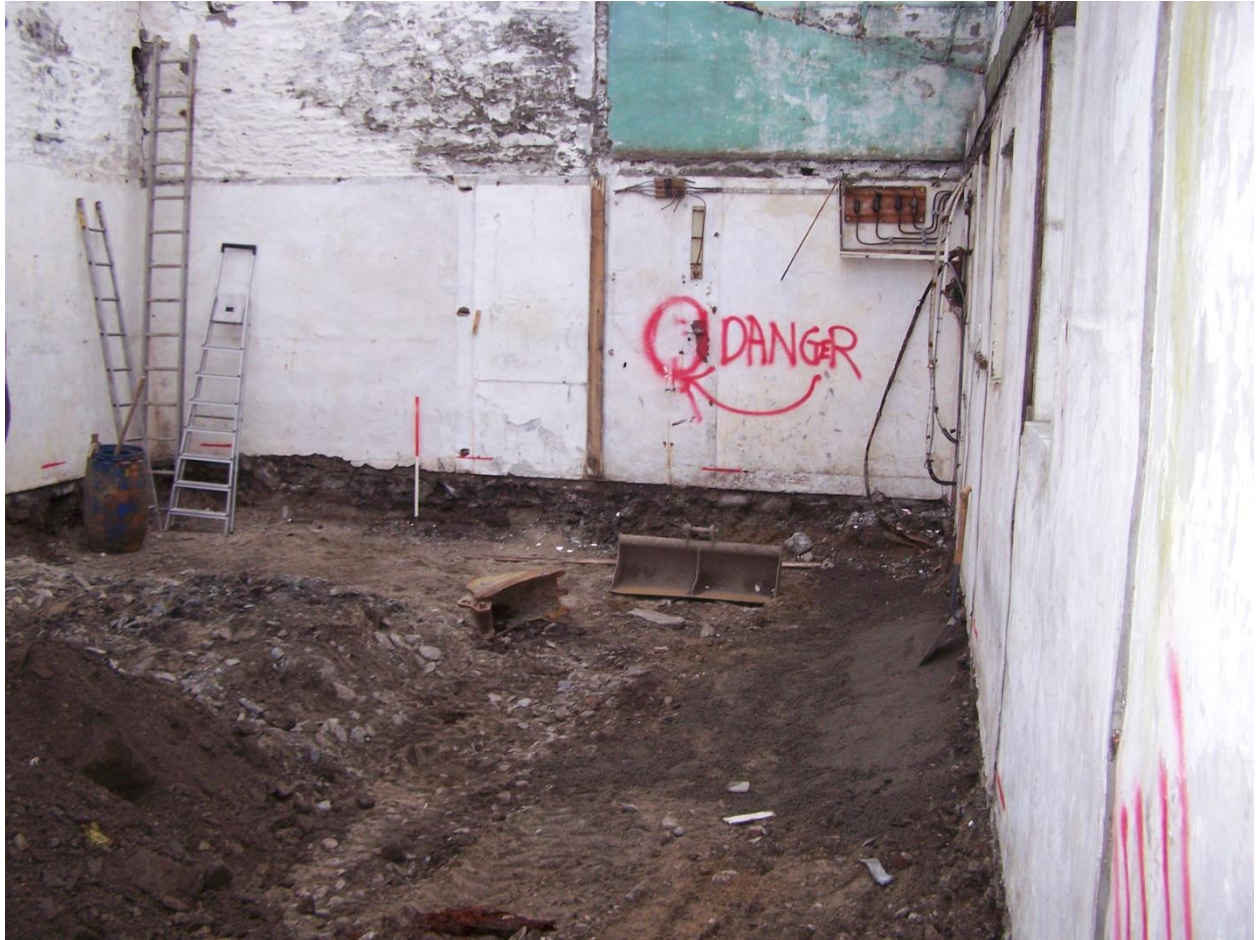
No archaeological features or artifacts were uncovered during the excavation. In the north and the southwest of the building a thin, patchy, loam layer sat above an orange sand containing late 19<sup>th</sup> or early 20<sup>th</sup> century building rubble (Photo 1). Beneath this was beach sand which seemed undisturbed. Excavation continued into this natural beach sand until the required building level was reached. In the southeast corner of the building the level of the bedrock was high, just under the modern floor, with a little levelling gravel apparent in places (Photo 2).

Photo 1: West end of building after removal of floor and reduction of ground level.

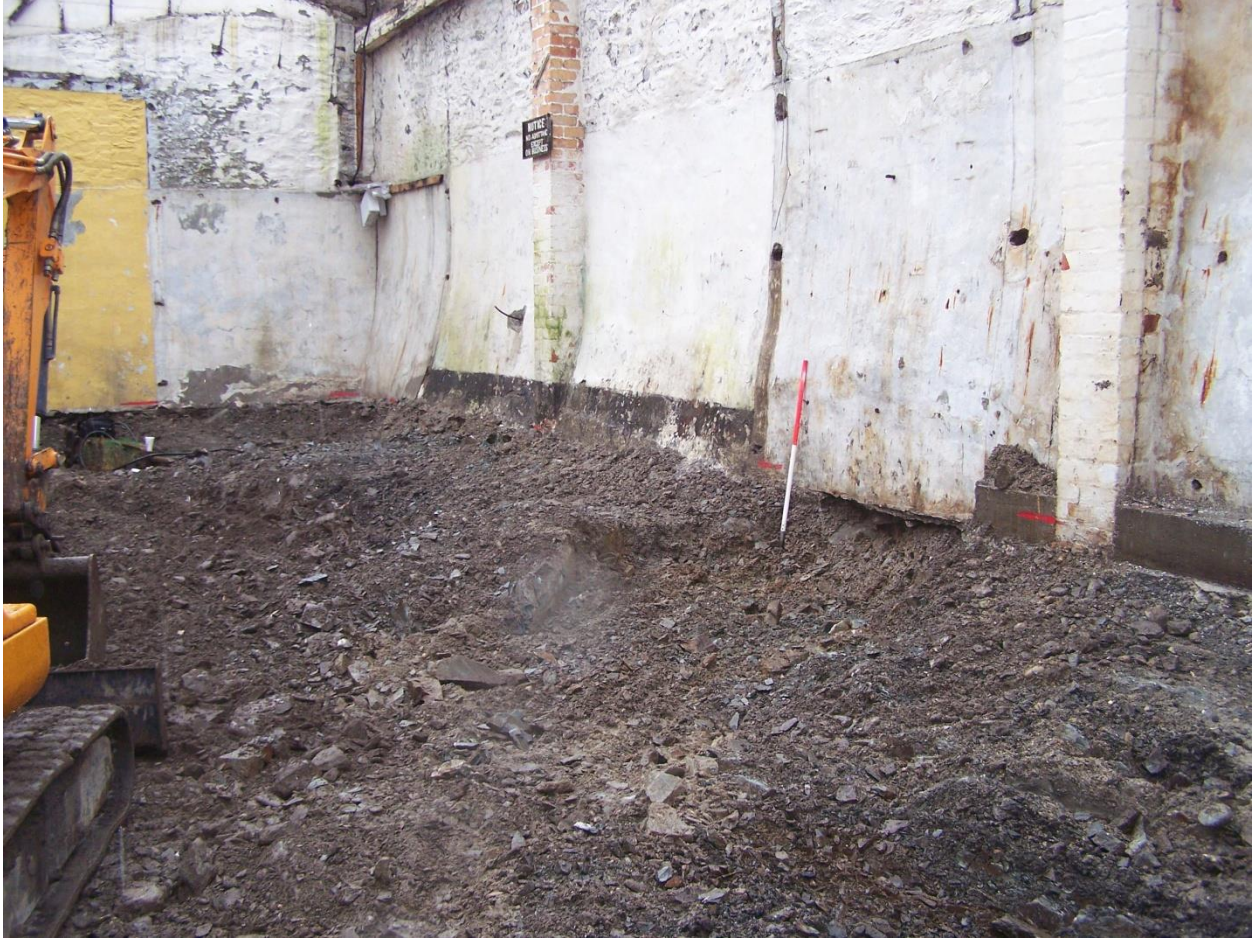
Although the scheduled south wall of the building did not appear to be harmed, undermined or compromised, as far as can be determined without an architect's opinion, its base was exposed by the removal of the floor. It was evident that this wall was not a single entity but in fact two walls, one keyed into the other. The eastern 12.4m of wall was constructed upon bedrock and had an apparent batter at its base. The remaining five metres of wall had a very different character, being without a batter and in places constructed upon the same sandy rubble fill of 19<sup>th</sup> or 20<sup>th</sup> century date found under the floor of much of the southwest of the building (Photo 2 to 3). It seems likely that this unbattered section of wall is a later addition to the battered section.

Photo 2: View of east end of building after removal of floor showing bedrock. Note change in wall type from battered wall sitting on bedrock, at east end, to plain wall founded on rubble infill at west

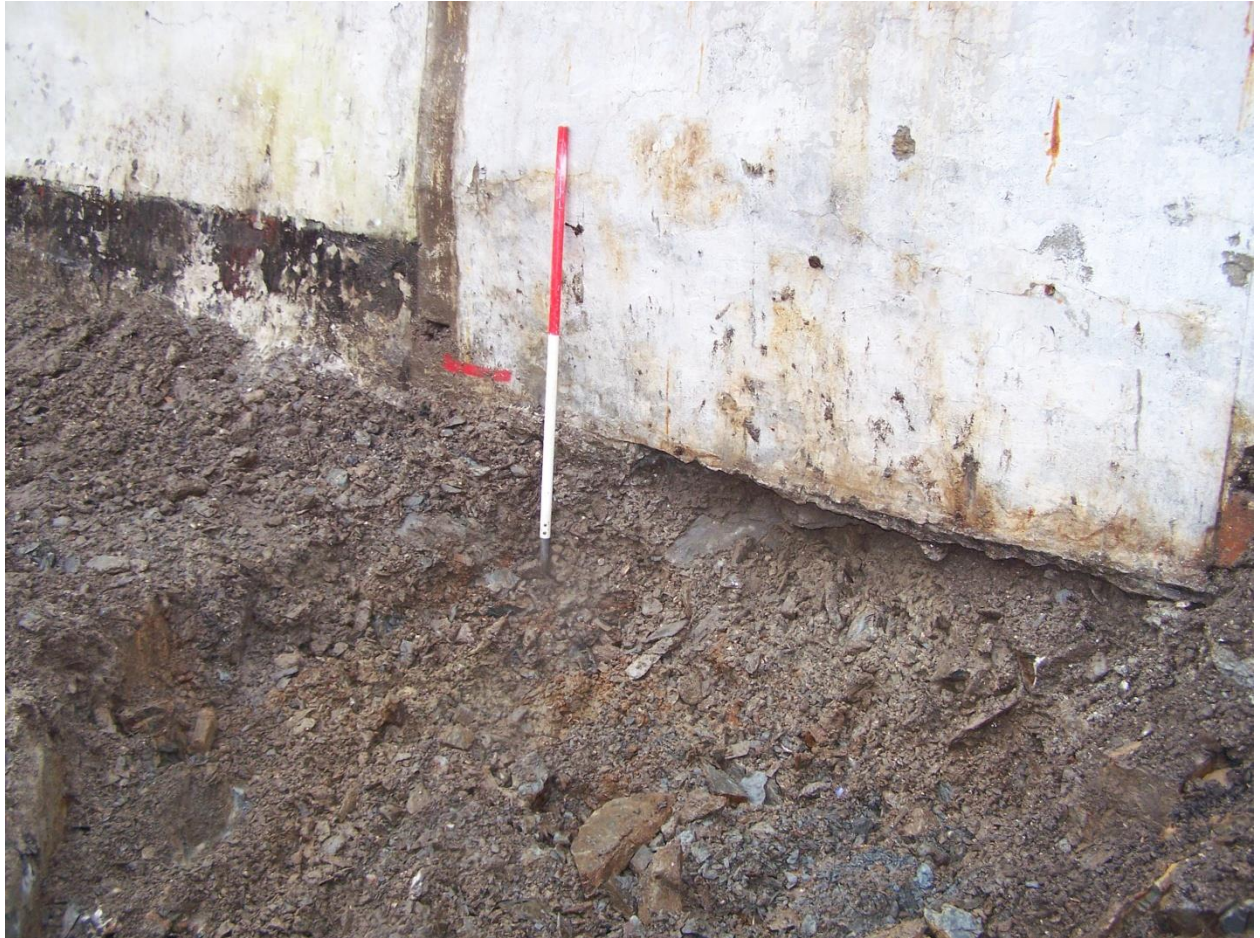
There were no archaeological structures or artifacts found during the monitoring of the excavations at this site. The monitoring however did allow for an examination of the base of the scheduled wall at the south of the building. This showed that the western portion of the wall is probably of 19<sup>th</sup> or 20<sup>th</sup> century construction, probably dating to the time of the construction of the rest of the warehouse. The easterly portion of the wall however was probably significantly older.

Photo 3: View of the interface between the battered wall (left of photo) and the plain wall (right of photo). Note the difference in the foundation materials of the two sections of wall.
