## **Monitoring Report No. 29**

**Freemanstown/Tobergill  
Donegore Hill**

*Site Name:* Campbell house development

*Brief Summary:* Evaluation of building site carried out by excavation of five test trenches. No archaeological features or artifacts were uncovered.

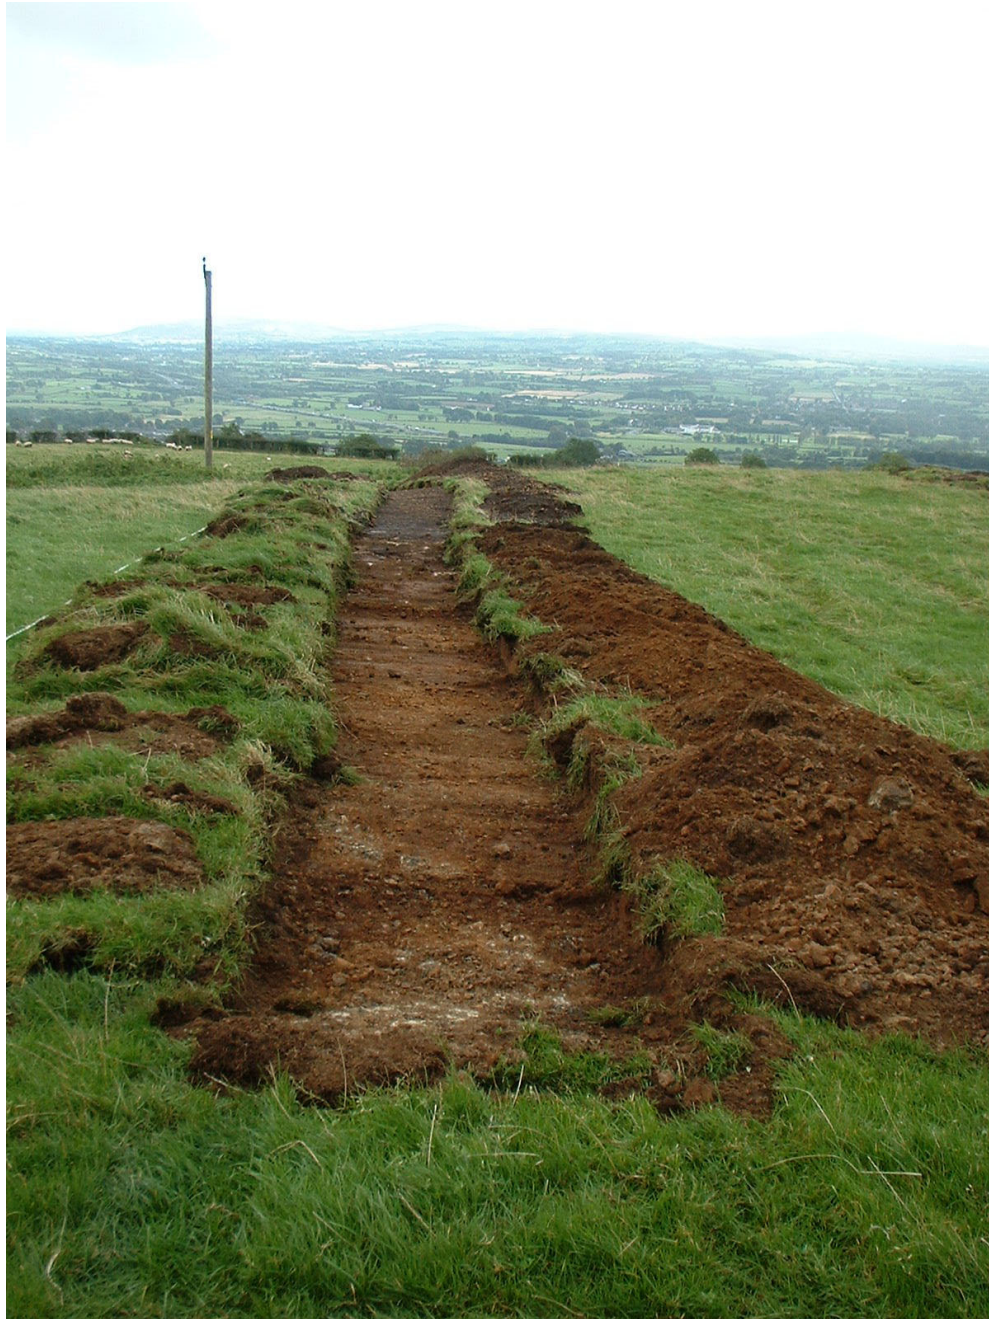
Trench 1: This trench was 1m wide by 35m long. It ran north-west to south-east and was located approximately 10 m south-west of the north-east boundary of the development site. The topsoil in this trench was a mid brown light sandy loam (Context 101) which varied from 15 to 20 cm in depth. For most of the length of the trench the topsoil sat directly on top of the subsoil (Context 102). The subsoil consisted on a thin layer of orange sandy clay sitting on top of basalt bedrock, which in places protruded through the orange sandy clay. In the 3m at the extreme south-east end of this trench the ground dropped rapidly to the west. At this end of the trench there was a deposit of orange clay (Context 103) located beneath the topsoil (Context 101). This orange clay layer contained fragments of brick and concrete. Beneath it was a layer of grey brown loam (Context 104) which sat above the subsoil (Context 102). I was informed by the land owner / developer Mr. Campbell that a 20<sup>th</sup> century agricultural building had been demolished in this field in recent decades and the rubble pushed down the slope to the south east of the trench. The loam layer (Context 104), located below the orange clay layer (103), was presumably an old topsoil layer covered during the demolition of this building. No artifacts or archaeological features were found during the excavation of this trench. (Photo 1)

*Photo 1: Trench 1 after excavation*

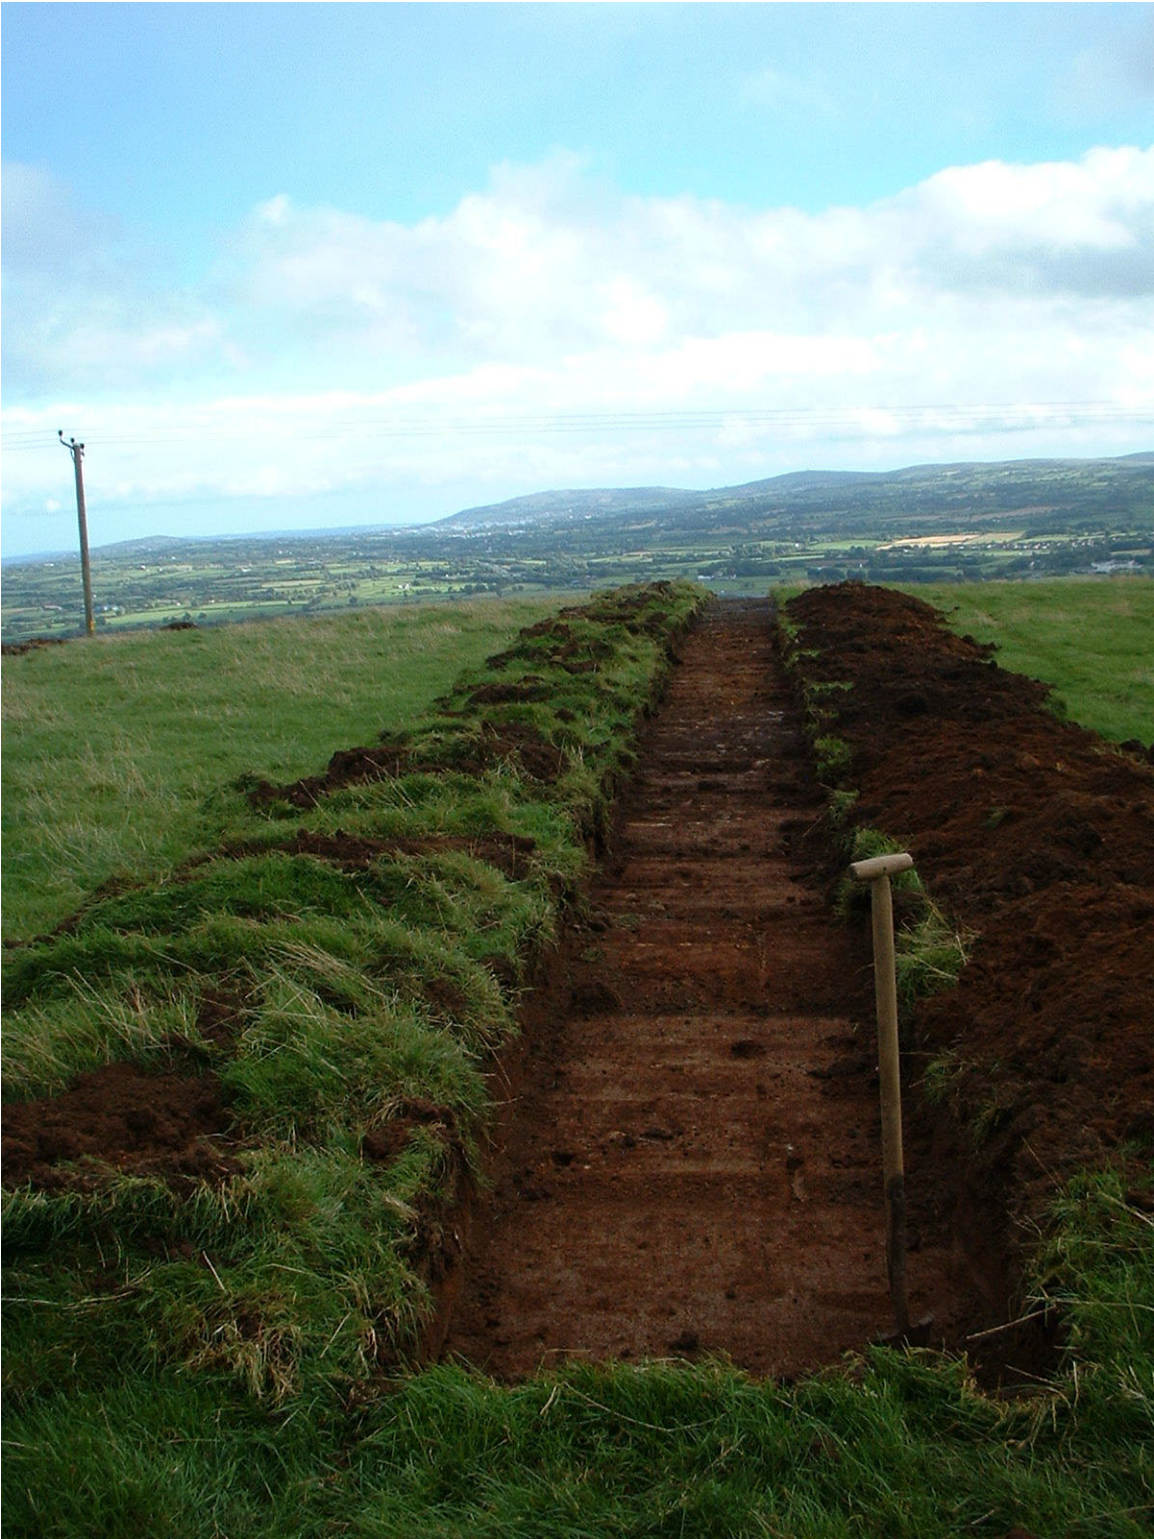
Trench 2: This trench was 1m wide by 40 m long. It ran north-west to south-east and was located approximately 20 m south-west of the north-east boundary of the development site and 10m south-west of Trench 1. The topsoil in this trench was a mid brown light sandy loam (Context 201) which was very similar to the topsoil in Trench 1. It varied from 5cm to 25cm in depth and for most of the length of the trench was located immediately above the subsoil (Context 202). The subsoil was an orange sandy clay through which the bedrock, and in a few places bedrock-derived rotted basalt protruded. It was very similar to the subsoil in Trench 1. As in Trench 1 there was a recently deposited clay (Context 204), located beneath the topsoil (201) in the extreme south east of the trench, which was sitting above a grey brown loam (Context 203). It seems likely that the clay layer (Context 204) is associated with the relatively recent demolition of an agricultural building and the loam beneath it (Context 203) is the topsoil on to which this demolition layer was deposited. No artifacts or archaeological features were found during the excavation of this trench. (Photo 2)

*Photo 2: Trench 2 after excavation*

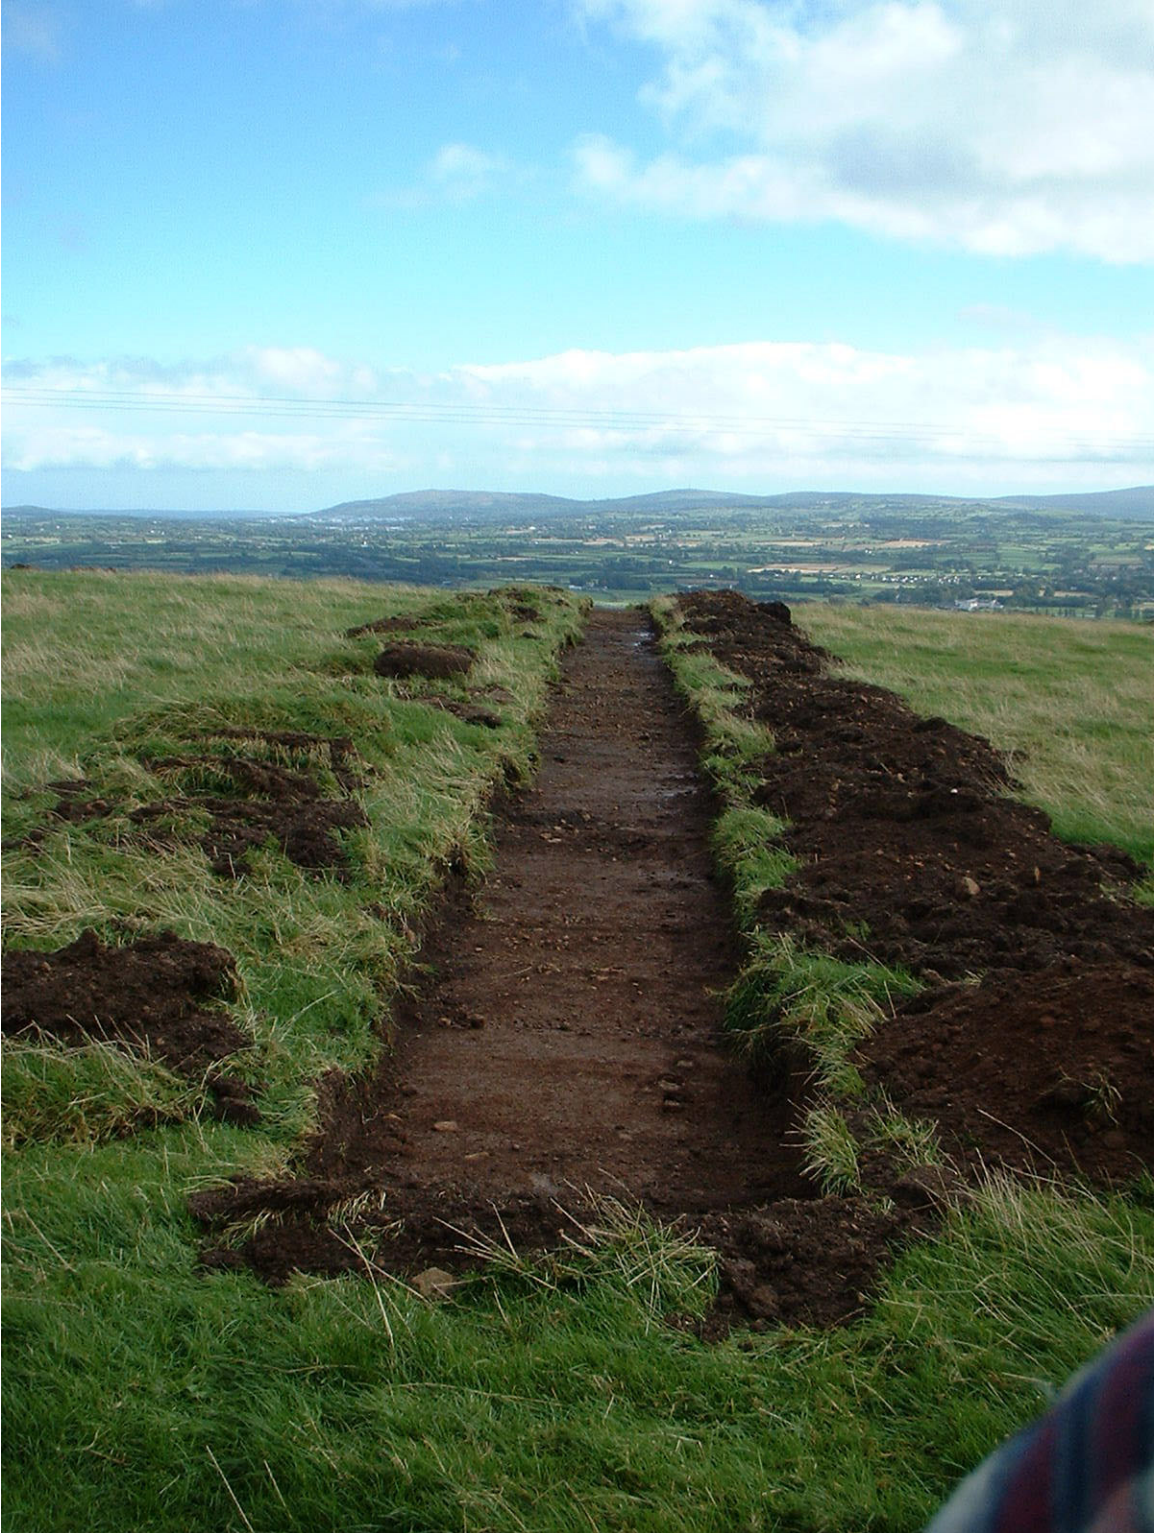
Trench 3: This trench was 1m wide by 40 m long. It ran north-west to south-east and was located approximately 30 m south-west of the north-east boundary of the development site and 10m south-west of Trench 2. The topsoil in this trench was a mid brown light sandy loam (Context 301) similar to the topsoil in Trench 1 and 2. It varied between 15 and 20cm thick and sat above the subsoil (Context 302). The subsoil was an orange sandy clay located above the basalt bedrock which sometimes protruded through it. In places the basalt bedrock had decayed into discrete lumps of rotted basalt. At the extreme south-east, where the ground begins to drop towards the break of slope, there was a slightly more grayish variant of the topsoil (Context 303) located beneath the topsoil (Context 301) and sitting above the subsoil (Context 302). It is likely that the distinction between Context 303 and the topsoil is the result of ploughing which did not fully penetrate the topsoil at the south east side of the development site where the level of the ground rapidly fell. No artifacts or archaeological features were found during the excavation of this trench. (Photo 3)

*Photo3: Trench 3 after excavation*

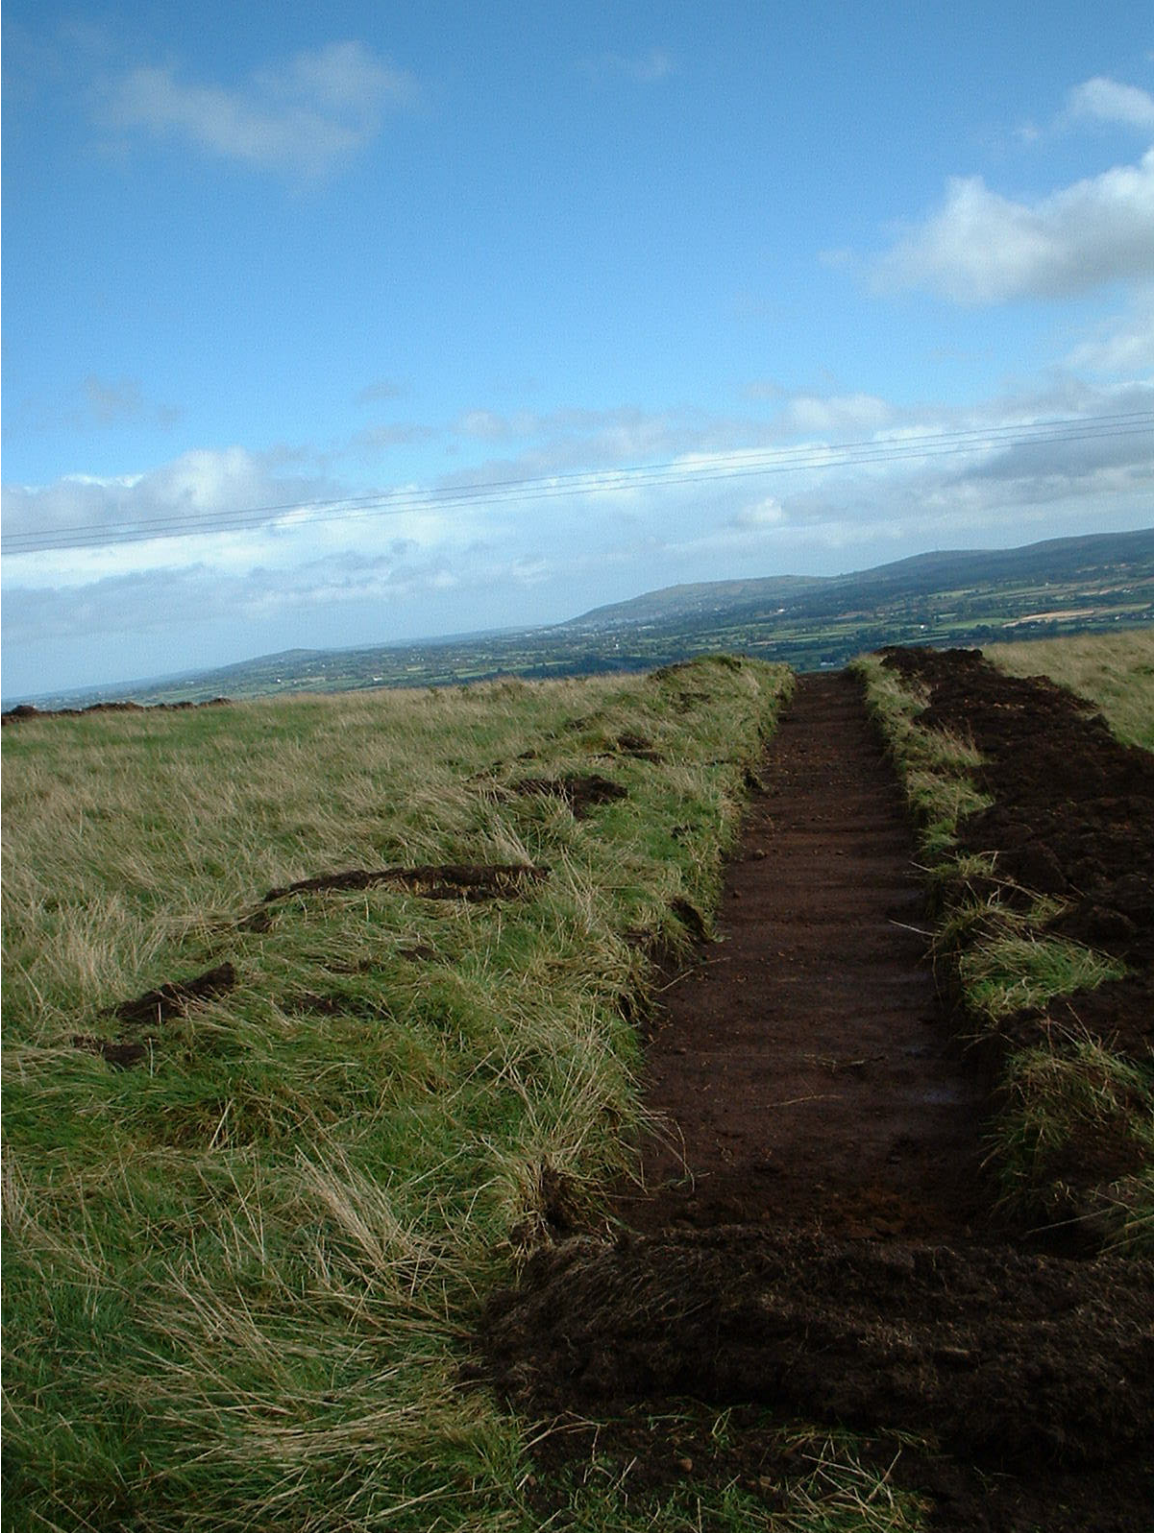
Trench 4: This trench was 1m wide by 40 m long. It ran north-west to south-east and was located approximately 40 m south-west of the north-east boundary of the development site and 10m south-west of Trench 3. The topsoil in this trench was a mid brown light sandy loam (Context 401) similar to the topsoil in the other trenches. In places the topsoil was very shallow, about 5cm in depth, but it deepened to the south-east, where it was up to 40cm deep. The subsoil (Context 403) was an orange sandy clay through which the basalt bedrock protruded in places. It was located directly beneath the topsoil (Context 401). No artifacts or archaeological features were found during the excavation of this trench. (Photo 4)

*Photo 4: Trench 4 after excavation*

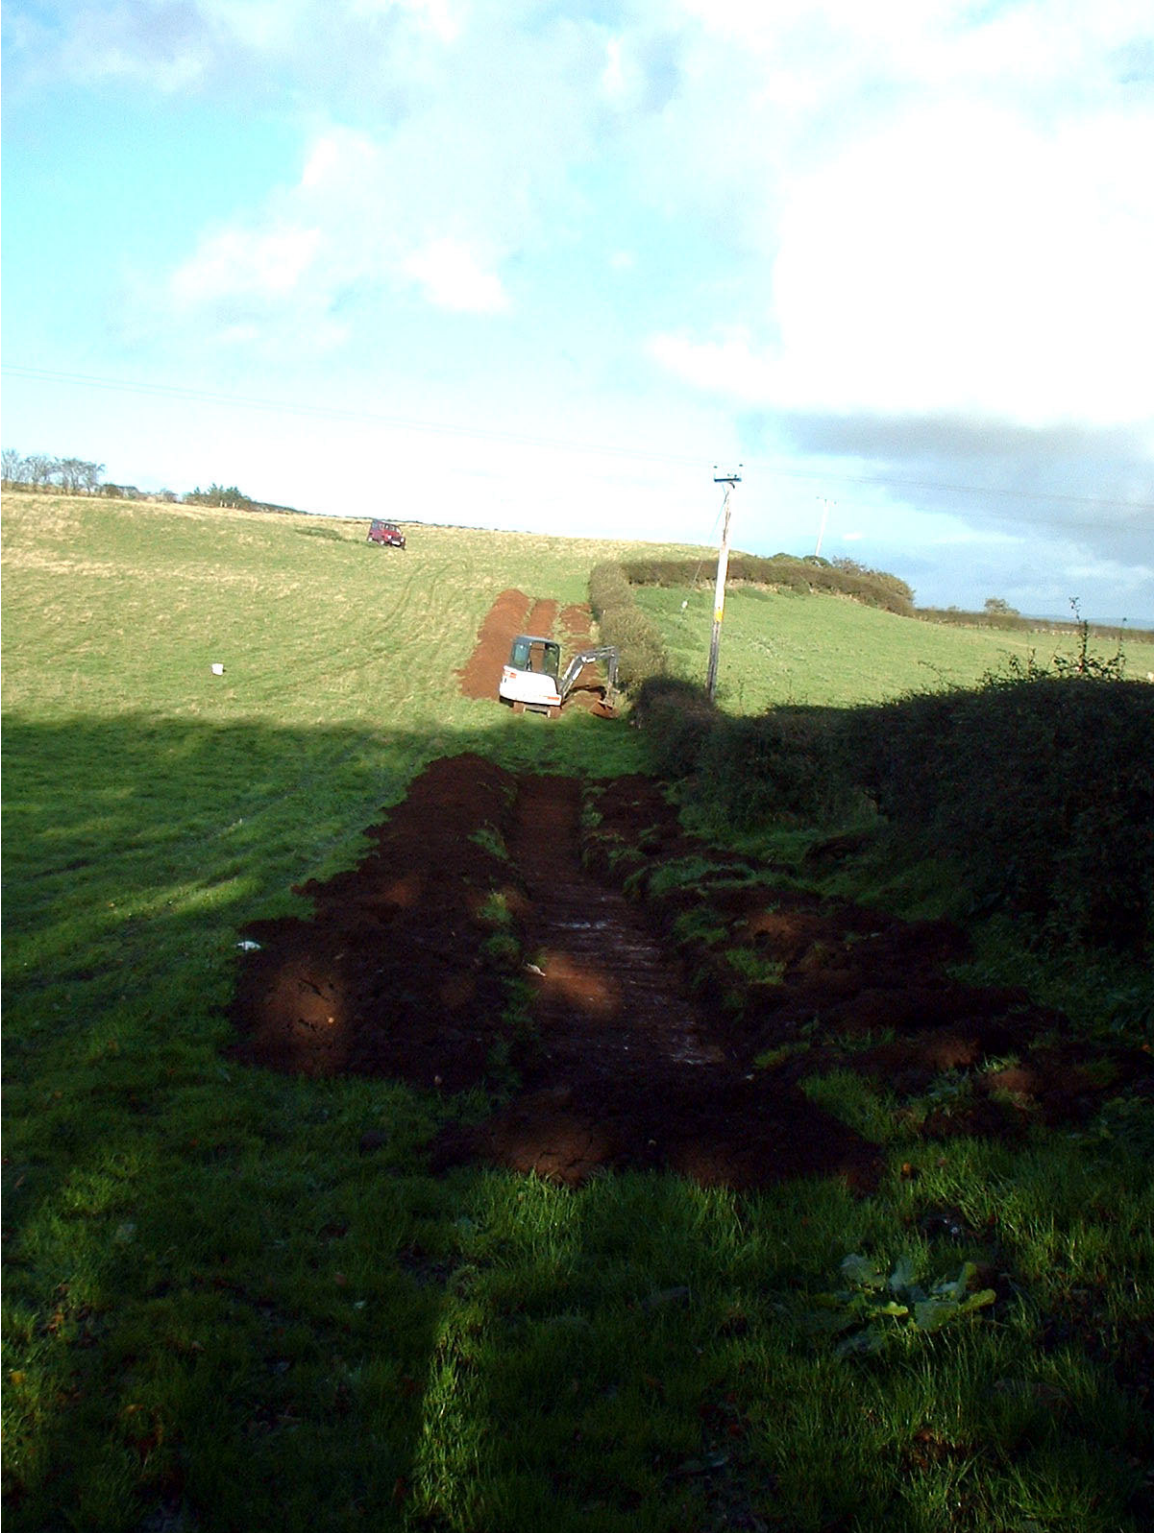
Trench 5: This trench was 1m wide and 70m long. It was located along the suggested line of the access road to the housing development and was orientated east-north-east by west-south-west. There was a gap of about 15m left in the center of the trench because of the presence of poorly located service pipes in that area. The topsoil (Context 501) was a mid brown light sandy loam with a slight amount of orange flecking in the matrix of the soil. It varied between 20 and 30cm deep. The topsoil was similar to the topsoil on the main development site but slightly more sandy and with the orange flecks in the soil matrix mentioned above. This change of texture and colour may be the result of more frequent (or more recent) ploughing of this area causing some of the subsoil to be mixed in with the topsoil. At the base of the topsoil there were patches of small stones and gravel consistent with the tendency for small stones to gather at the base of plough soils. Immediately beneath the topsoil (501) was the subsoil (502) which was an orange sandy, and in places slightly gravelly, clay. No artifacts or archaeological features were found during the excavation of this trench. (Photo 5).

*Photo 5: Trench 5 after excavation*

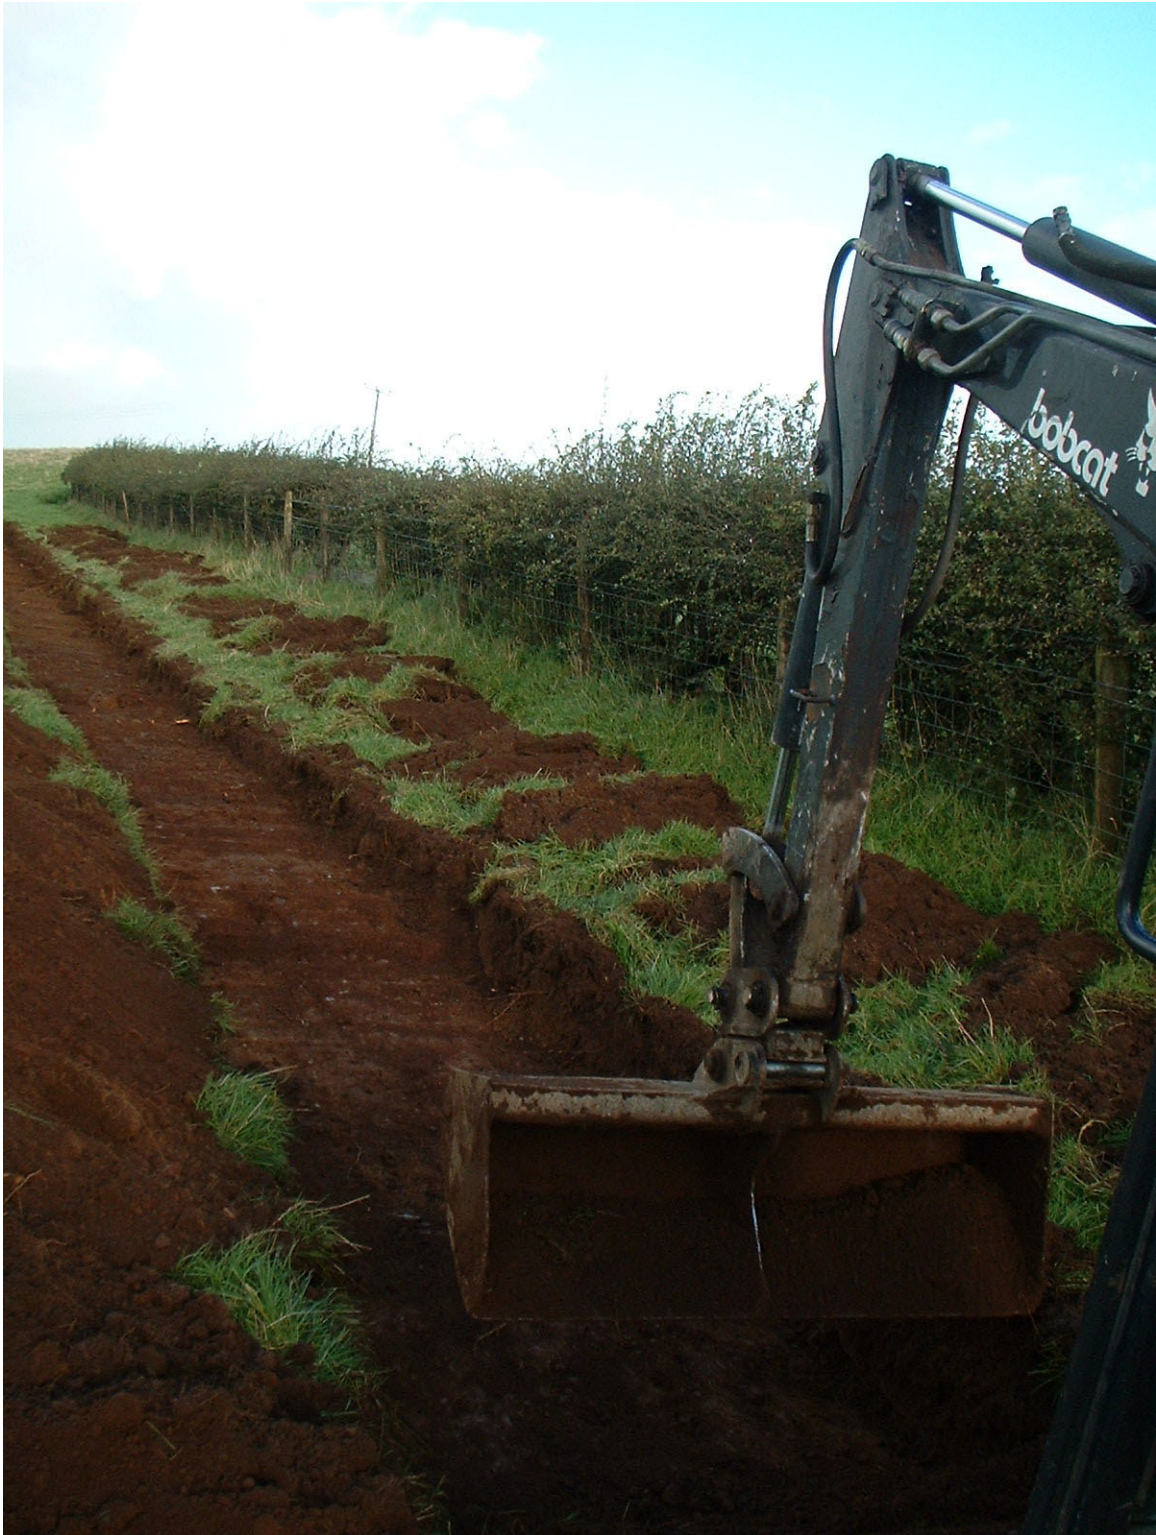
Photo 6: Excavation of Trench 5 showing utilization of toothless “sheugh” bucket
