Monitoring Report No. 30

**Killesher
Co. Fermanagh**

AE/05/132

Site Name: Elliot York Development

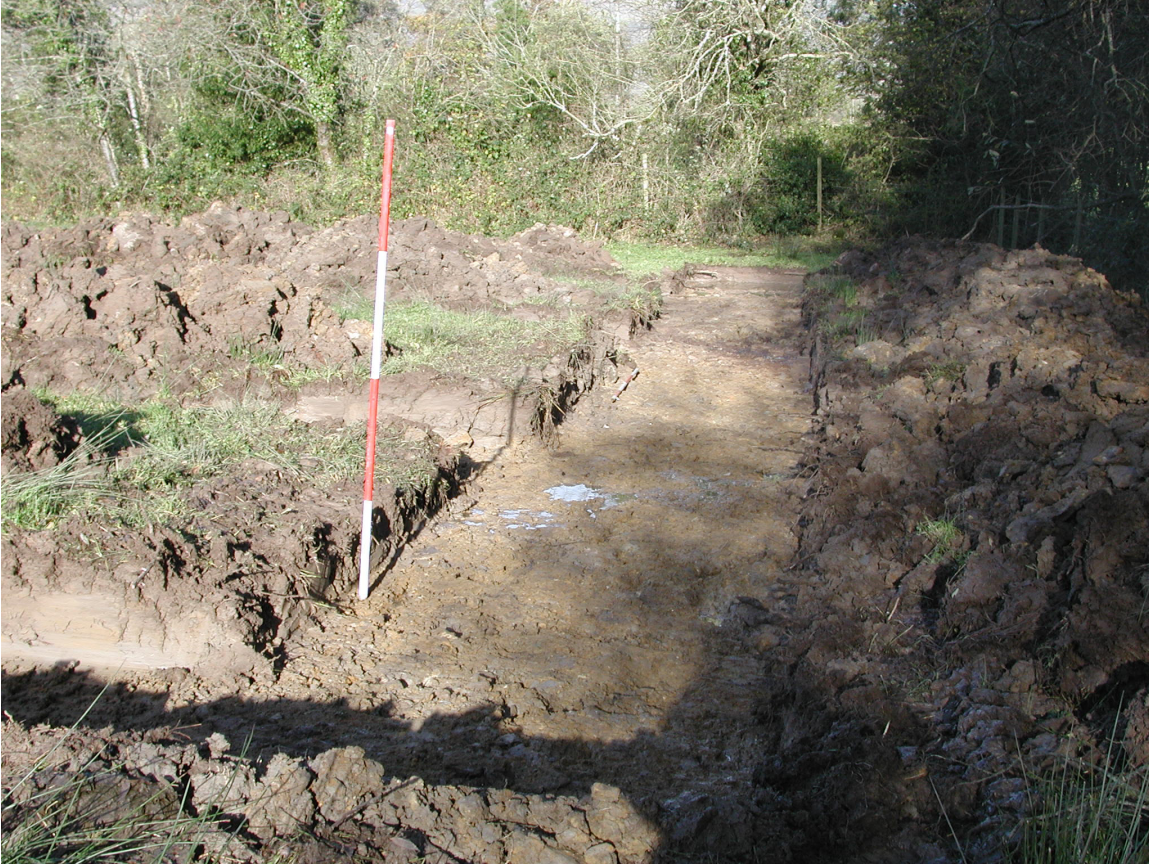
Photo 1: Trench 1 after excavation

Trench 1: This trench was 2m wide by 25m long. It ran north-east to south-west and was located approximately 3 m north-west of the eastern field / site boundary. The topsoil in this trench was a grey brown silty loam (Context 101), which averaged approximately 30cm in depth. The topsoil sat directly on top of the subsoil (Context 102). The subsoil consisted of a yellow orange sandy clay which contained within its matrix naturally occurring sandstone stones up to a maximum of approximately 50cm in diameter. No artifacts or archaeological features were found during the excavation of this trench. (Photo 1)

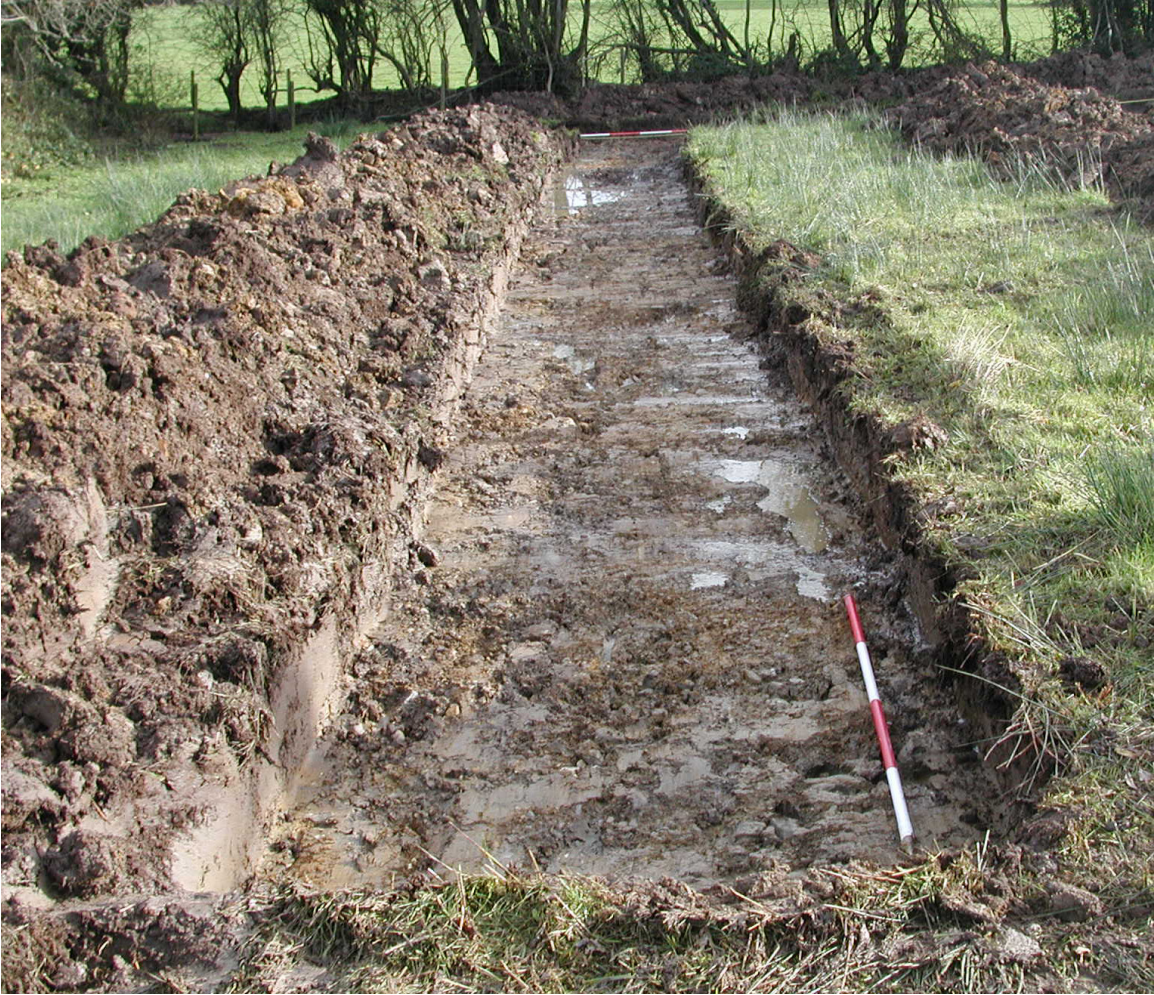
Photo 2: Trench 2 after excavation

Trench 2: This trench was 2m wide by 25m long. It ran north-west to south-east and was located at a right angle to Trench 1. The topsoil in this trench was a grey brown silty loam (Context 201) which was between 25 and 40cm in depth. The topsoil sat directly on top of the subsoil (Context 202). The subsoil consisted of a yellow to orange sandy clay, which contained within its matrix naturally occurring sandstone stones up to a maximum of approximately 30cm in diameter. No artifacts or archaeological features were found during the excavation of this trench. (Photo 2)

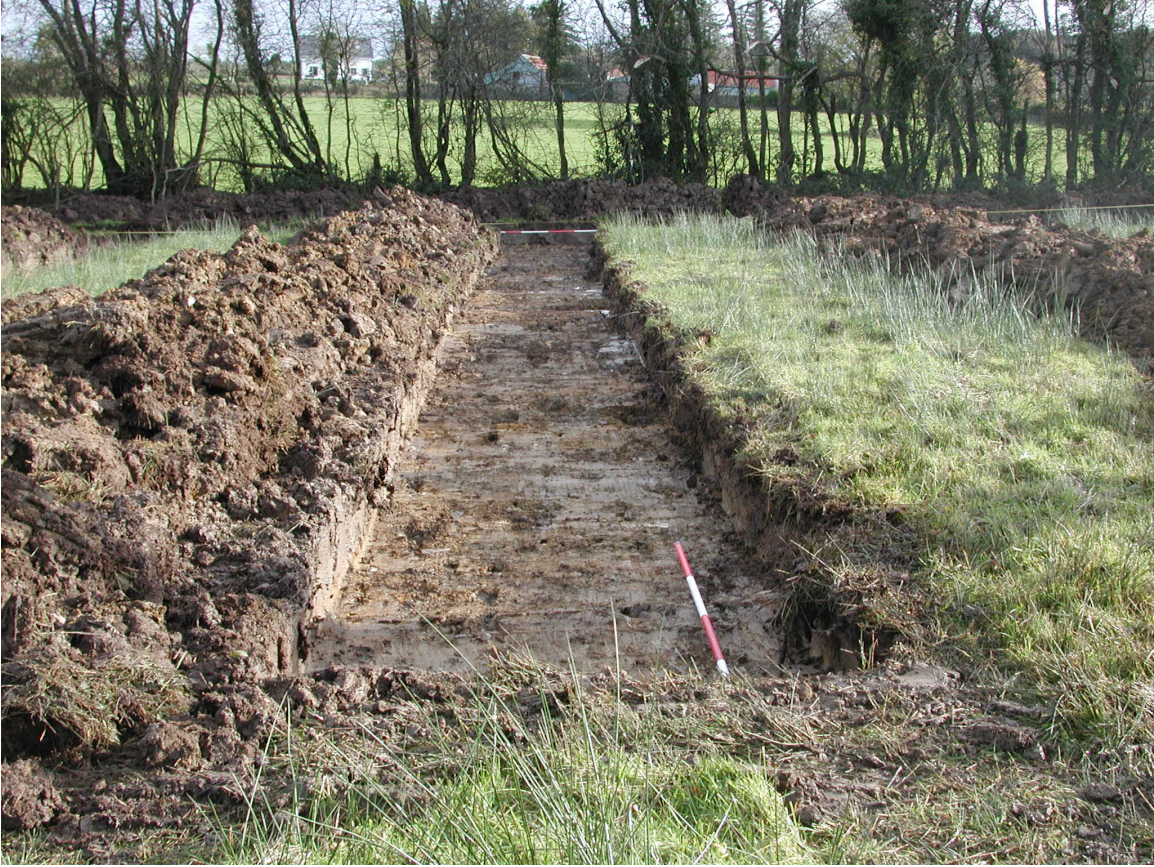
Photo 3: Trench 3 after excavation

Trench 3: This trench was 2m wide by 25m long. It ran north-west to south-east and was located at a right angle to Trench 1. The topsoil in this trench was a grey brown silty loam (Context 301), which was between 40 and 50cm in depth. The topsoil sat directly on top of the subsoil (Context 302). The subsoil consisted of a yellow to orange sandy clay, which contained within its matrix naturally occurring sandstone stones up to a maximum of approximately 30cm in diameter. No artifacts or archaeological features were found during the excavation of this trench. (Photo 3)

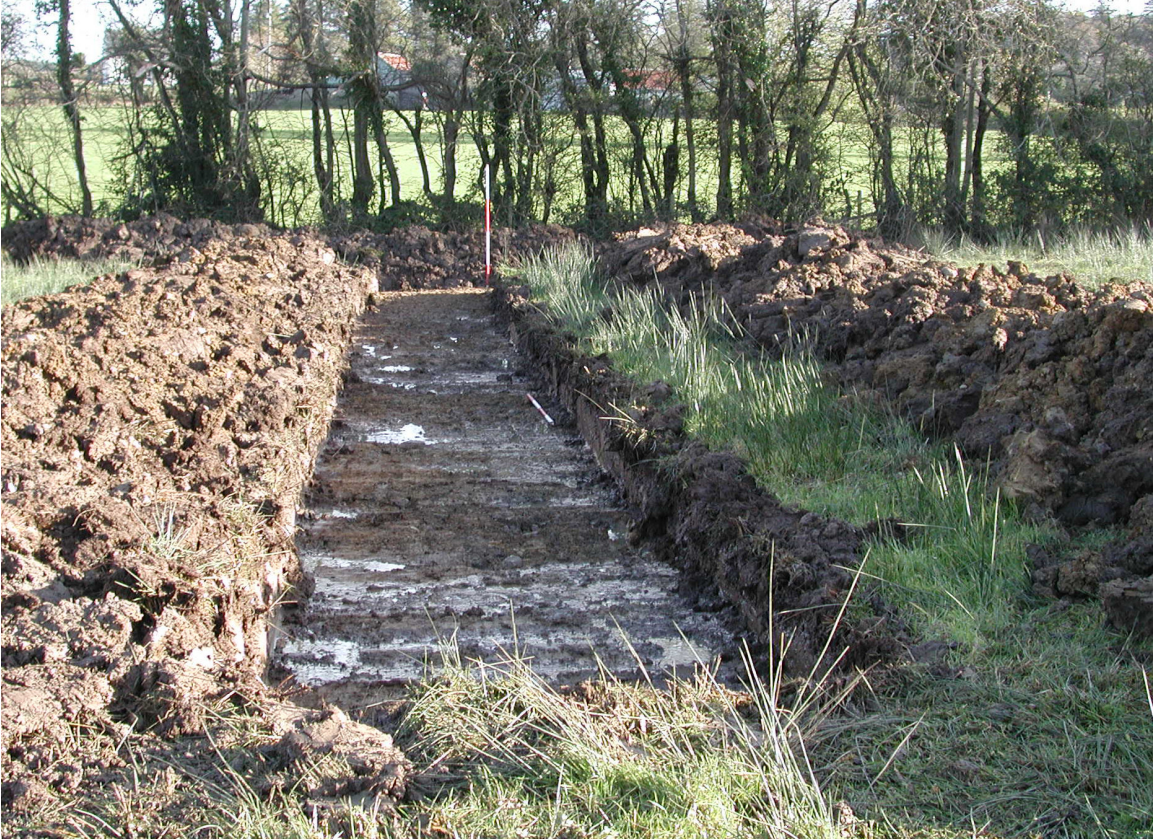
Photo 4: Trench 4 after excavation

Trench 4: This trench was 2m wide by 25m long. It ran north-west to south-east and was located at a right angle to Trench 1. The topsoil in this trench was a grey brown silty loam (Context 401,) which was between 40 and 50cm in depth. The topsoil sat directly on top of the subsoil (Context 402). The subsoil consisted of a yellow / mustard sandy clay, which contained within its matrix naturally occurring sandstone stones up to a maximum of approximately 30cm in diameter. No artifacts or archaeological features were found during the excavation of this trench. (Photo 4)

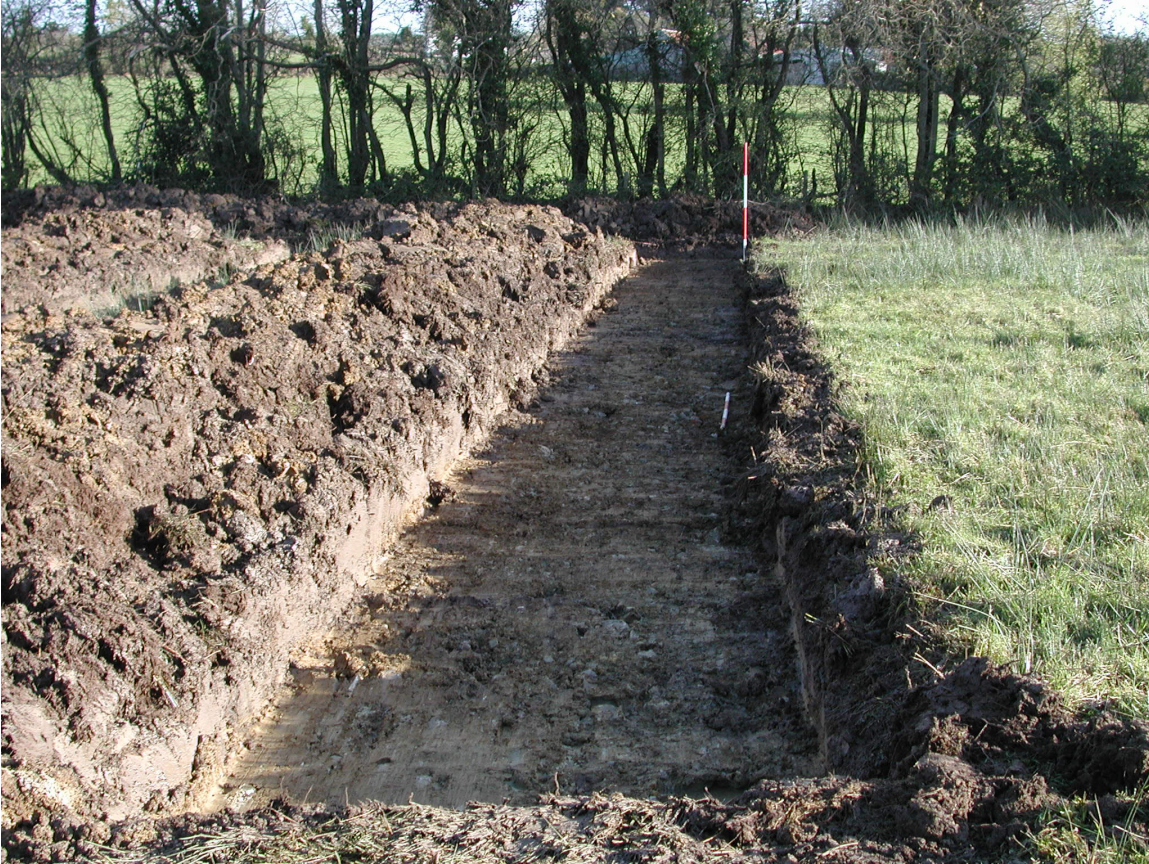
Photo 5: Trench 5 after excavation

Trench 5: This trench was 2m wide by 25m long. It ran north-west to south-east and was located at a right angle to Trench 1. The topsoil in this trench was a grey brown silty loam (Context 501), which was between 40 and 50cm in depth. The topsoil sat directly on top of the subsoil (Context 502). The subsoil consisted of a yellow to mustard sandy clay, which contained within its matrix naturally occurring sandstone stones up to a maximum of approximately 30cm in diameter. No artifacts or archaeological features were found during the excavation of this trench. (Photo 5)

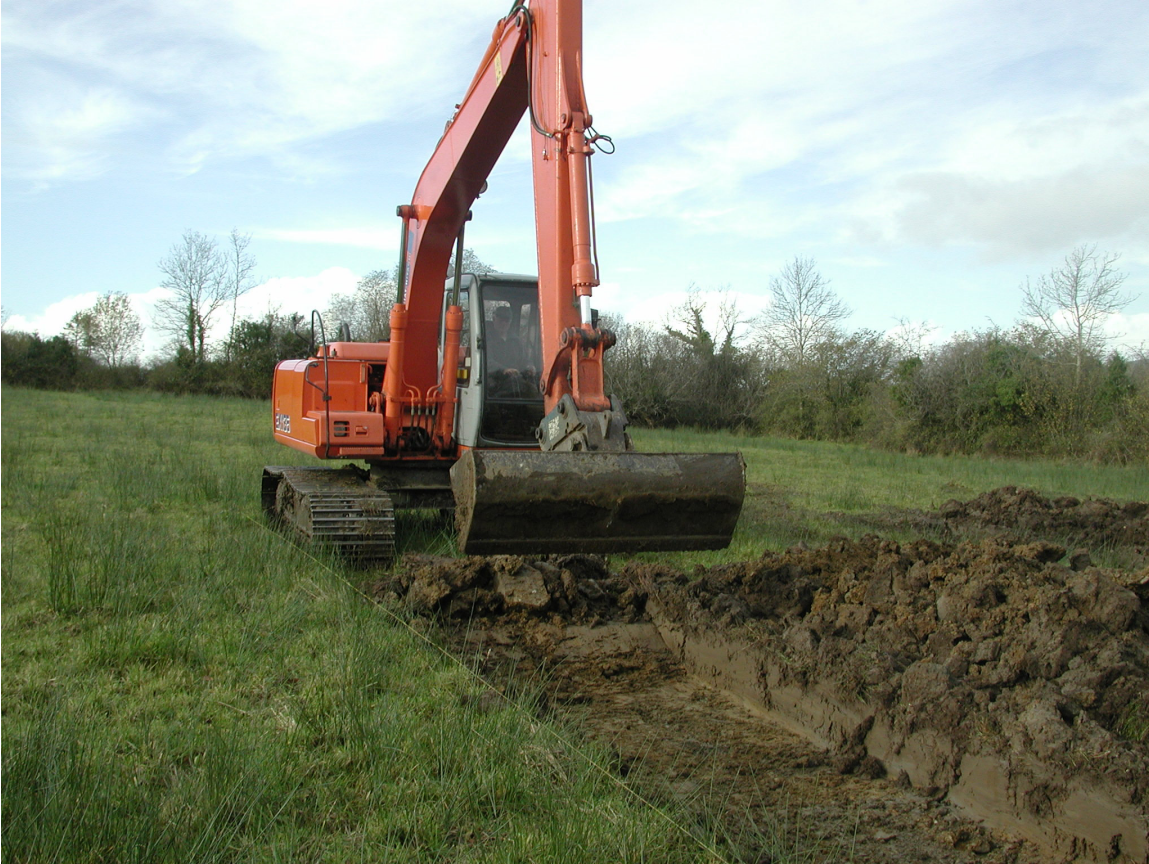
Photo 6: Excavation of Trench 5 showing utilization of toothless “sheugh” bucket.

A total of five trenches were excavated as part of this evaluation procedure (Figures 1 – 4). The trenches were excavated using a mechanical digger equipped with a toothless “sheugh” bucket (Photo 6). These trenches were located on the part of the development site suggested for the location of the house footprint. The five trenches all measured 2m by 25m. Trench 1 was located approximately 3m north-west of the field / site boundary. This was so as to not disturb the root systems of the hedge and some trees located along the field boundary. Trenches 2 to 5 were located at right angles to and running west from Trench 1 spaced at five metre intervals.
