Monitoring Report No. 59

**16 Sandeel Lane
Orlock
Groomsport
Co. Down**

AE/06/86

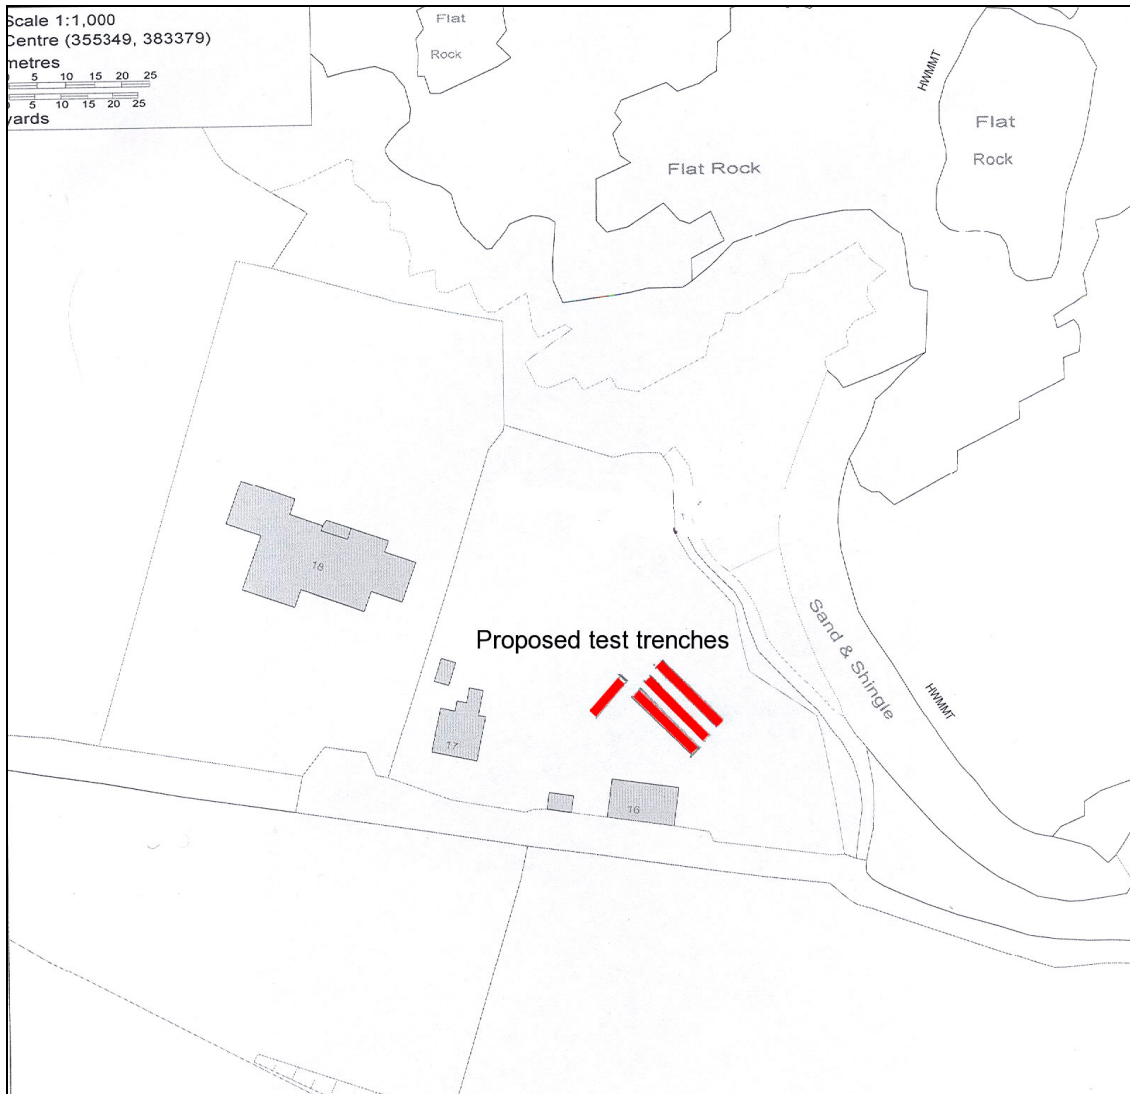
Fig. 3: Proposed location of test trenches (marked in red), as requested by Gina Baban, PHM Caseworker, 22 March 2006.

Monitoring of test trench excavation took place on 28th April 2006. Four test trenches were requested by the PHM Caseworker, Gina Baban, on the site plan (Fig. 3) – three measuring c. 20m x 2m and one c. 15m x 2m. Upon arrival at site it became clear that such an organisation of trenches was impractical since the site plan provided by the PHM Caseworker was out of date. A redevelopment of the neighbouring property (17 Sandeel Lane) had resulted in a large new house being constructed at the northern, seaward edge of this property. This construction work had a direct affect on the area of 16 Sandeel Lane. Part of the area to be trial trenched was covered by builders' rubble and shingle, and the southeastern area of the 16 Sandeel Lane property had been hard-cored to allow for access of heavy machinery, which had severely rutted the remaining grass area. These factors meant that the original trenching methodology was reviewed in the field and replaced with one consisting of four parallel trenches c. 13m x 2m (Fig. 4).

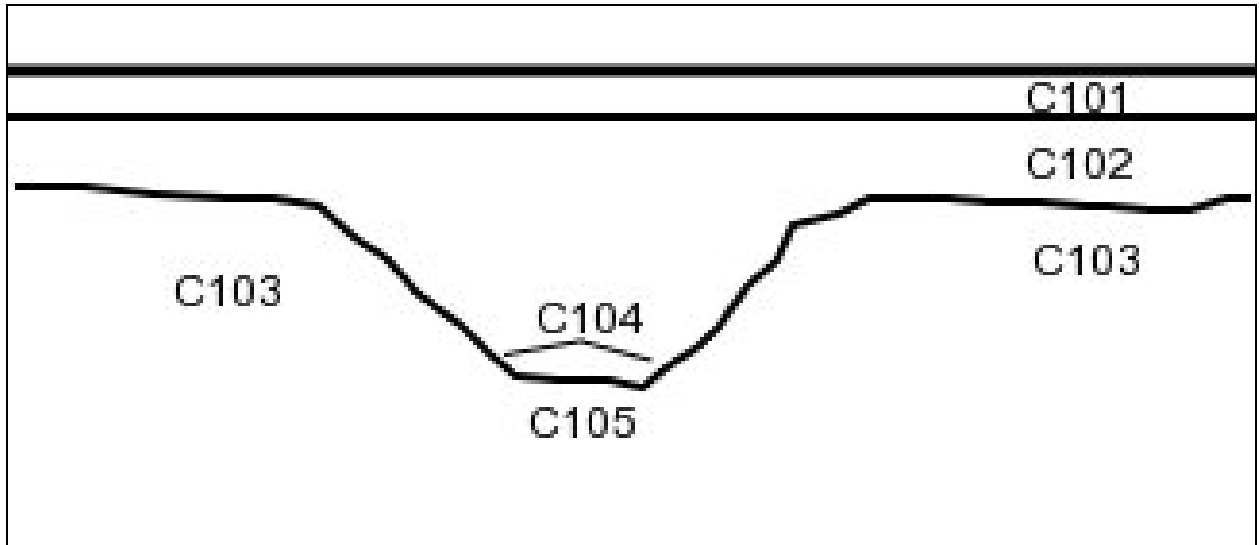
Fig. 5: Sketch showing stratigraphical relationships in Trench 1.

In Trench 1 the builders' rubble (C102) ranged from between 0.40m and 1.50m in depth (Plates 2 and 3). The excessive depth of C102 in this trench was due to a pit (C104) having been cut through the orange clay (C103), which was then infilled with the builders' rubble which characterised C102. At the depth of 1.50m a layer of withered (yet still green) grass was found *in situ* above a layer of light brown sand (C105). A sondage, c. 0.3m³, was dug into C105 (Plate 4) but it proved to be an archaeologically sterile context. The excessive depth of the excavation, however, meant that no further work was attempted, both for health and safety considerations, and also because it is highly unlikely that the house foundations would impact on C105 (Fig. 5).

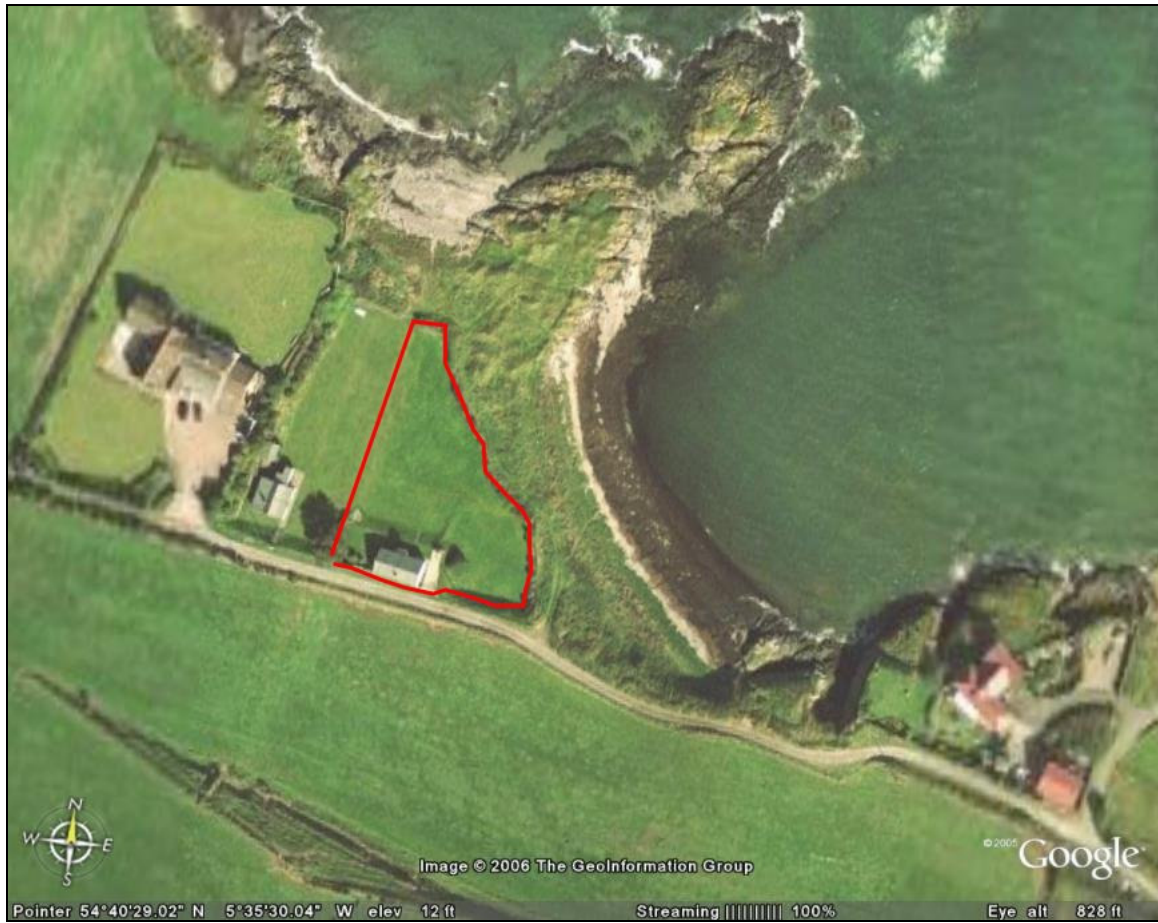
Plate 1: Satellite Image of area (outlined in red) – taken before construction of replacement building for 17 Sandeel Lane, and before hard-coring of area around 16 Sandeel Lane (www.earth.google.com)

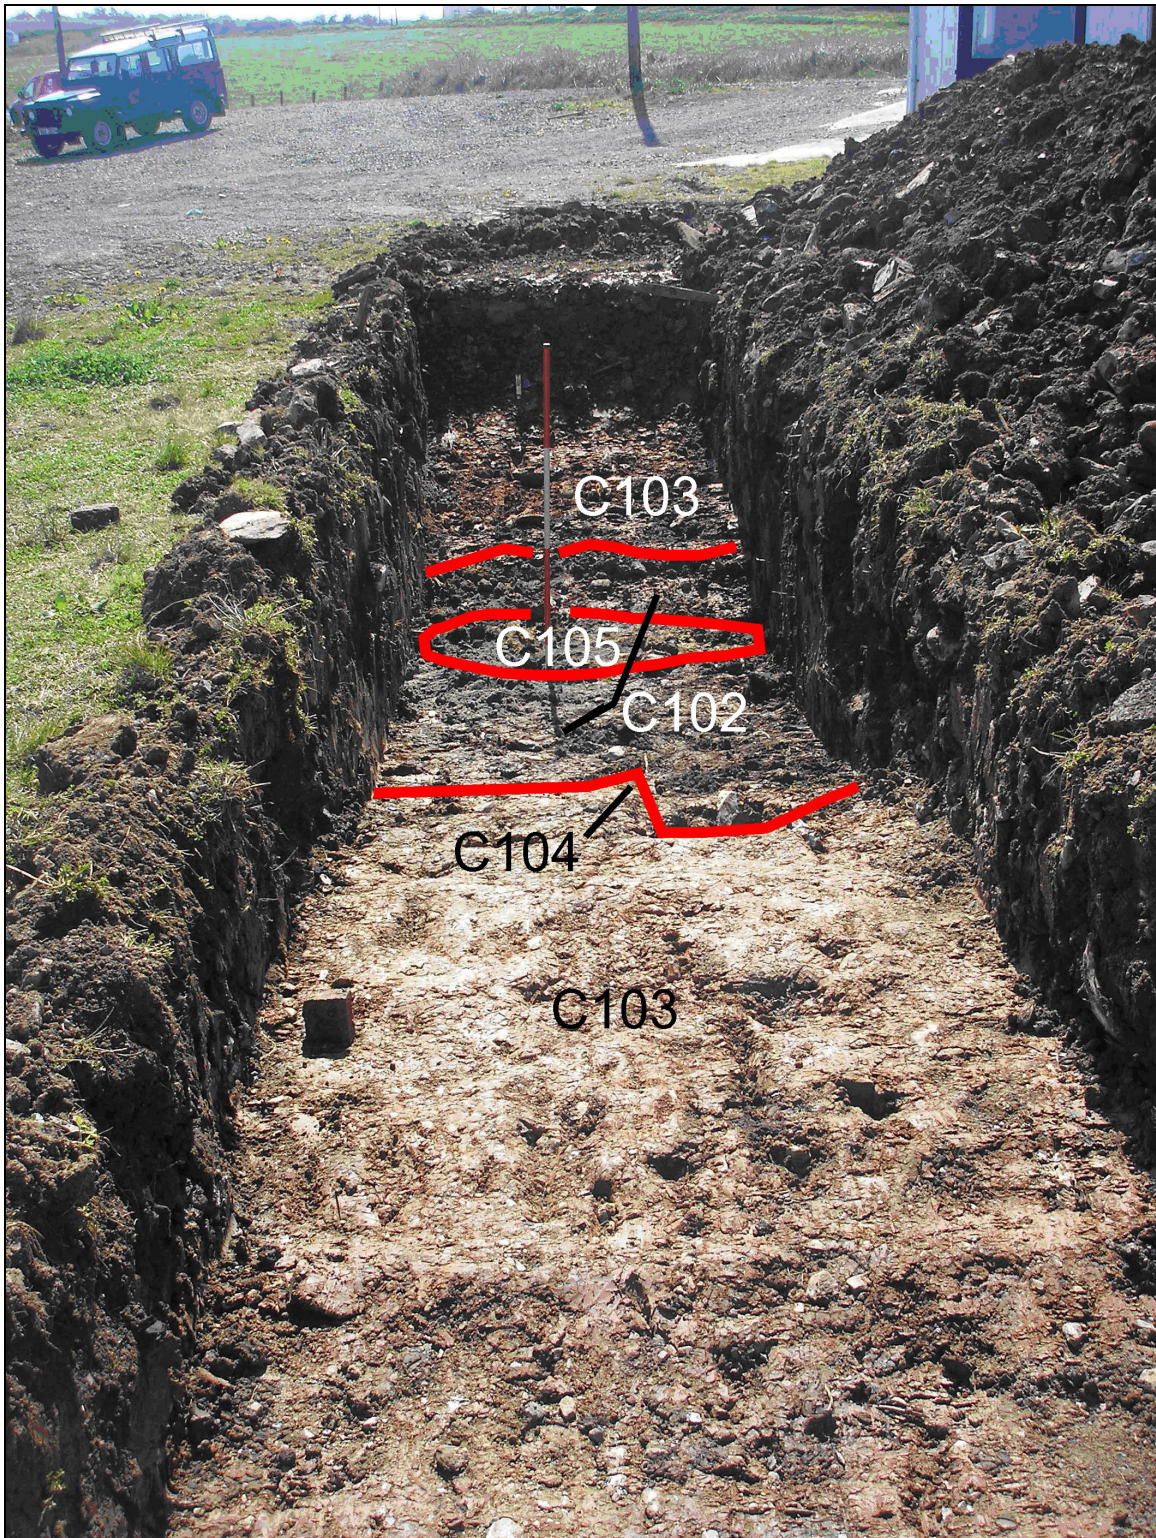
Plate 2: Trench 1, looking south-east: Showing C103 in foreground and background, cut C104, the rubble infill C102 and C105 (sand layer).

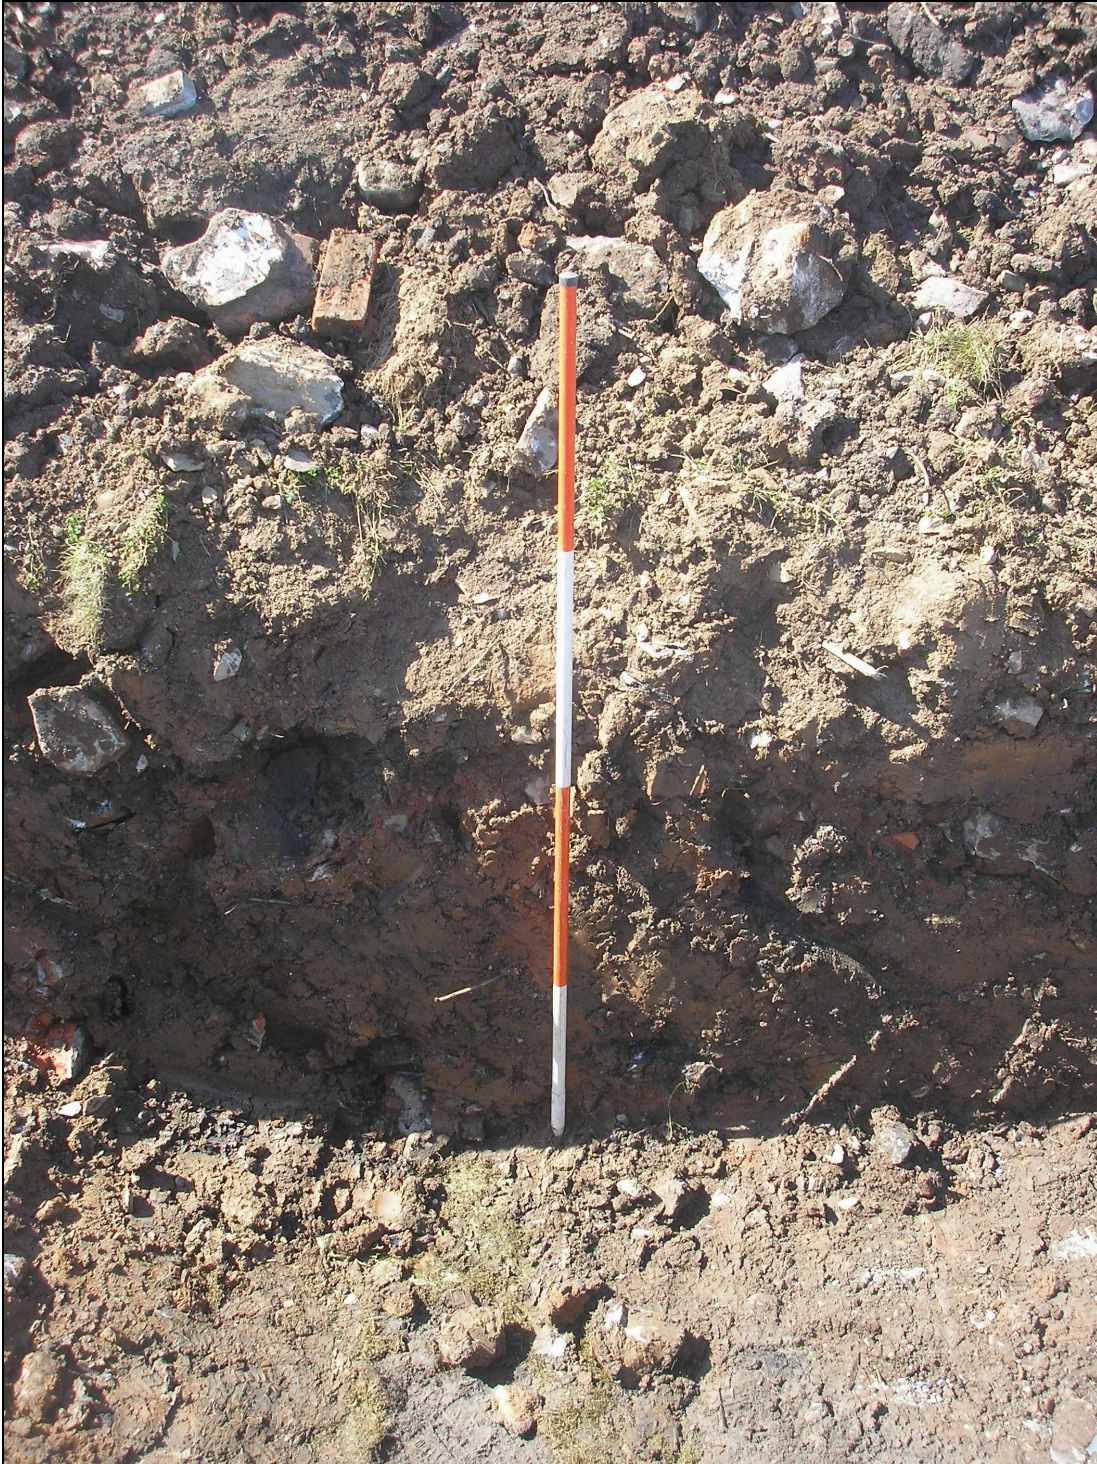
Plate 3: Trench 1 looking south-west: profile of pit-cut (C104) infilled with C102.
Withered grass above bottom of pit-cut C104 is recognisable in front of ranging rod.

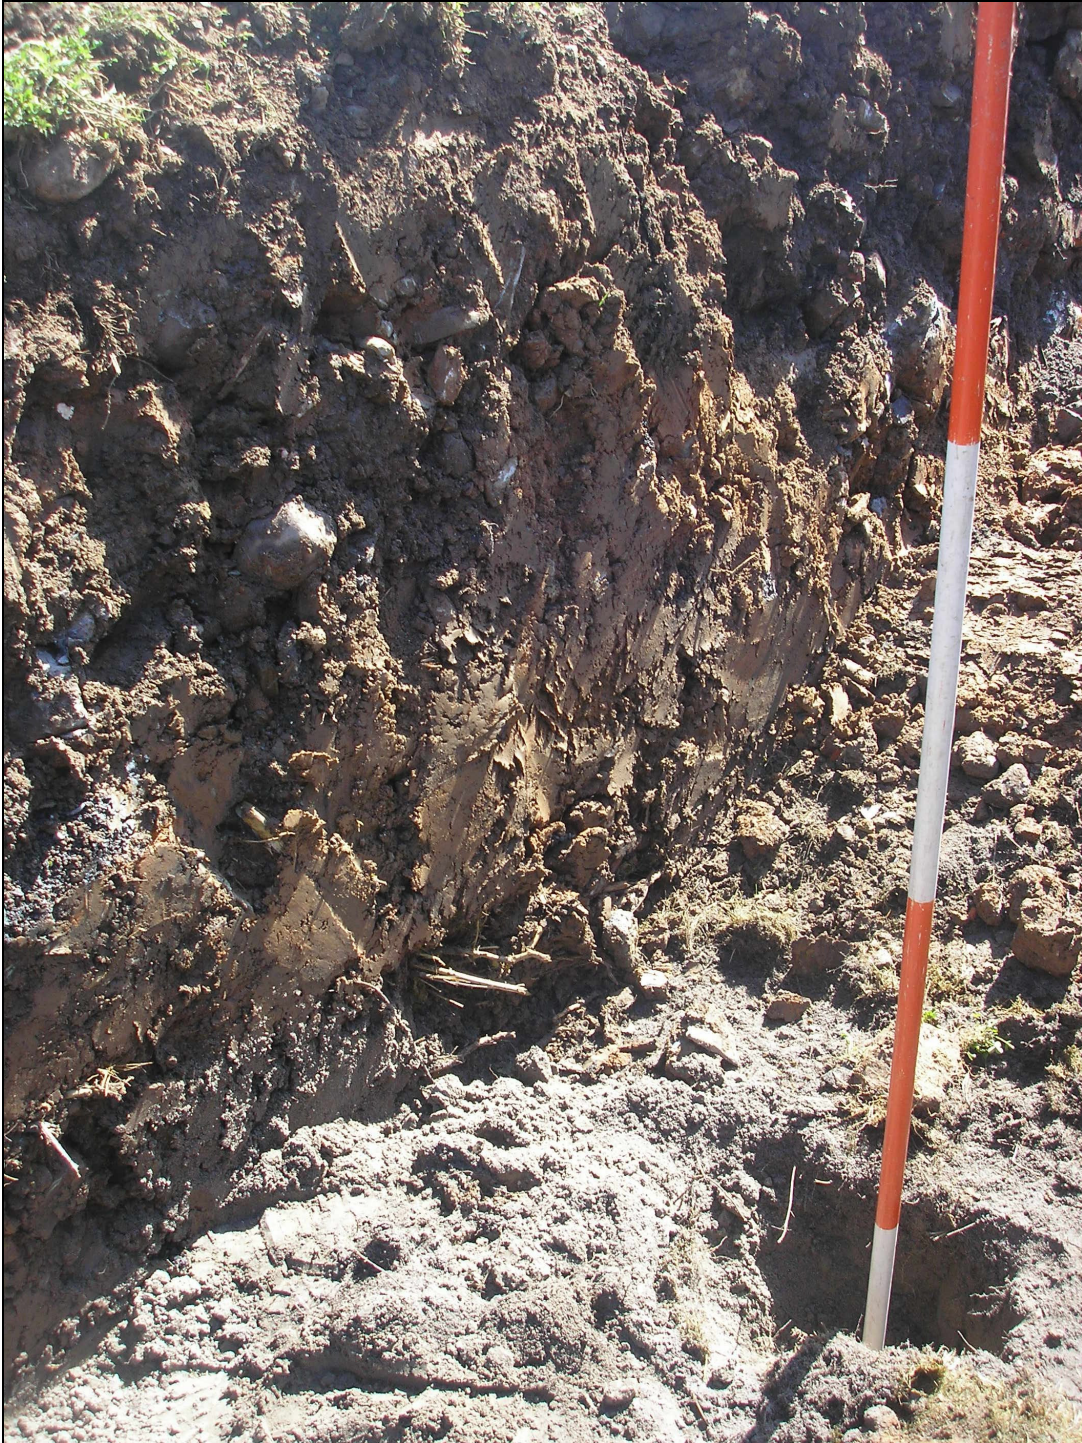
Plate 4: Trench 1 looking south: Sondage through C105. Withered grass above C104 is visible around the area of the sondage.

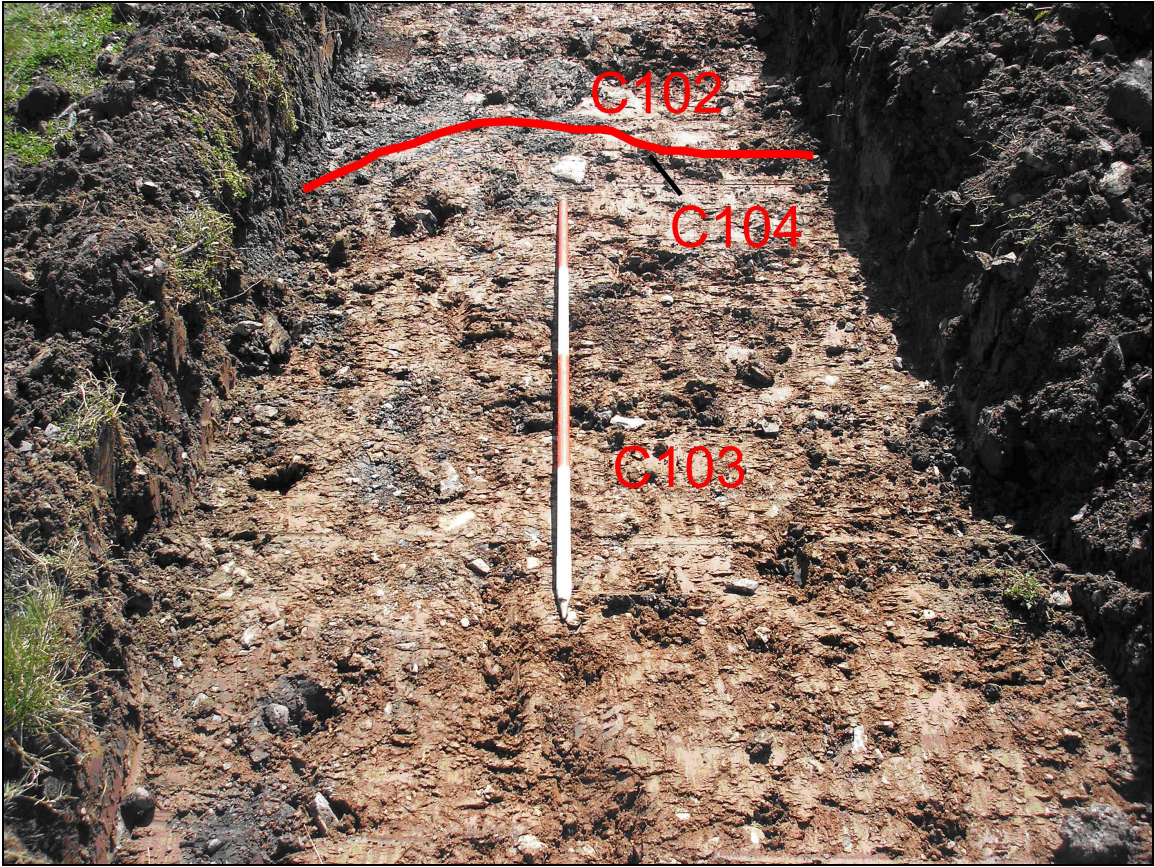
Plate 5: Trench 2, looking south-east: C103 with cut (C104) and rubble infill (C102) to rear.

In Trench 2 the topsoil and builders' rubble (C101 & C102) was removed to a depth of between 0.40m and 0.80m (Plate 5); in Trench 3 the topsoil and builders' rubble (C101 & C102) was removed to a depth of between 0.45m and 0.85m (Plate 6); and in Trench 4 the topsoil and builders' rubble (C101 & C102) was removed to a depth of between 0.4m and 0.65m. In all three trenches this uncovered a layer of orange boulder clay (C103) to the west of the trench which was then cut into by the pit (C104) and infilled with C102. The northern and western edge of this cut feature could be seen in Trench 4 (Plate 7). It was decided, however, knowing the nature and potential depth of this deposit, that C102 not be fully excavated in these trenches.

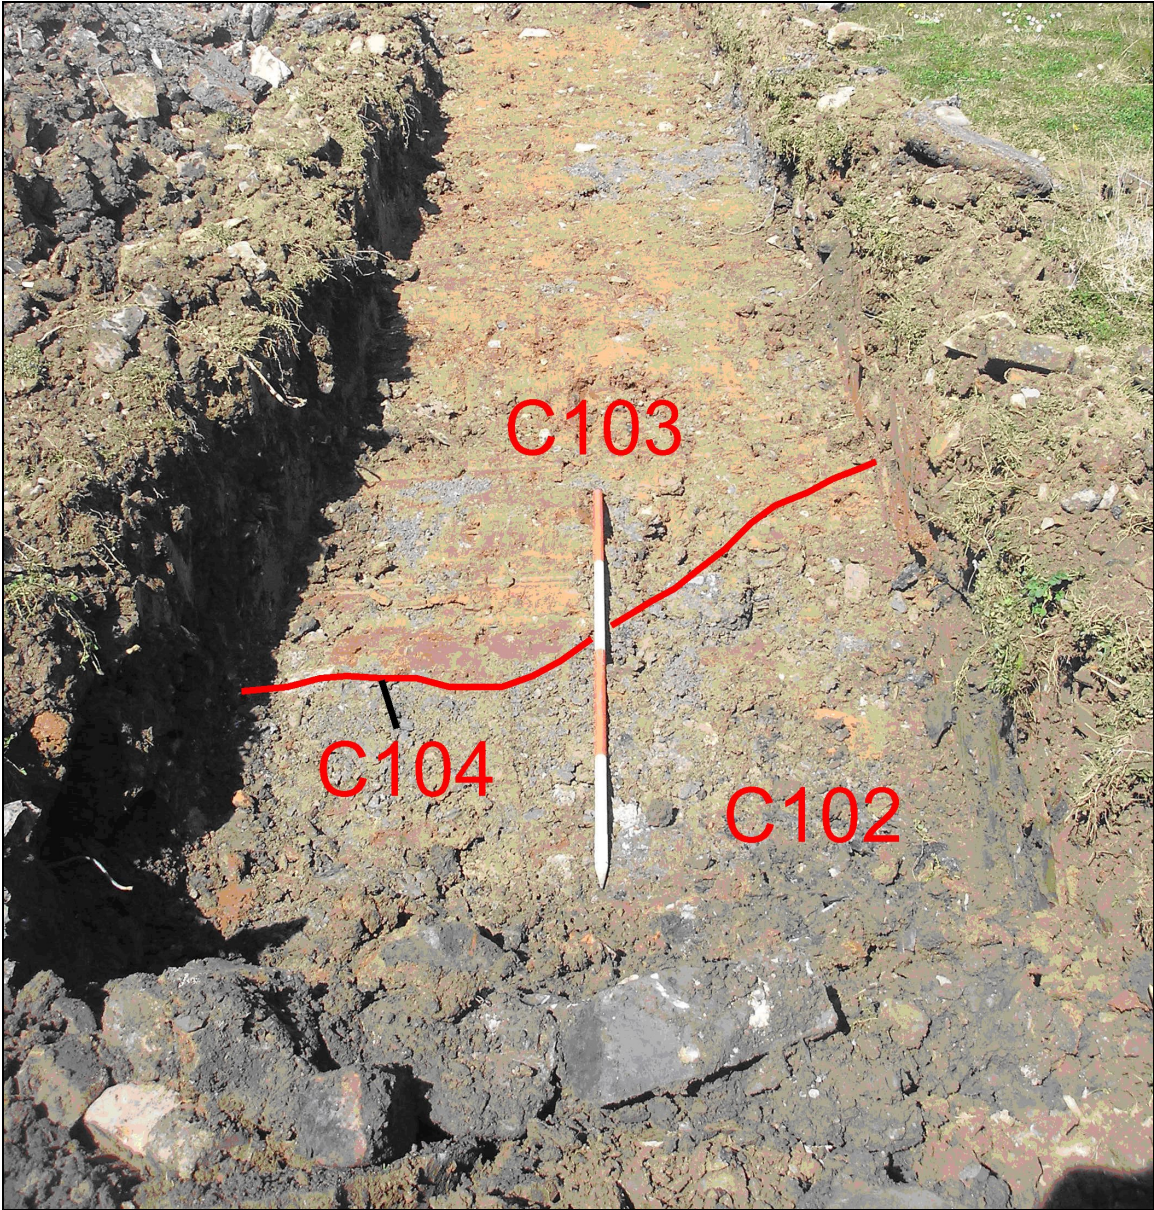
Plate 6: Trench 3 looking northwest: C103 with pit-cut (C104) and rubble infill (C102) in foreground.

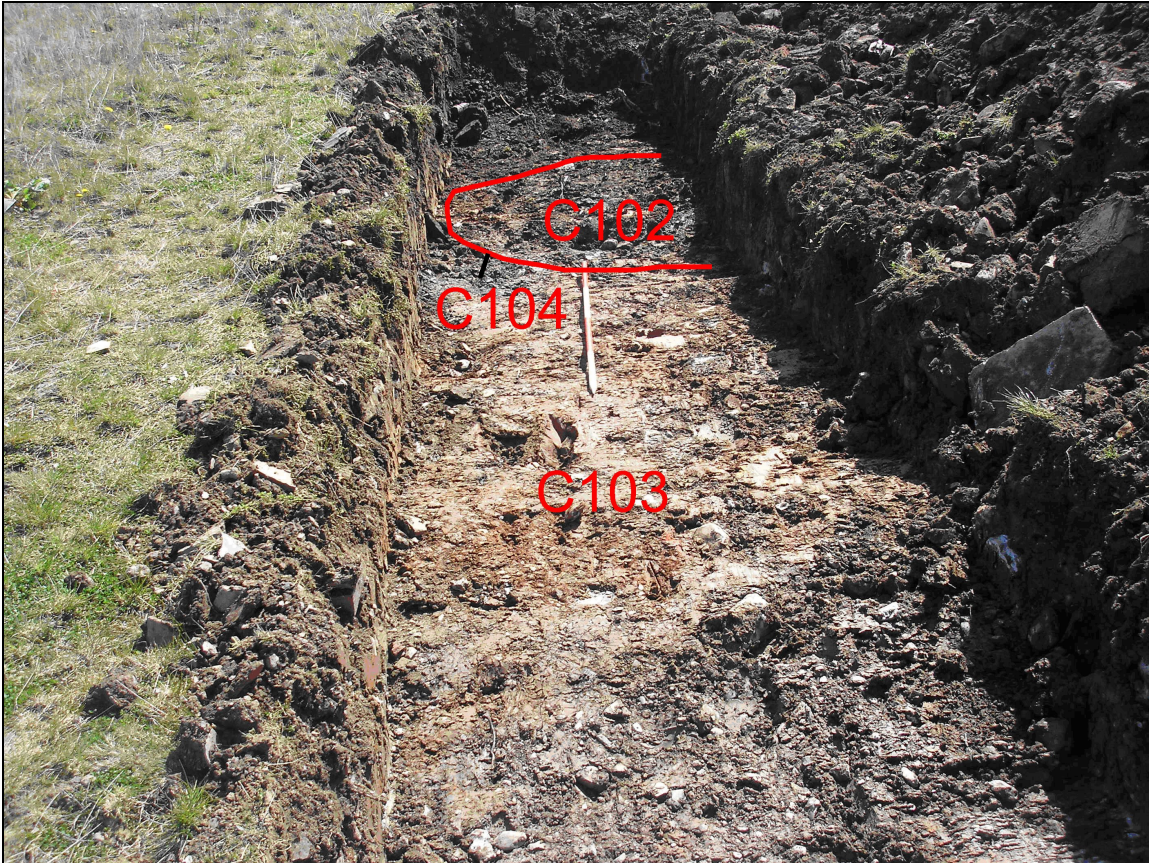
Plate 7: Trench 4 looking southeast: C103 showing western and northern edge of pit-cut (C104) and rubble infill (C102) in background.
