## **Monitoring Report No. 98**

**2 Kearney Road  
Knockinelder  
Portaferry  
Co. Down**

**AE/06/234**

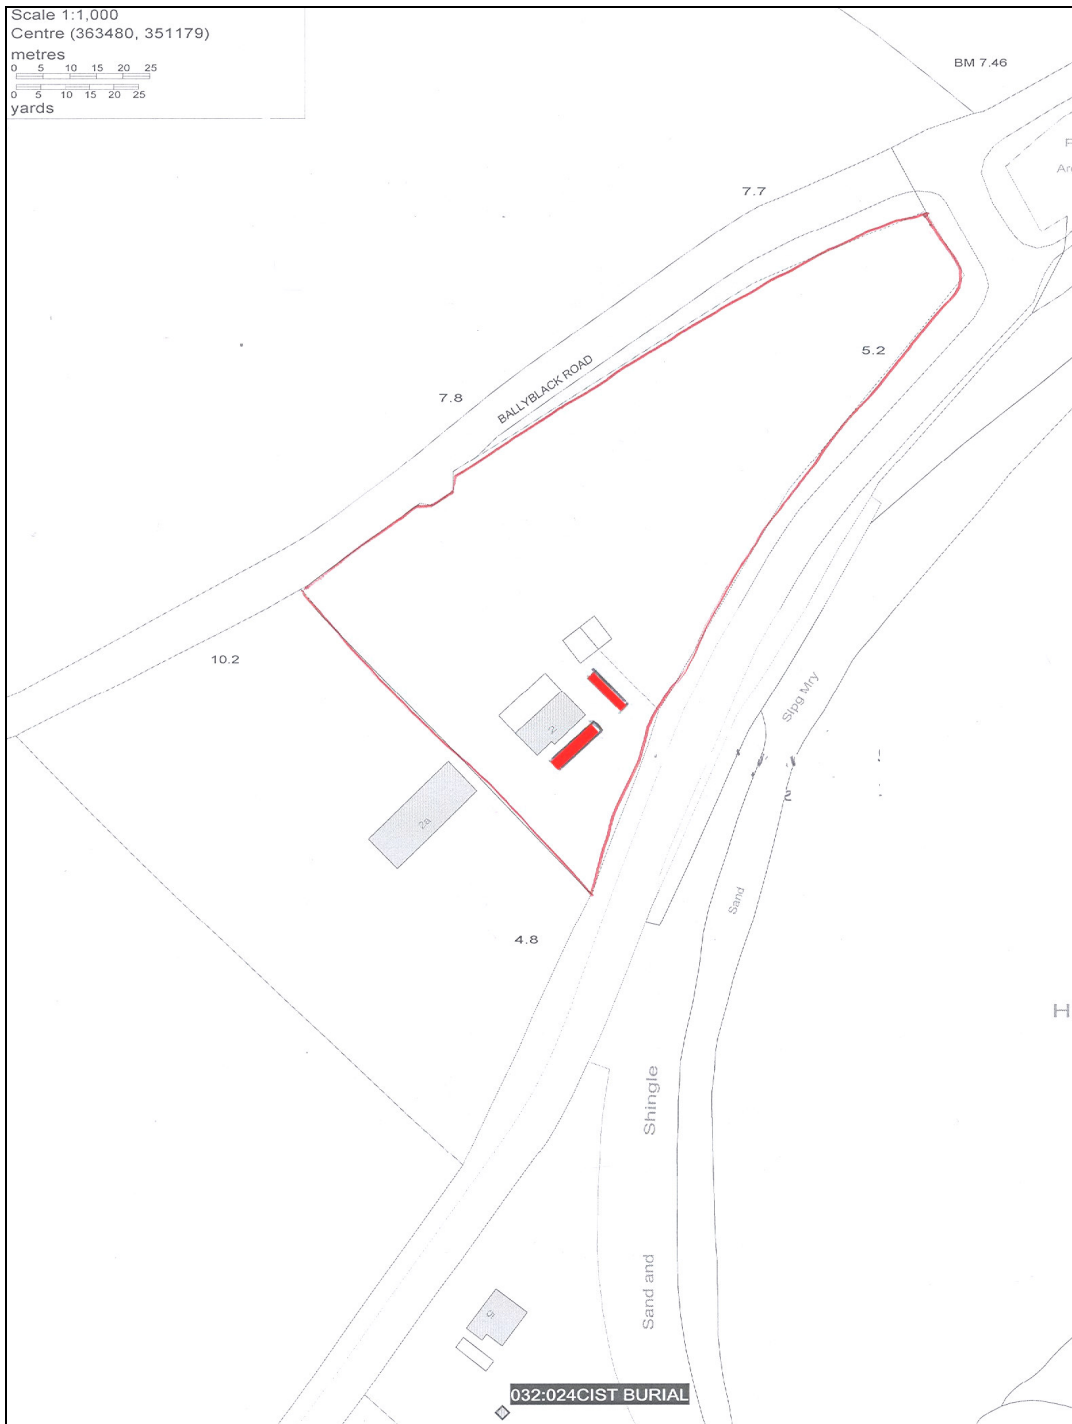
Fig. 3: Location of test trenches (marked in red).

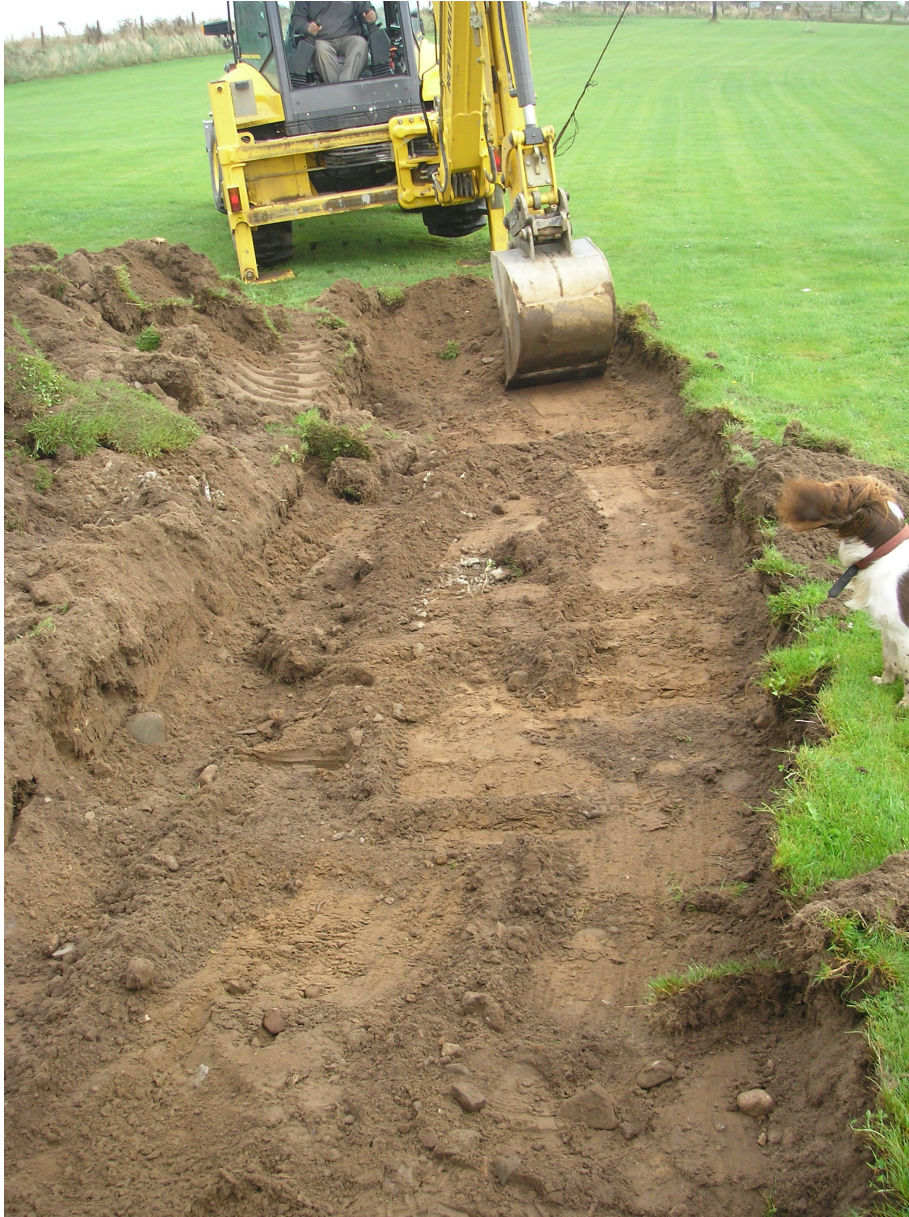
Trench 1 was positioned to the south of the present dwelling and measured approximately 9m by 2m due to the presence of an electricity pylon in the area. The sod and topsoil layer in this trench (Context No. 101) consisted of a very sandy light brown loam with few inclusions of small rounded, probably water-rolled pebbles (average size 40mm x 20mm x 10mm). This layer had an average depth of 0.4m.

Plate 1: Excavation of Trench 1, looking east.

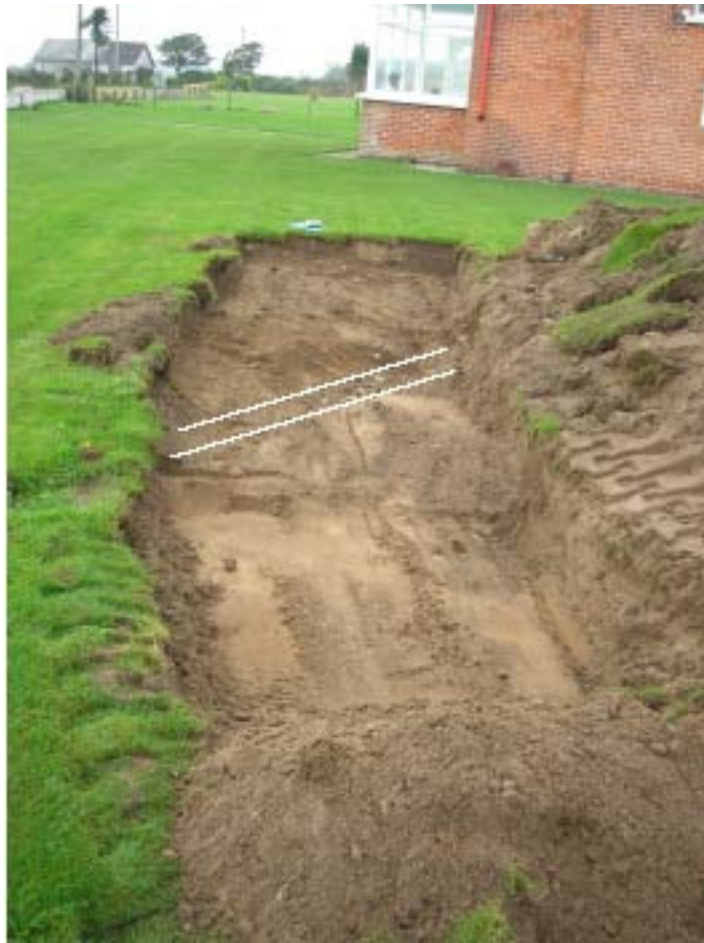
Below the sod and topsoil (Context No.101) was the subsoil (Context No. 102). This consisted of a yellow orange sand with few inclusions of small rounded beach pebbles (average size 60mm x 40mm x 15mm). An electricity cable was encountered cutting the sandy subsoil. The cut for this cable (Context No. 103) ran approximately north-west / south-east and the fill (Context No.104) consisted of the cable itself and a matrix of angular stones and gravel. There were no finds or features of an archaeological nature encountered in this trench.

Plate 2: Trench 1 looking west, after excavation to surface of subsoil (Context No.102), showing cut (Context No. 103) for electric cable (white dashed line).

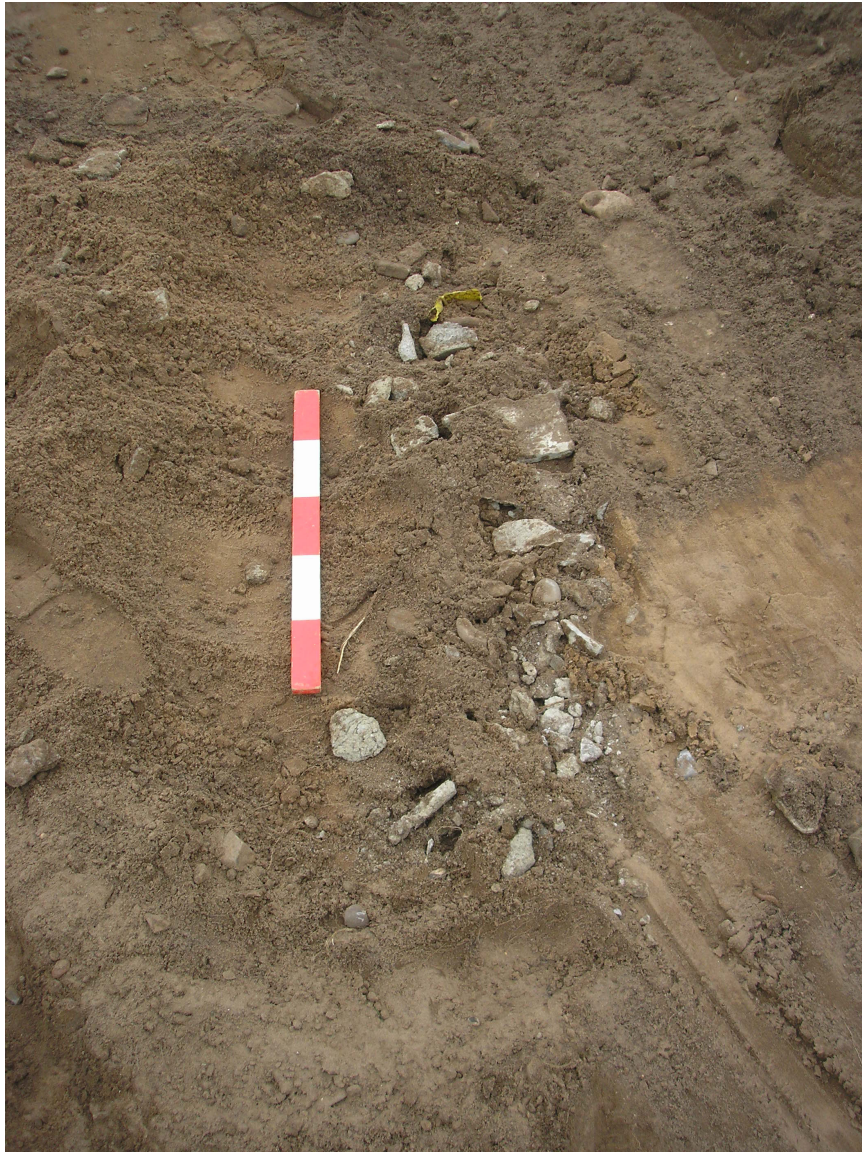
Plate 3: Detail of stone fill (Context No.104) of the cut (Context No. 103) for the electric cable.

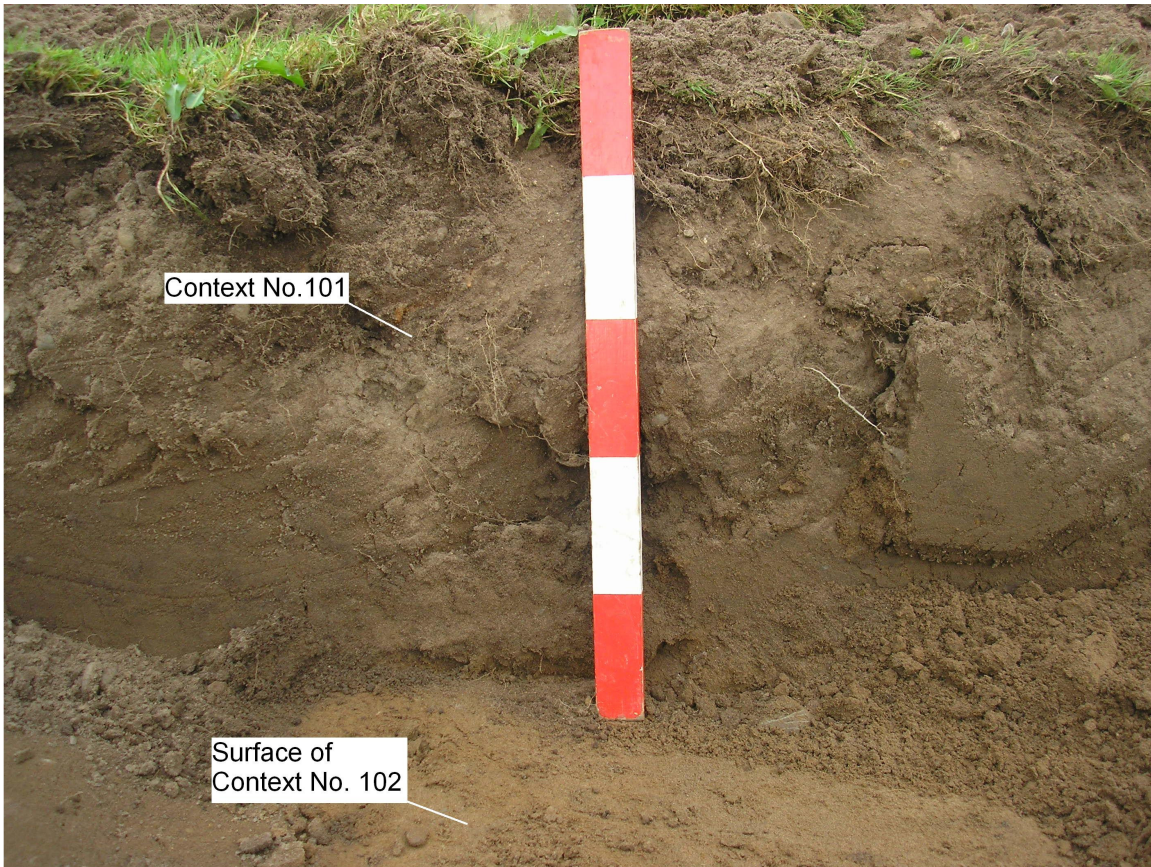
Plate 4: South facing section Trench 1

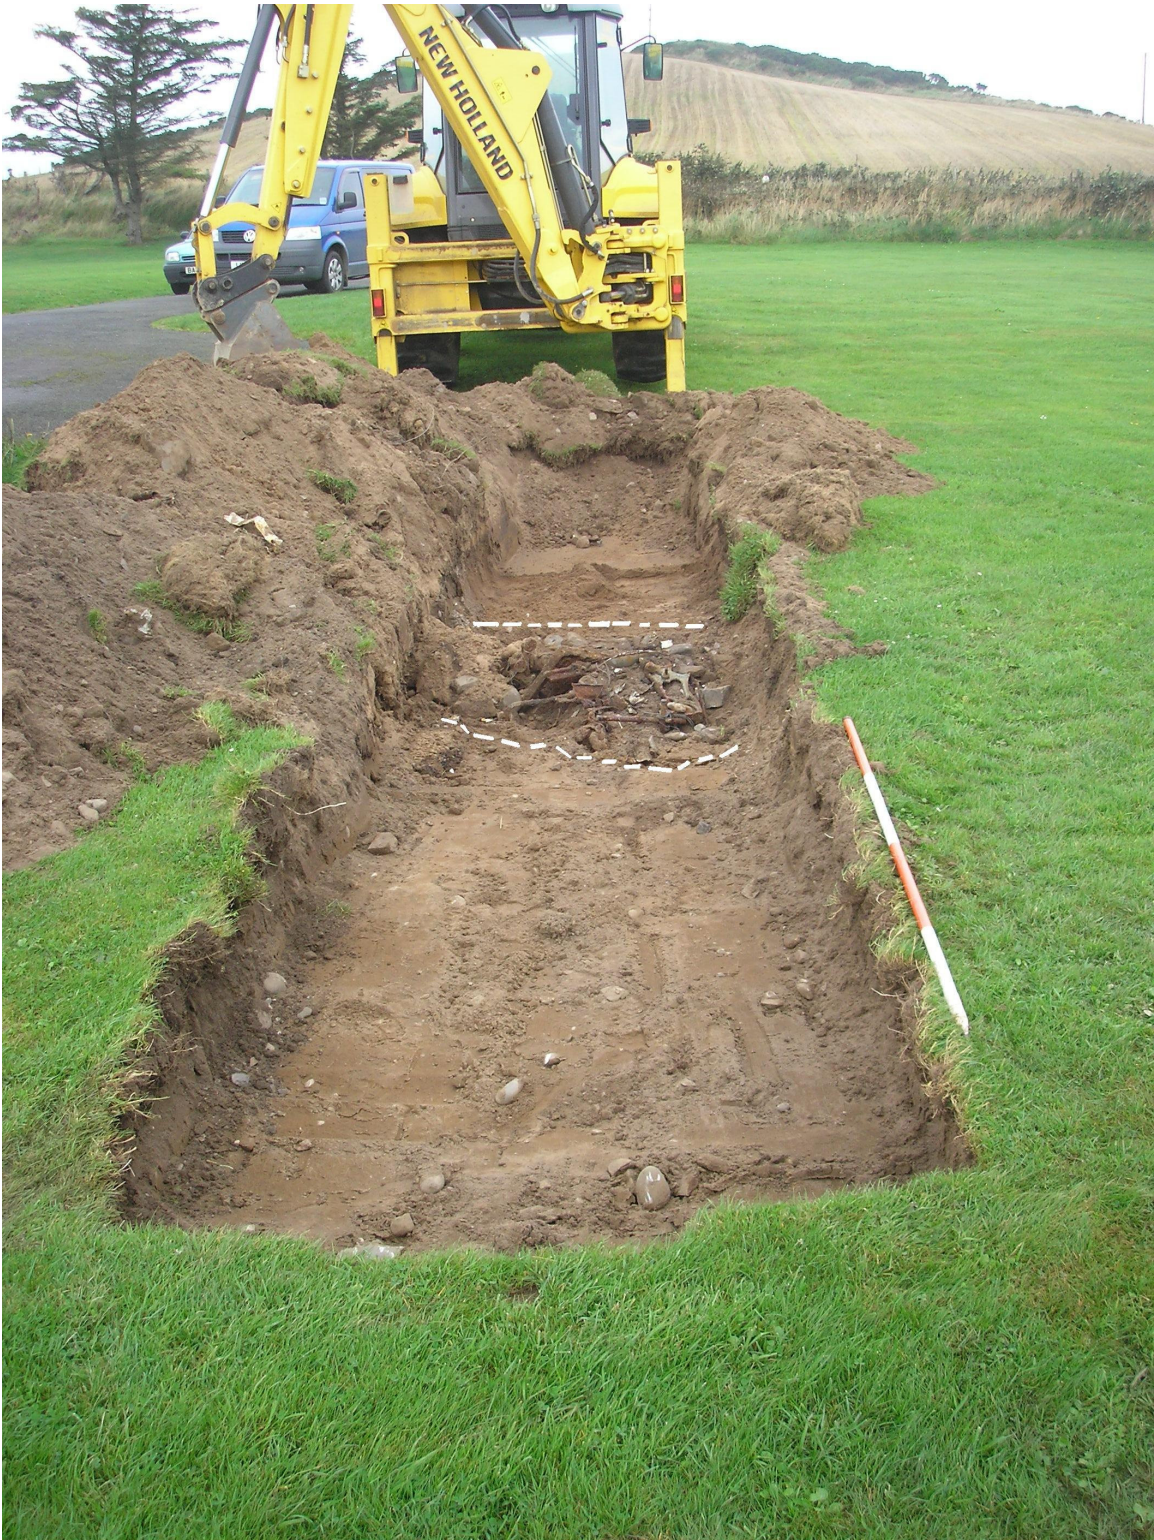
This overlay the subsoil (Context No. 204) which consisted of a yellow orange sand with few inclusions of small rounded beach pebbles. A cut of a pit (Context No. 205) was observed cutting the sandy subsoil. This pit was approximately 1.6m in length and spanned the 2m width of the trench. The fill of this pit (Context No. 206) consisted of a matrix of mangled metal, wood and motorcycle components. The stratigraphic sequence detailed above for Trench 2 probably came about due to the insertion and back filling of the pit (Context No. 205 and Context No. 206). There were no features or artefacts of an archaeological nature encountered in this trench

Plate 5: Excavation of Trench 2 to subsoil (Context No.204) showing pit cut (Context No. 205) as white dashed line, looking north.

Nothing of archaeological significance was noted during the evaluation. The pit observed in Trench 2 (Context No.205) shows that a certain degree of modern disturbance has occurred on site. It is recommended that no further archaeological fieldwork is carried out at the development site. No publication is required, apart from a short summary in the annual bulletin of excavations.

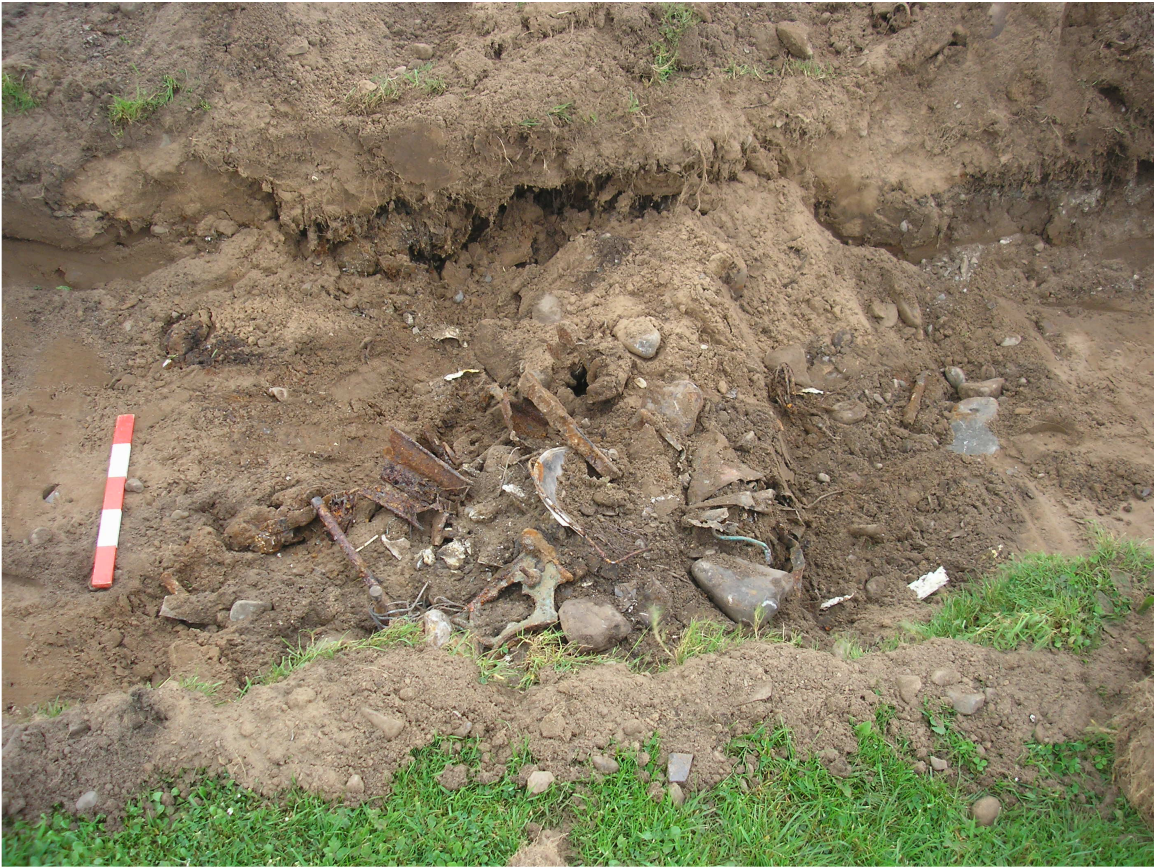
Plate 6: Detail of fill (Context No.206) of pit, looking west.
