Monitoring Report No. 116

**Tully Castle
Tully
Co. Fermanagh**

AE/07/57

Monitoring of socket for insertion of lectern-type sign. Nothing of archaeological significance found.

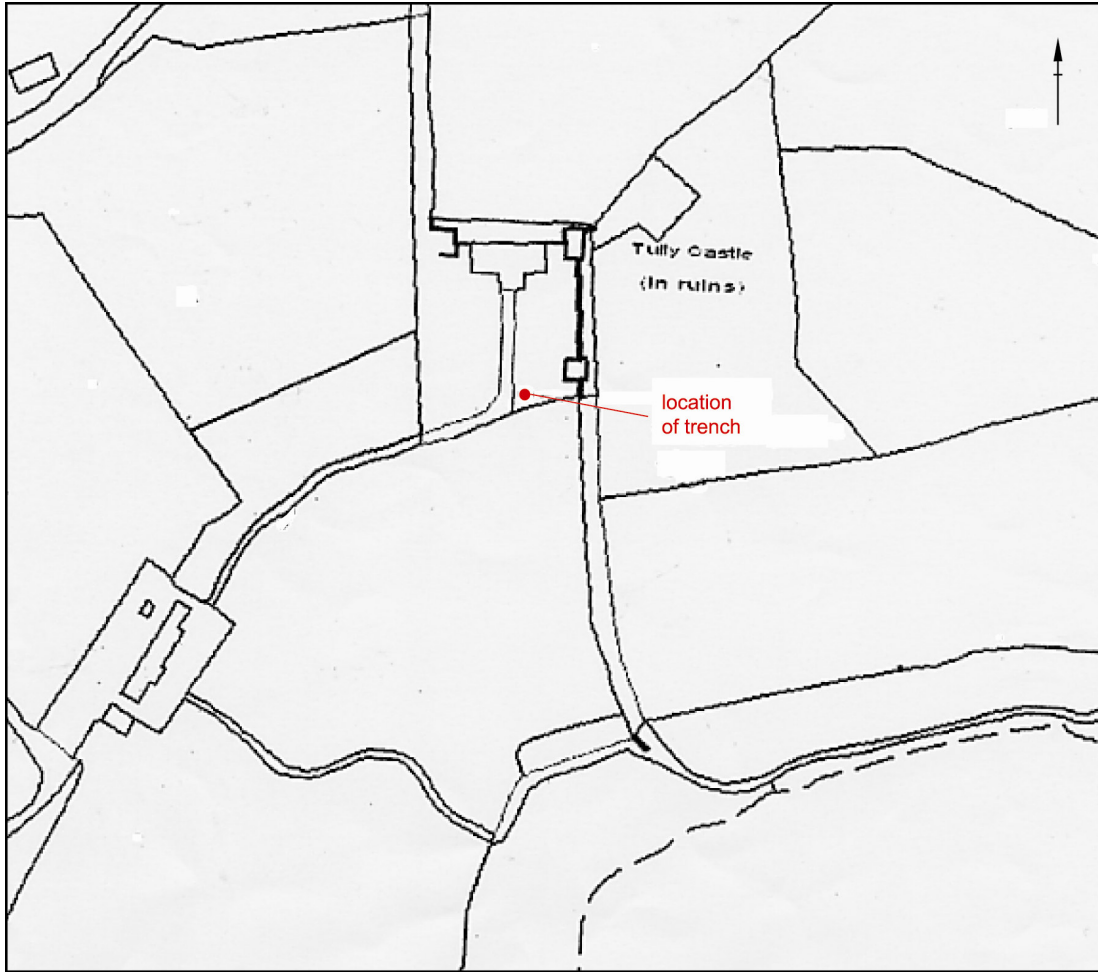
Figure 2: Plan of castle showing location of trench.

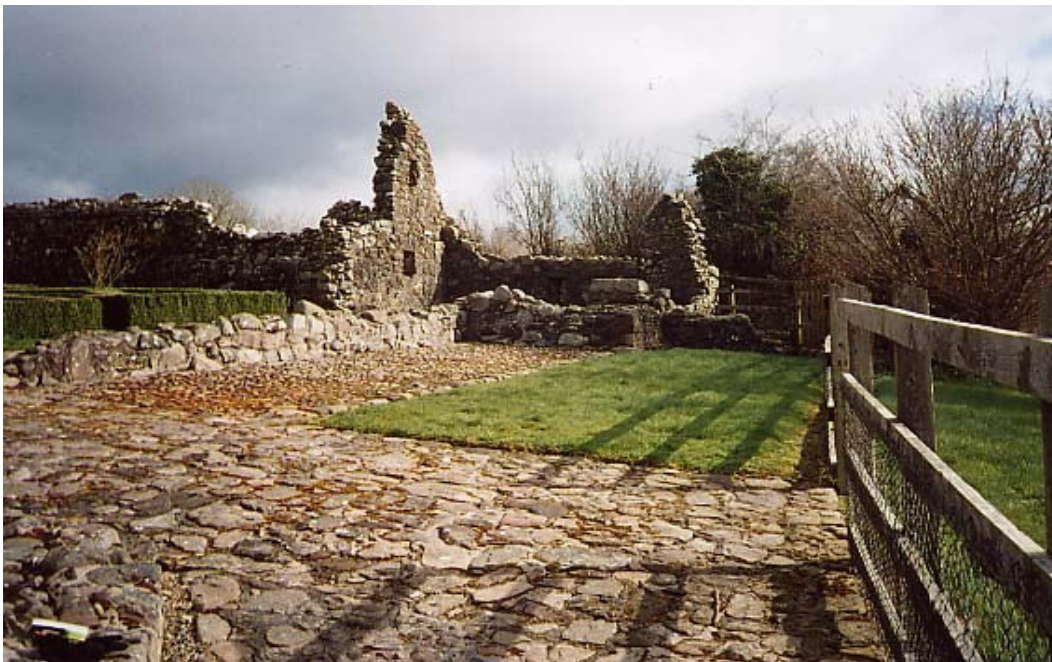
A trench was hand dug at the south end of the garden area to the front of the castle. The dimensions were .5m x .5m, and it was also .5m deep. The trench was dug to accommodate a lectern-type information sign set on a single square steel post.

Plate 1: Location of trench pre-excitation, looking north-east towards south-east flanker.

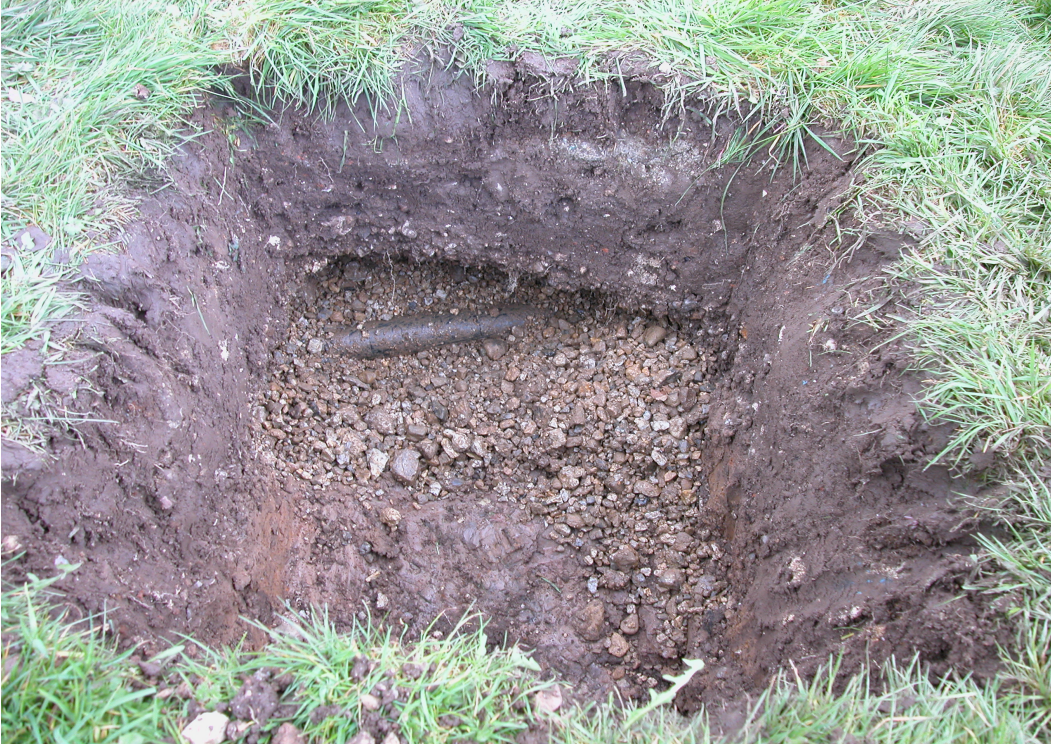
The topsoil (Context 100) was .25 to .27m deep, a dark brown silty loam. Below the topsoil was subsoil (Context 101), a mid orange-brown clay. Cut into the subsoil was a modern pipe trench (Context 102) filled with gravel (Context 103).

Plate 2: Trench showing plastic pipe in gravel (Context 103), looking east.

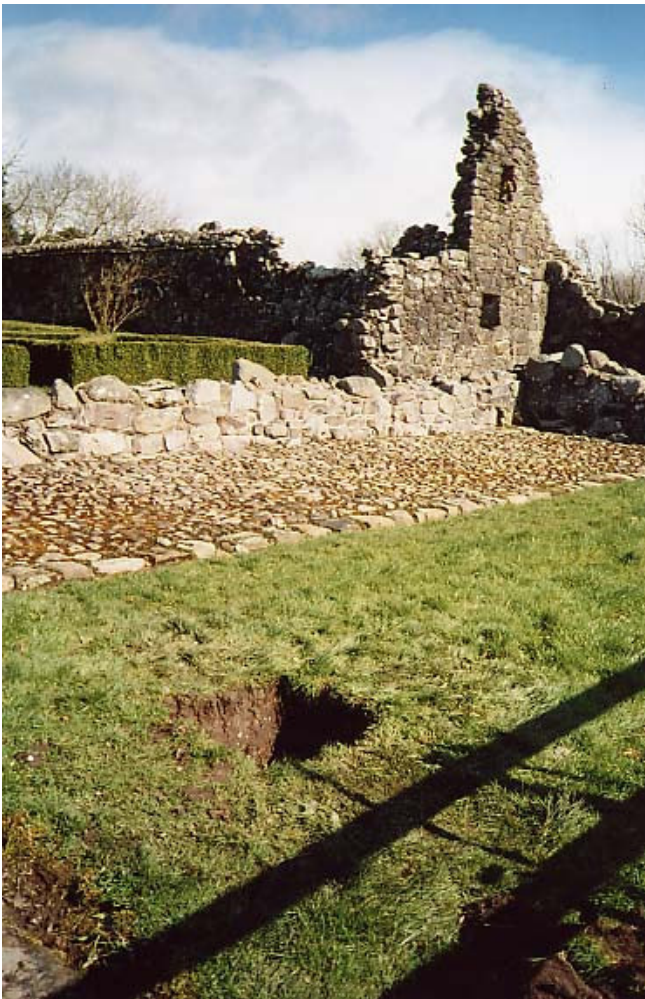
Plate 3: Trench post-excavation, looking north-east.
