Evaluation/Monitoring Report No. 232

**A SITE 100M NORTH OF 102 NEWTOWNARDS ROAD
BALLYRICKARD
COMBER
COUNTY DOWN**

LICENCE NO.: AE/11/90E

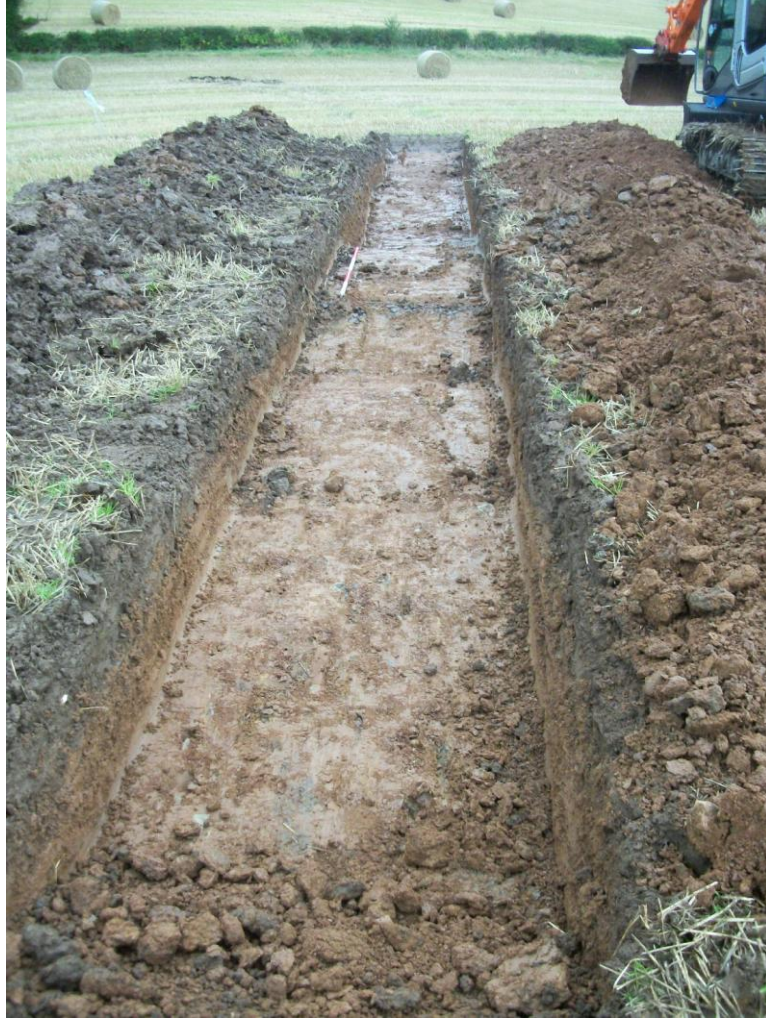
Plate Four: Trench One following excavation to subsoil level, looking east

Trench One ran roughly parallel to the southernmost boundary of the site and adjacent farmyard. It was located approximately 20m from this boundary. Trench One was approximately 1.5m wide and 17m long (Plate Four). The topsoil in Trench One (Context No. 101) consisted of greyish brown clay containing few small angular stones

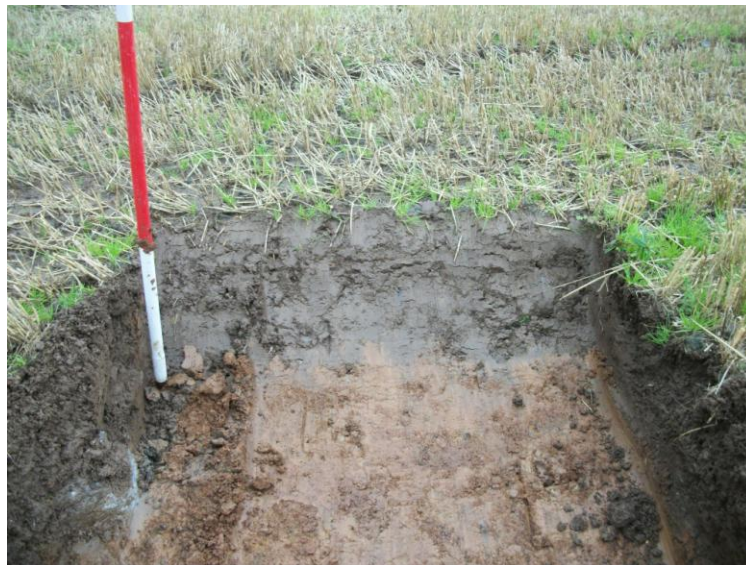
Plate Five: West-facing section of Trench One, looking east

(average size: 50x30x10mm) along with a few sherds of 20th century pottery. The layer varied in thickness from 0.15-0.32m, becoming shallower as the trench followed the natural slope of the hill. The topsoil directly overlay the boulder clay subsoil (context no. 104: Plate Five). Cut into the subsoil were two modern drains (context nos. 102 and 103). Both drains ran roughly north-south across the trench and were made up of angular shale fragments. There were no other features in the surface of the subsoil which was encountered at a depth of 0.2-0.3m.

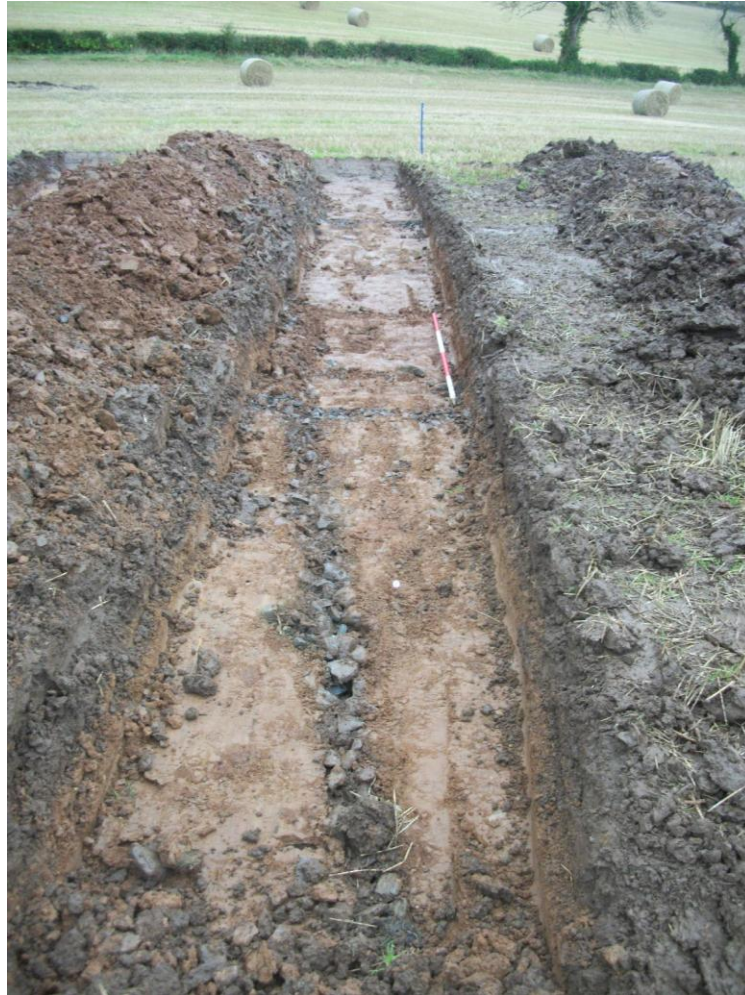
Plate Six: Trench Two following excavation to subsoil level and showing modern drains, looking east

Trench Two ran parallel to Trench One and was approximately 2.5m to the south-east of it. The trench was approximately 1.5m wide and 16m long (Plate Six). It contained a similar stratigraphy to that observed in Trench One. The topsoil (context no. 201) consisted of greyish brown clay which was 0.2-0.3m thick and contained few small angular stones (average size: 50x30x10mm). No artefacts were recovered during the excavation of Trench Two. Again, as in Trench One, the topsoil directly overlay the subsoil (context no. 205: Plate Seven) which consisted of orange boulder clay encountered at a depth of approximately 0.2-0.3m. Three drains were observed in Trench Two. Two of these (context nos. 202 and 203) equated to the continuation of the north-south drains seen in Trench One (context nos. 102 and 103), again consisting of angular shale fragments. Another drain (context no. 204) running roughly east-west was visible in the western part of the trench. This drain was probably an old 'pen drain' and was cut by the westernmost of the north-south drains (context no. 103). There were no other subsoil-cut features observed in Trench Two.

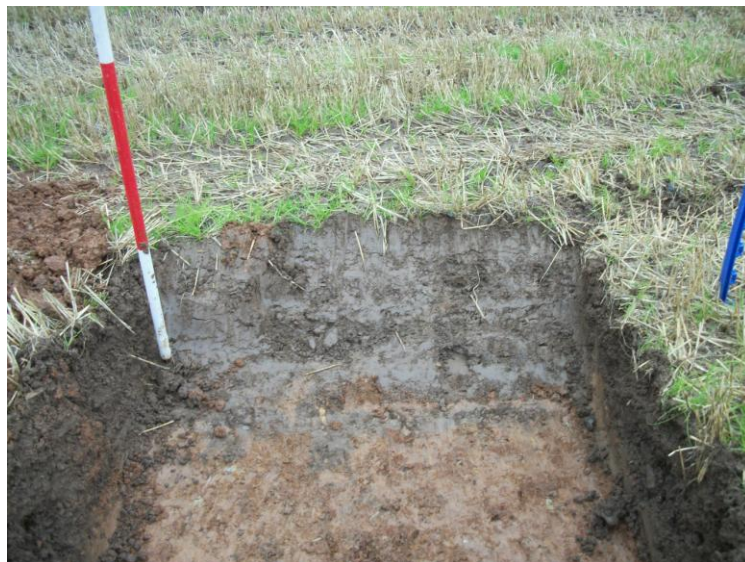
Plate Seven: West-facing section of Trench Two, looking east

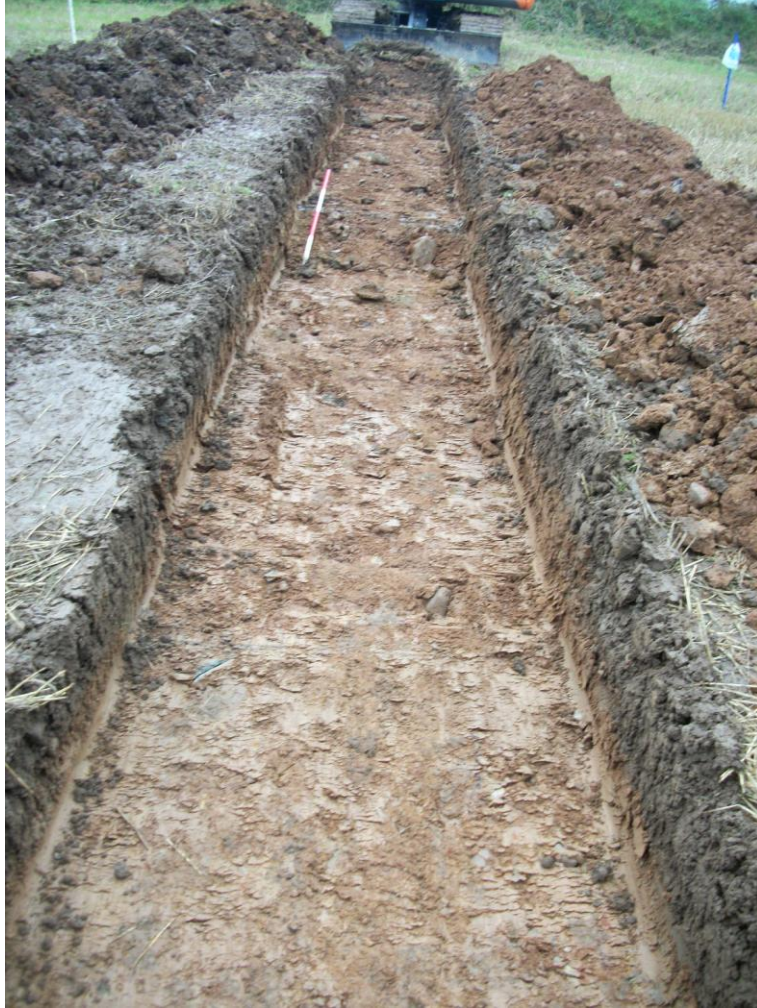
Plate Eight: Trench Three following excavation to subsoil level, looking west

Trench Three was positioned over the footprint of the proposed garage and ran parallel to Trench Two. It was 8m to the south-east of the latter. The trench was 1.5m long and 15m long (Plate Eight). Trench Three exhibited a simple sequence of strata like that seen in Trenches One and Two (Plate Nine). The topsoil (context no. 301) consisted of greyish brown clay which was 0.2-0.3m thick and directly overlay the subsoil (context no. 304). There were two modern drains running north-south across the trench (context nos. 302 and 303) which, like those in Trenches One and Two, consisted of angular shale fragments. Below the stones in each drain a plastic pipe could be seen. There were no other features in the subsoil which consisted of boulder clay and which was encountered at a depth of around 0.2-0.3m. No artefacts were found within this trench.

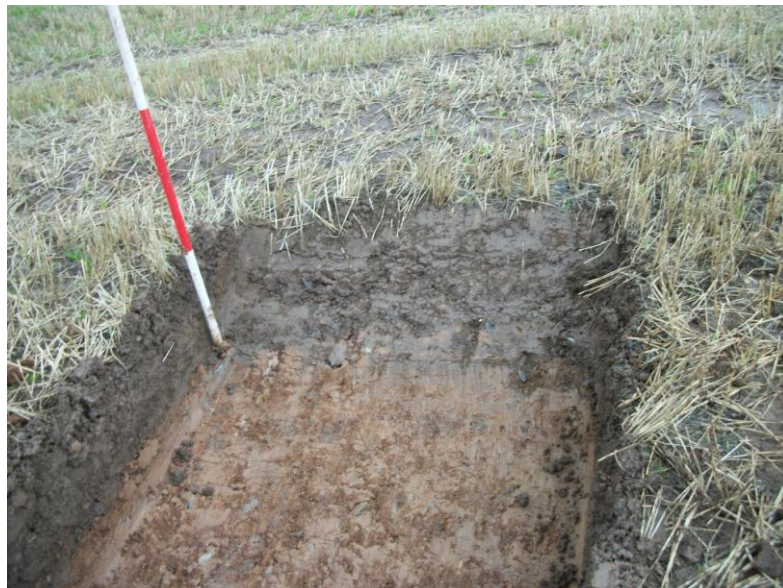
Plate Nine: West-facing section of Trench Three, looking east
