Data Structure Report No. 95

Excavations at the southern doorway of Templecorran Church, Ballycarry, Co.
Antrim

ANT 047:010

AE/13/88E

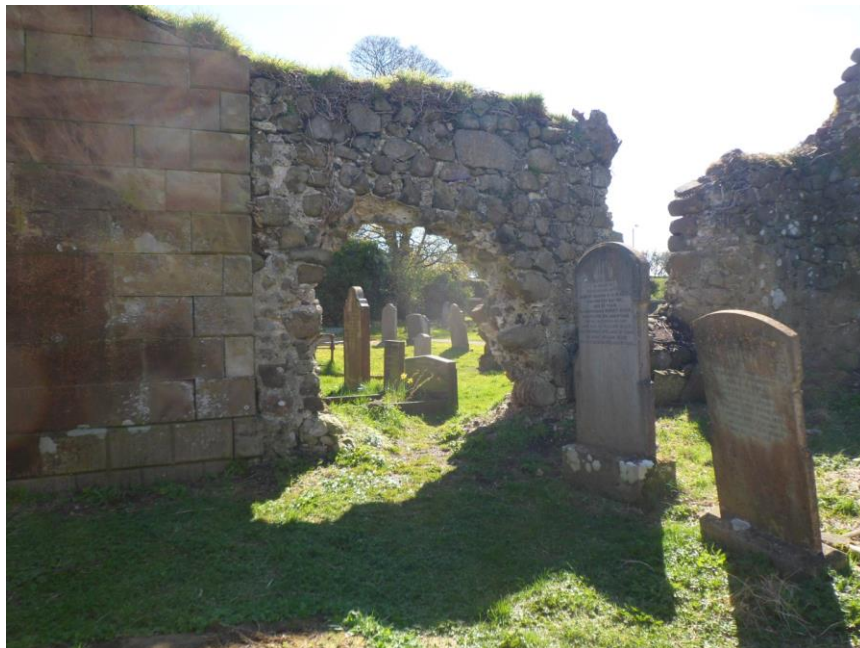
Plate 1: Pre-excavation view of the southern doorway from the interior of the church looking south-west. Prior to the excavation taking place, scaffolding was erected by the Carrickfergus depot of the NIEA in the gap in the southern wall.

3.1.1 A single trench was excavated across the doorway situated along the southern wall of the church (Plate 1; Figure 2). The trench was manually excavated to the surface of the natural bedrock (Context No.109) which was encountered at an average depth of 0.8m from the present ground surface. Following the excavation of the trench, it was left open at the request of Andrew Gault (NIEA) to allow visual inspection by a Structural Engineer.

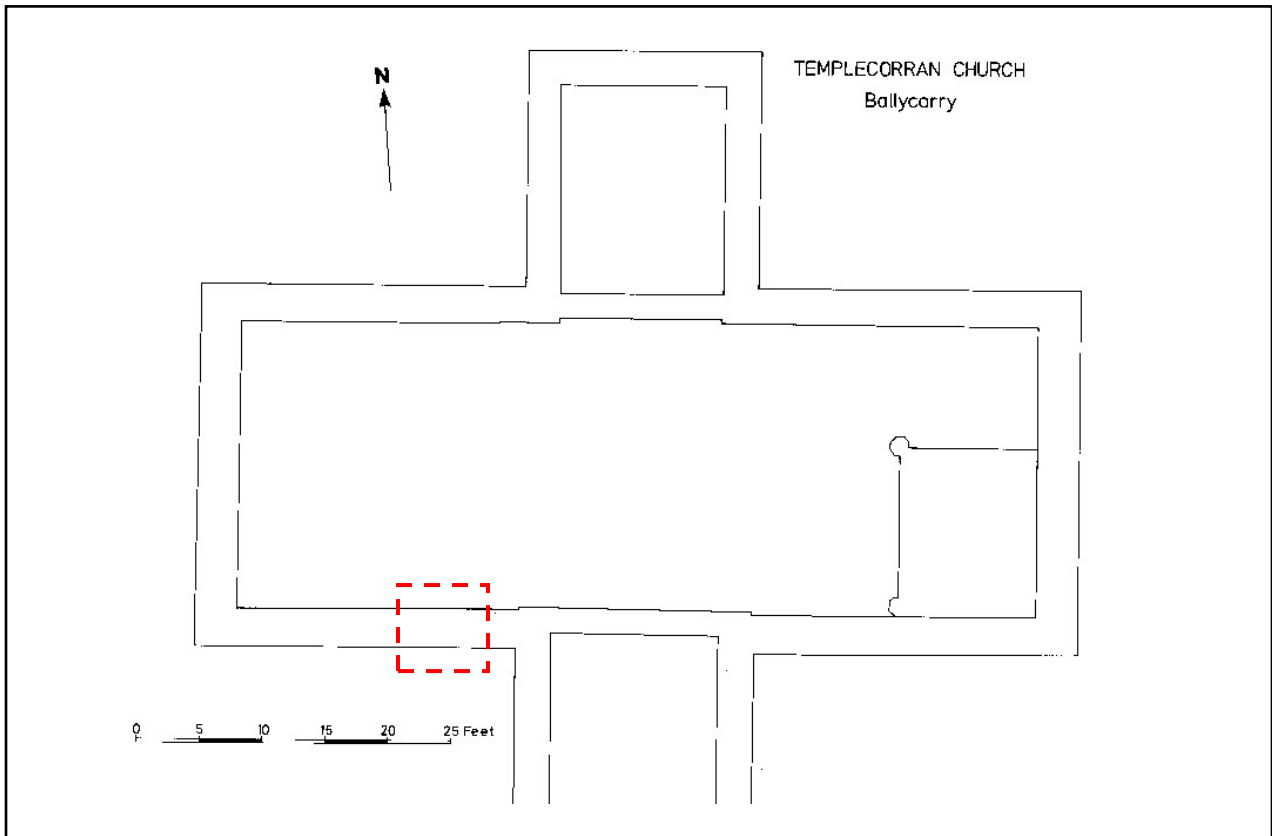
Figure 2: Plan of Templecorran church (ANT 047:010) showing location and approximate outline/scale of proposed excavation trench. Plan downloaded from the NI-SMR online (<http://apps.ehsni.gov.uk/ambit/Default.aspx> Accessed April 29th, 2013).

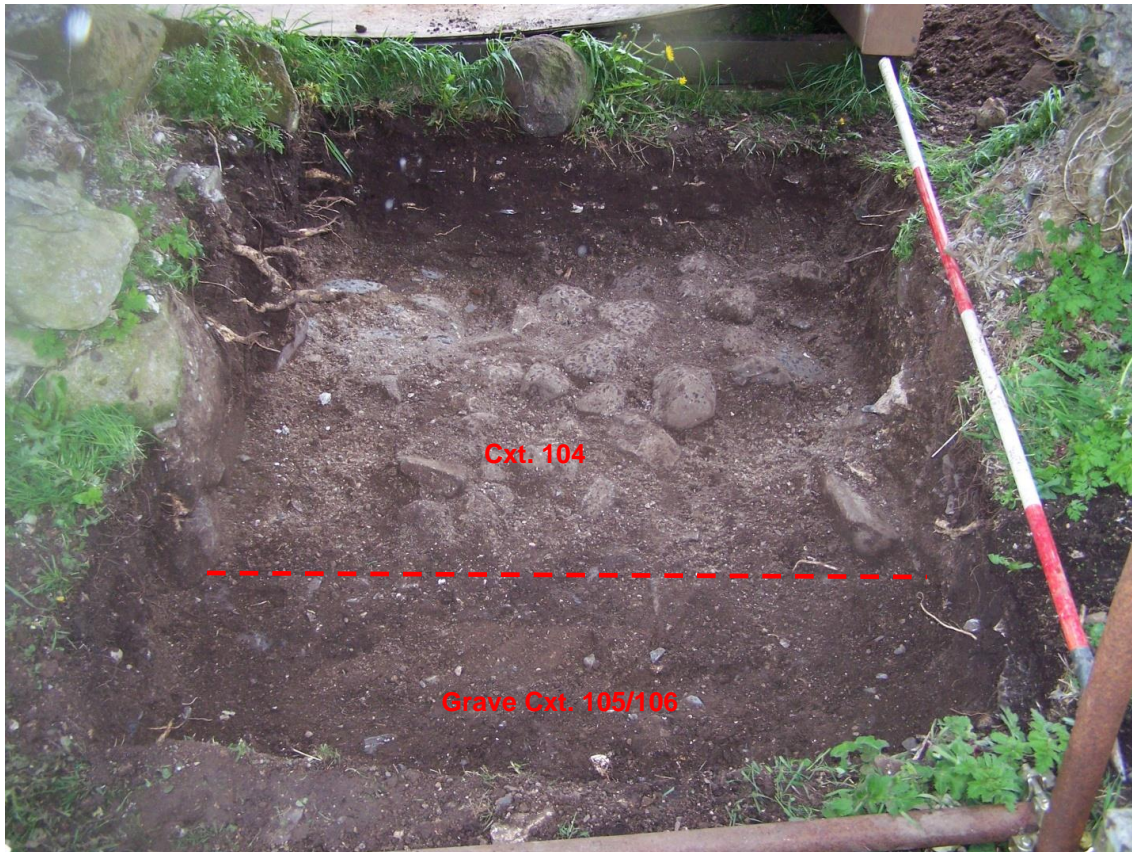
Plate 2: Possible demolition deposit (Context No. 104) and Grave (Context No. 105) looking south.

- 3.2.5 The removal of the brown clay loam (Context No. 102) revealed two deposits. The first was a firm dark brown silty clay (Context No. 105) that was present at the northern end of the trench. This deposit (Context No. 105) was an average of 0.3m wide (exposed dimensions north/south) and spanned the width of the northern end of the trench. This deposit (Context No. 105) was not excavated as it was clear that it was the fill of a relatively recent (early twentieth-century) grave cut (Context No. 106). Excavation in this end of the trench ceased to avoid unnecessary disturbance of this grave (Context No. 105/106). Removal of the brown clay loam (Context No. 102) also revealed a discreet deposit of angular stones within a mortar flecked sandy loam (Context No. 103). It is probable that the grave (Context Nos. 105/106) along the northern end of the trench was actually cut through the graveyard soil/topsoil (Context No. 102) rather than predating the build up of this deposit. However, due to the similarities of the soil matrix of both deposits, the grave was not recognised until the fill (Context No. 105) contrasted against the mortar rich demolition deposits (Context No. 103 and 104).

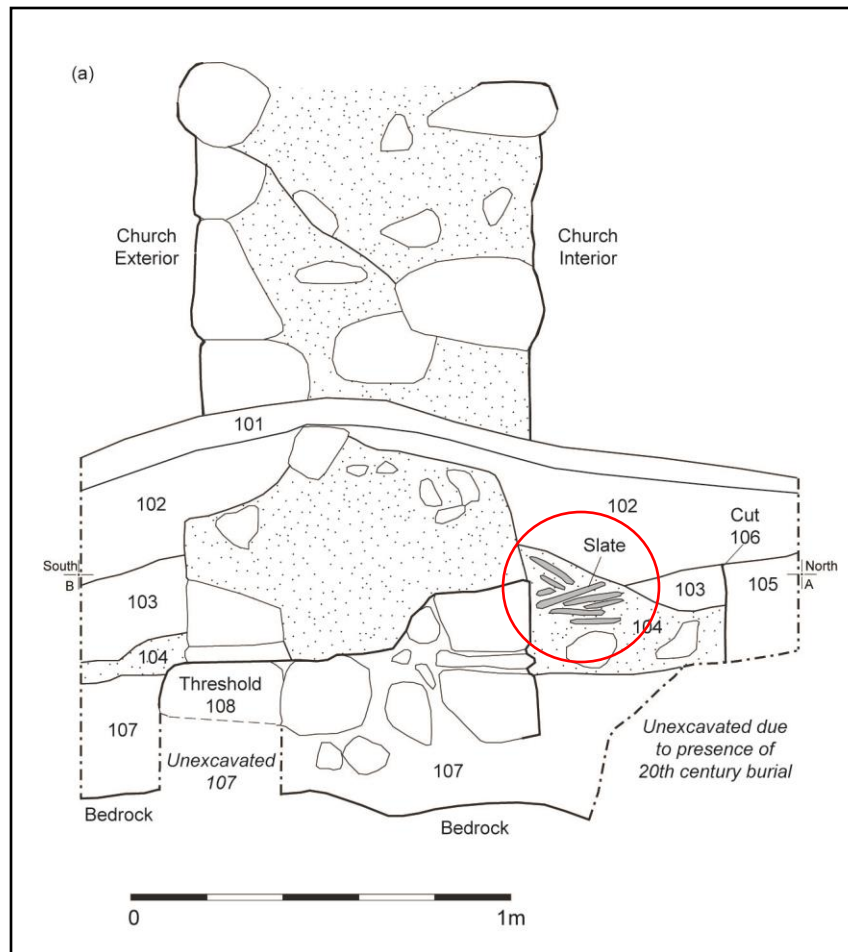
Figure 3: East-facing section of the trench. A cluster of roofing slates within the mortar rich demolition deposit (Context No. 104) is circled.

3.2.6 The mortar flecked sandy loam (Context No. 103) measured 1.65m (north/south) and was on average 0.2m thick. Occasional medium sized angular stones were observed throughout this deposit (Context No. 103) as well as a quantity of roofing slates and disarticulated human bone. The mortar flecked sandy loam (Context No. 103) was removed to reveal a firm stony, mortar rich demolition deposit (Context No. 104). This deposit (Context No. 104) spanned the width of the trench (east/west) and measured 0.65m (north/south) and small to medium angular stones were frequent throughout. This deposit (Context No. 104) varied in thickness from 0.12m-0.35m and produced numerous fragments of roofing slate (a cluster is circled in Figure 3). It is probable that the mortar rich deposit (Context No. 104) relates to a period of decay of the structure where the roofing material and masonry have fallen both inside and outside of the structure.

3.2.8 The walls of the southern doorway were observed in both the east-facing section and west-facing section of the trench (Figures 3 and 4). The wall (Context No. 110) comprised medium to large rounded boulders bonded with a creamish buff mortar. A great deal of disturbance has occurred to the southern doorway with collapse due to decay of the lime mortar and root disturbance. This decay of the doorway is particularly evident on the eastern side of the door way (Figure 4) illustrating the extent to which roots and humic topsoil have worked in amongst the superstructure of the wall, ultimately destabilising the fabric of the building.

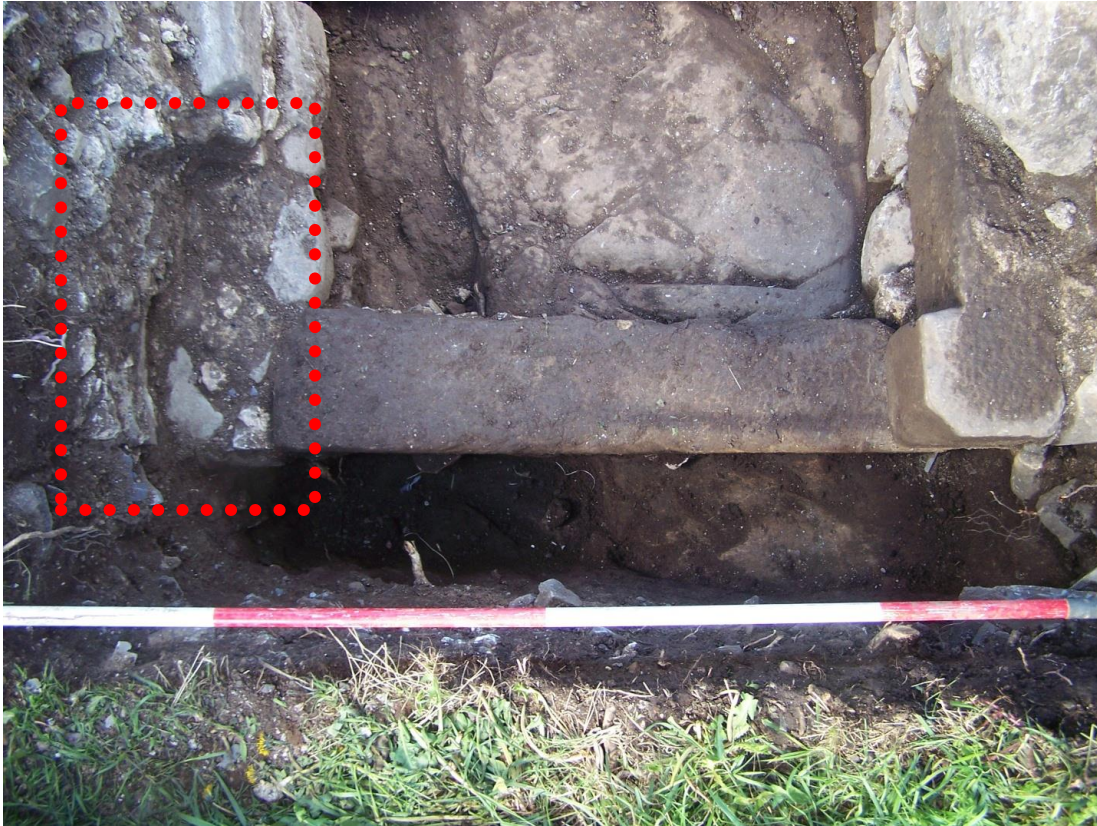
Plate 3: Plan-view of the threshold (Context No. 108) and surviving eastern door jamb (Context No. 110). Highlighted is the recess in the western portion of the southern wall (Context No. 110) showing the cut stone (western door-jamb) has been robbed out from this side of the doorway.

3.2.7 Removal of the mortar rich demolition deposit (Context No. 104) revealed the *in situ* stone threshold (Context No. 108). It appears that this stone (a single slab of probable sandstone, maximum exposed dimensions of 1.24m east west x 0.29m north/south x 0.13m thick) was laid directly on a relict topsoil (Context No. 107). The door-jambs of the southern wall (Context No. 110) mortared directly onto it (Figure 4; Plates 3 and 4).

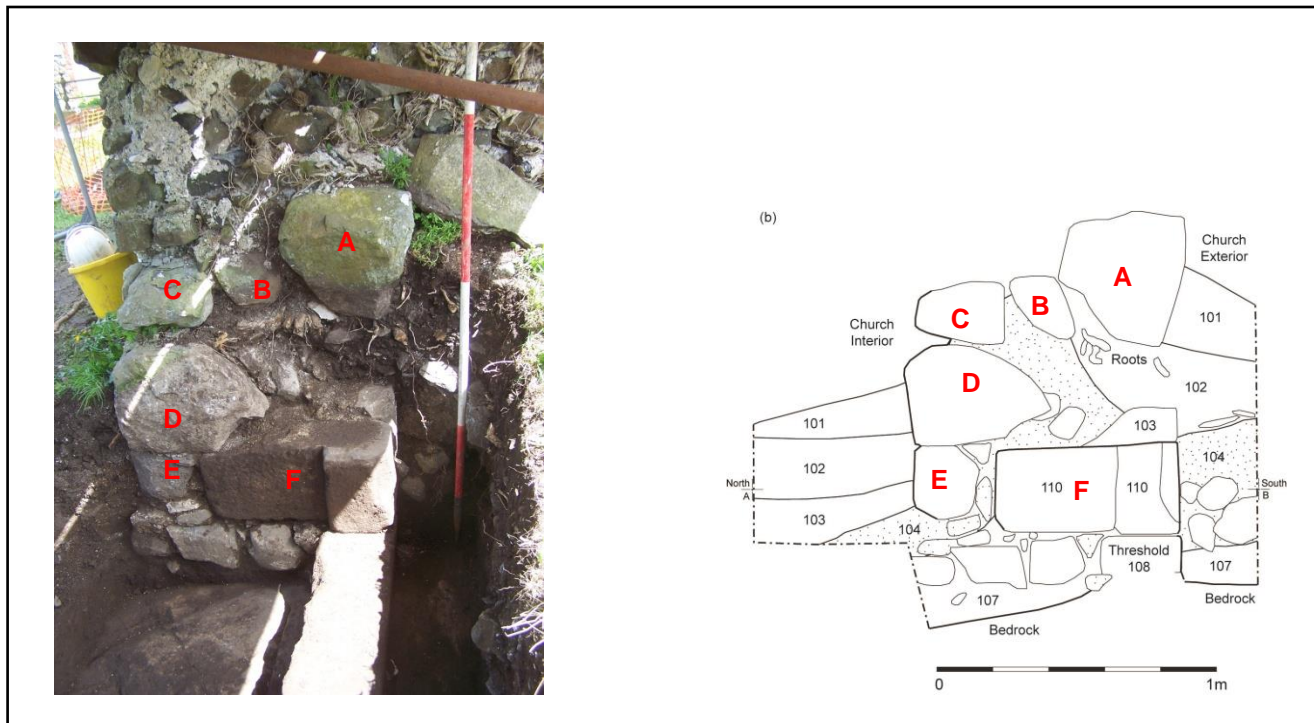
Figure 4: eastern side of the southern doorway (left) with corresponding section drawing (right).

3.2.9 A single dressed stone (labeled 'F' in figure 4; detailed view Plate 4) was observed at the eastern side of the doorway. The corresponding dressed stone from the western side was absent, although the mortar bedding for the stone is *in situ* (Plate 3). It is probable that the entire doorway was originally edged with similar stone to the surviving door-jamb, and they have been robbed out following the abandonment of the church in the late seventeenth century.

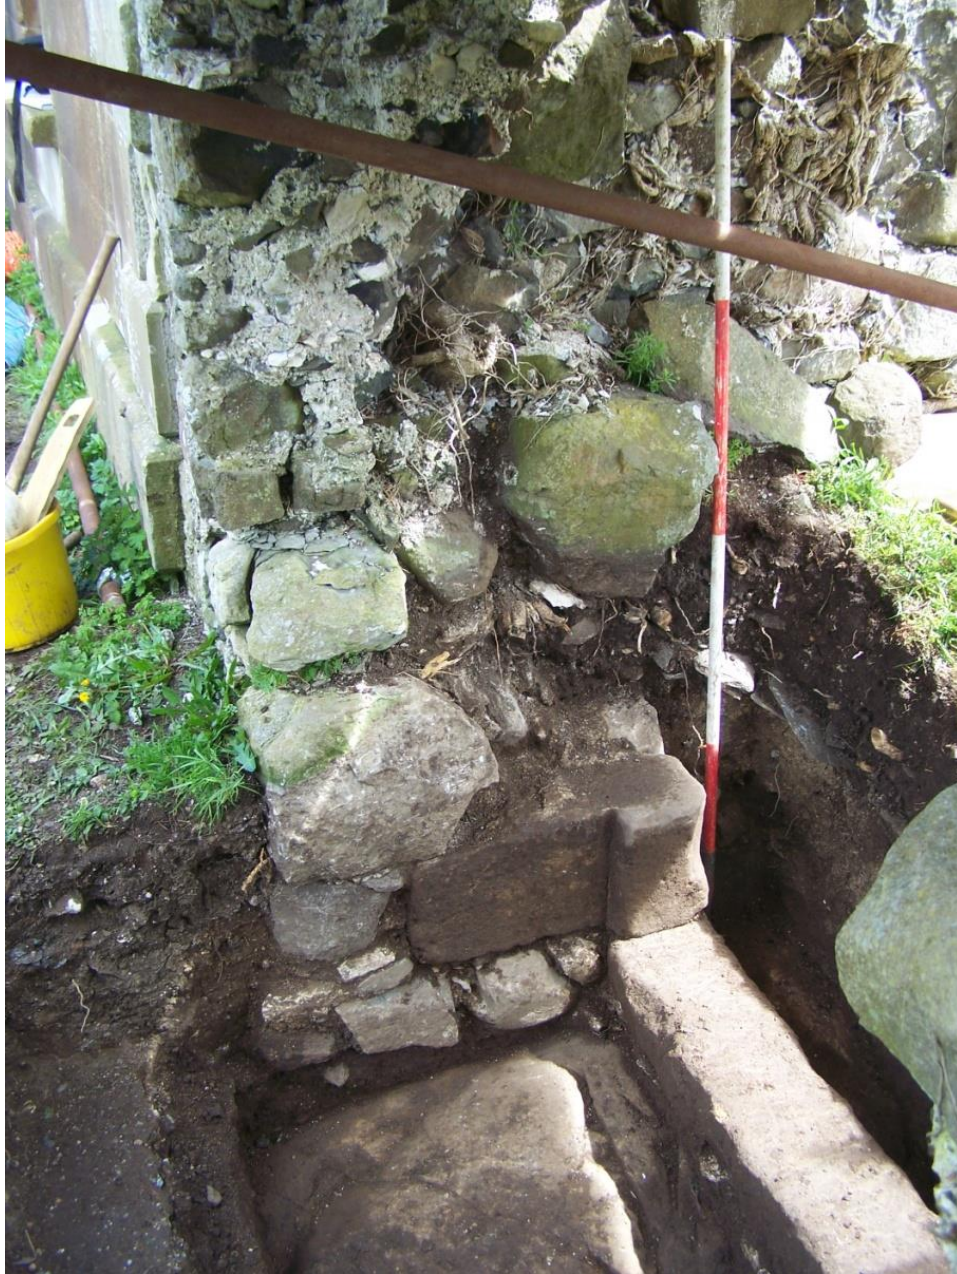
Plate 4: Photo of the *in situ* door-jamb (Context No. 110) and threshold (Context No. 108) post excavation, looking south-east.

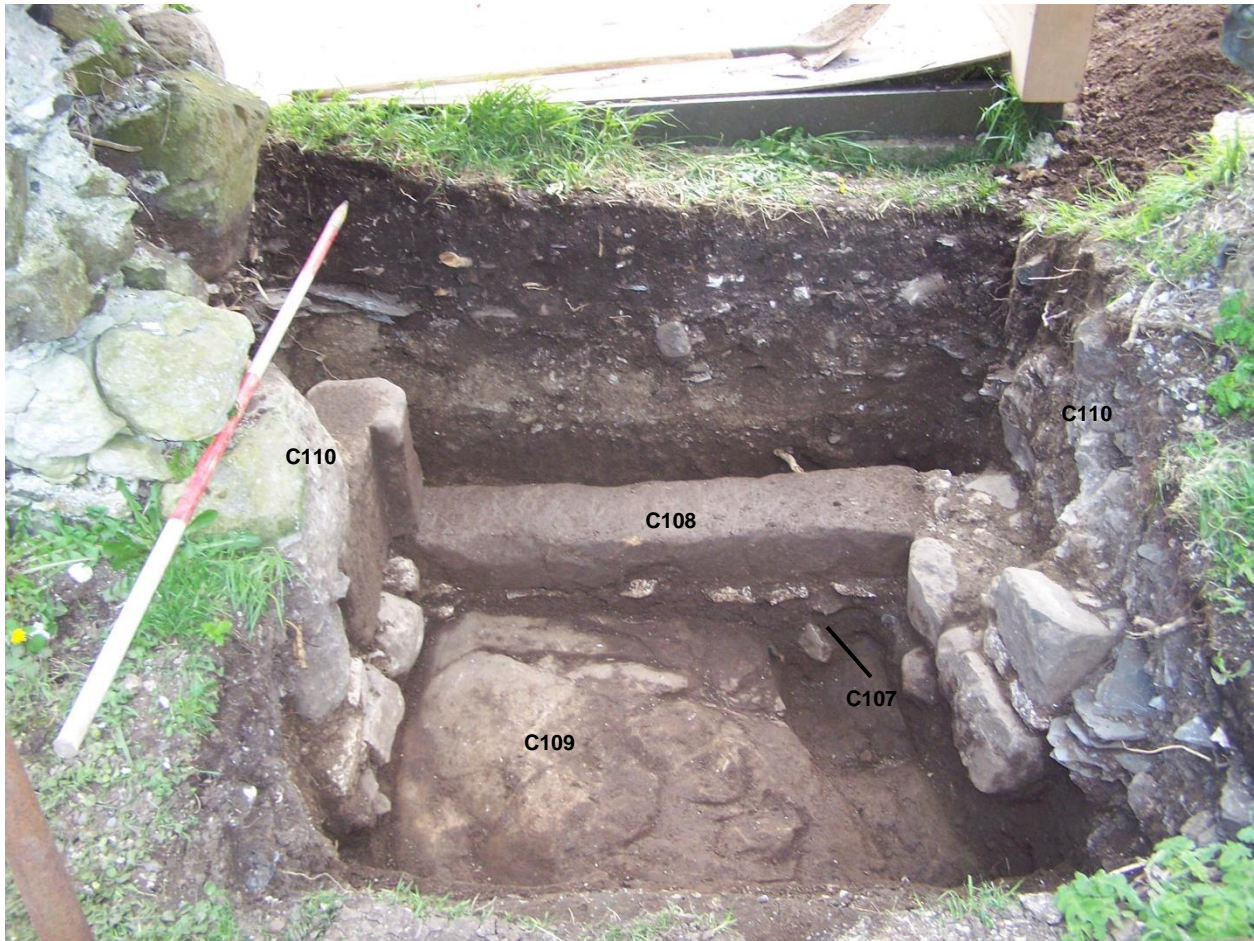
Plate 5: Post-excavation photo of the trench looking south, taken from the interior of the church. Shown are the threshold (Context No. 108), soil deposit/relict topsoil (Context No. 107), natural bedrock (Context No. 109) southern wall and door jamb of church (Context No. 110), looking south.

3.2.11 The silty clay (Context No. 107) directly overlay the natural bedrock (Context No. 109) which consists of basalt. The bedrock (Context No. 109) sloped from east to west, with no archaeological features being observed at this level. The trench was recorded and left open at the request of Andrew Gault (NIEA).

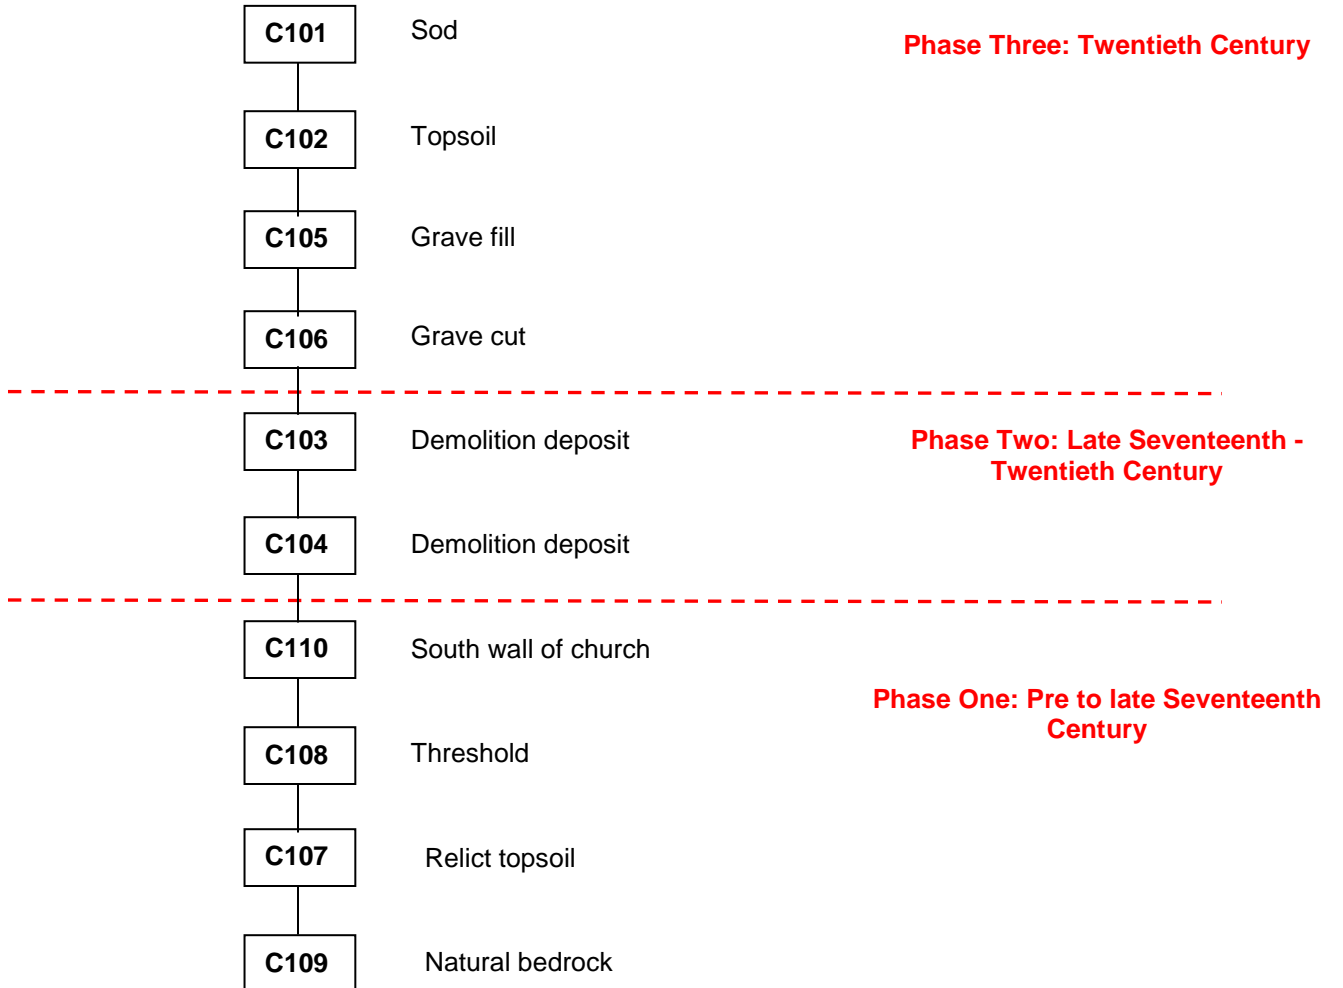
Appendix Two: Harris Matrix

Context No.	Description
101	Sod layer
102	Topsoil / mixed graveyard soil
103	Mortar-flecked sandy loam
104	Mortar-rich demolition deposit
105	20 th Century grave fill
106	20 th Century grave cut
107	Relict topsoil
108	<i>In situ</i> threshold
109	Natural bedrock
110	Extant southern wall of the church
