**CAF Data Structure Report No. 105**

**Excavations at Carrickfergus Castle,**

**Co. Antrim**

CAF DSR 105

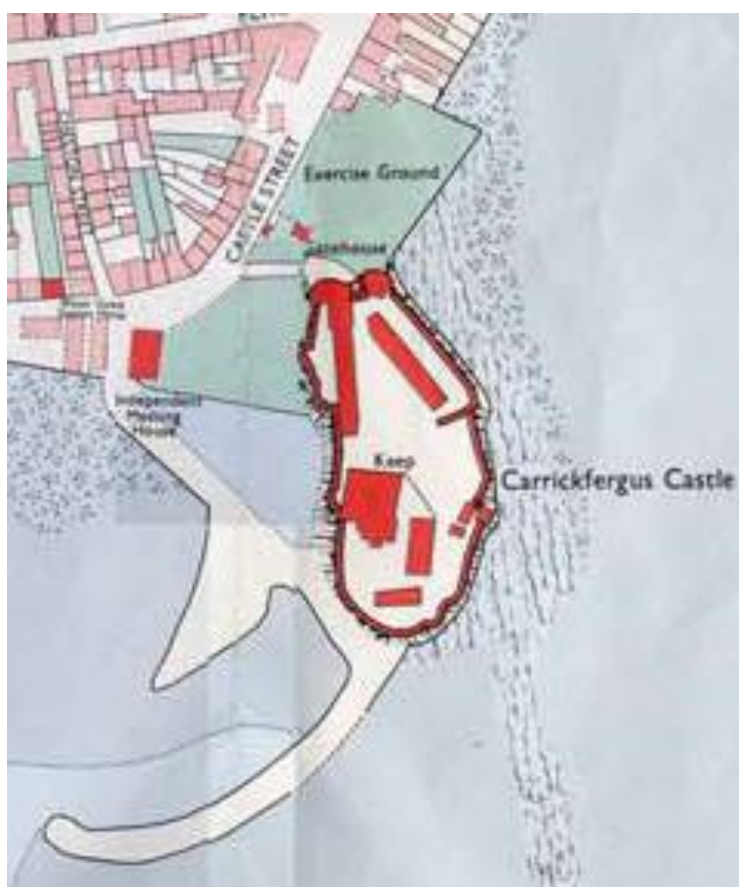
Plate 8. Detail of Carrickfergus Castle from Ordnance Survey map of Carrickfergus, circa 1840.

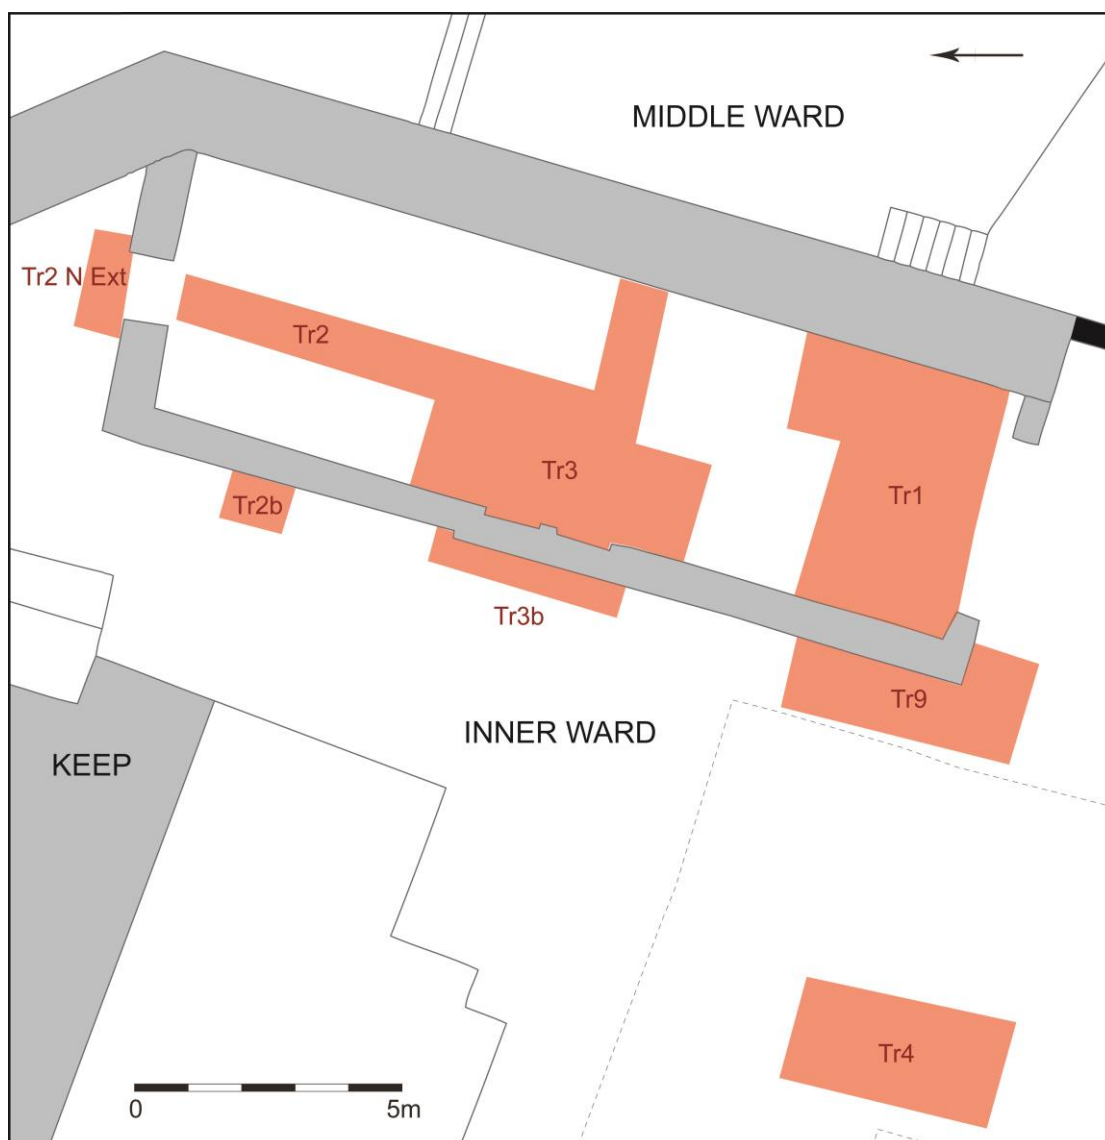
**Fig. 5. Location of trenches in the Inner Ward.**

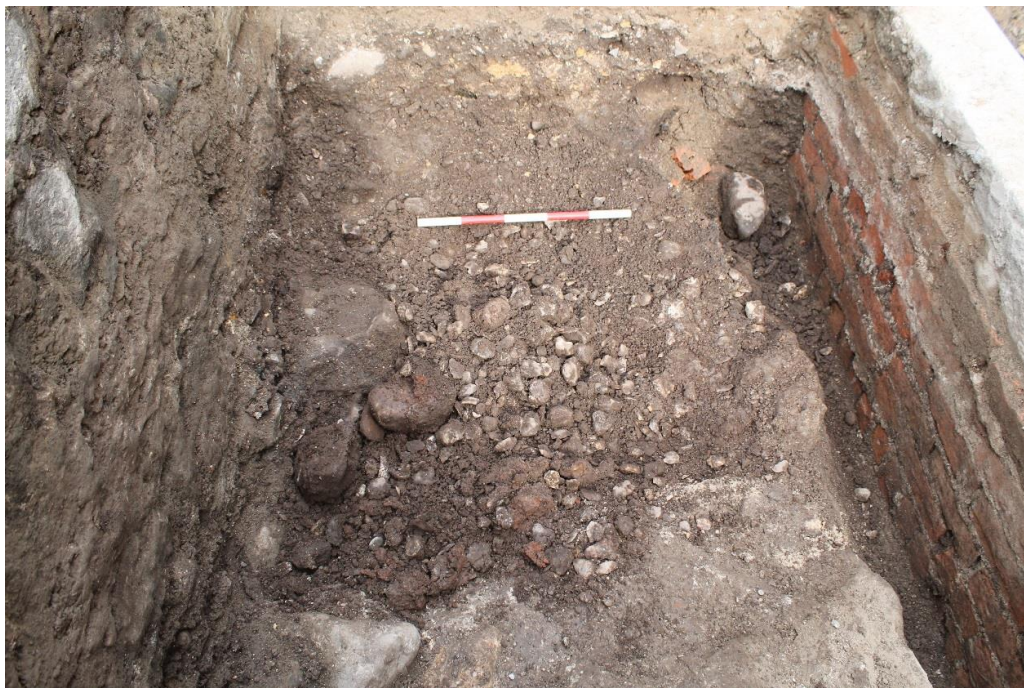
**Plate 9. Inner Ward. Western side of Trench 1. Flint-rich layer C.136 during excavation. From south.**

Directly above the bedrock (C.145) in the west of Trench 1 was a layer of mid-brown clay loam (C.144). Above this in the north-west of the trench was a layer of large stones (C.143), averaging 0.20m-0.38m in length within a layer of mid-brown loamy clay. This horizon may be the result of degraded bedrock as observed in the nearby Trench 3. Immediately above it was a layer of grey-brown clay loam (C.136) that was 0.16m deep. Nearly 50% of this layer consisted of struck and unstruck flint and it clearly represents a prehistoric soil horizon where flint-knapping has been taking place and it may be the same horizon as C.140 in the east of Trench 1 but separated from it by the later insertion of the Victorian munitions railway.

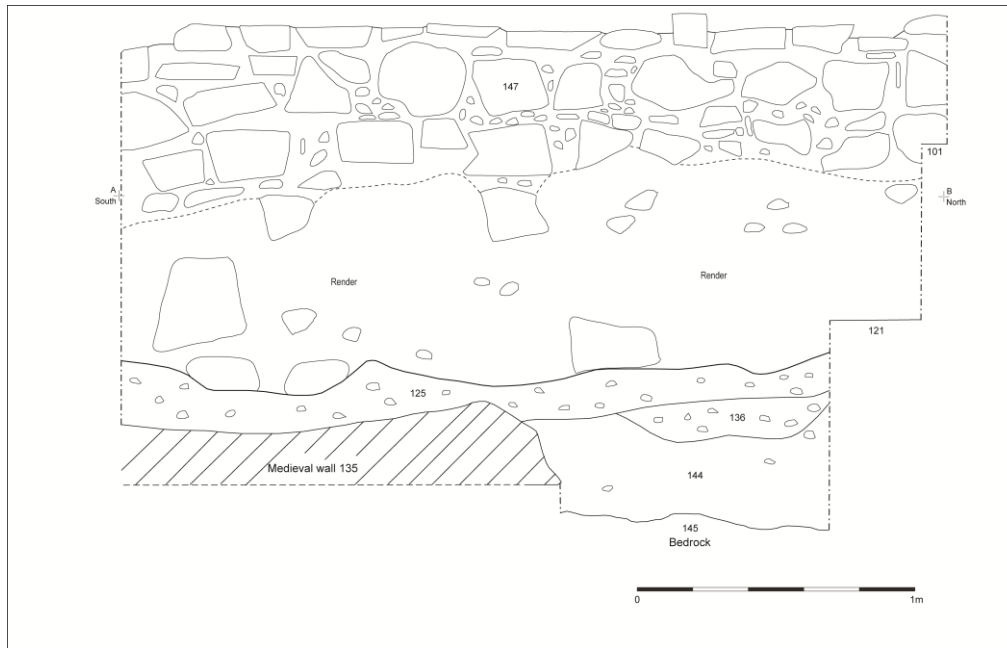
**Fig 8. Inner Ward. Trench 1. East-facing elevation of Medieval wall C. 135, the west wall of the store house, C.147.**

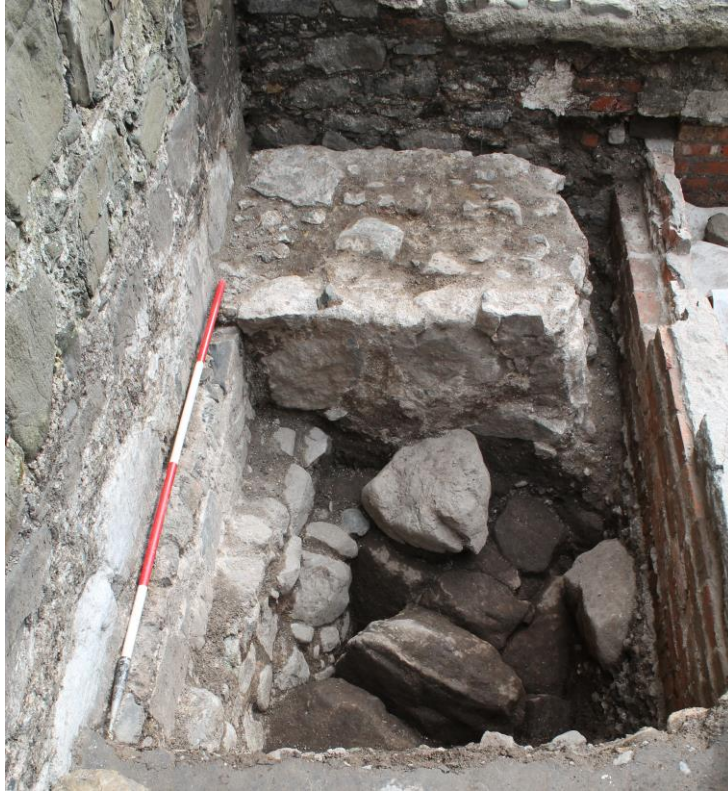
**Plate 10. Inner Ward. Trench 1. Base and footings of the eastern wall of the Inner Ward, Medieval wall C. 106, bedrock and the eastern wall of the Victorian railway. From north.**

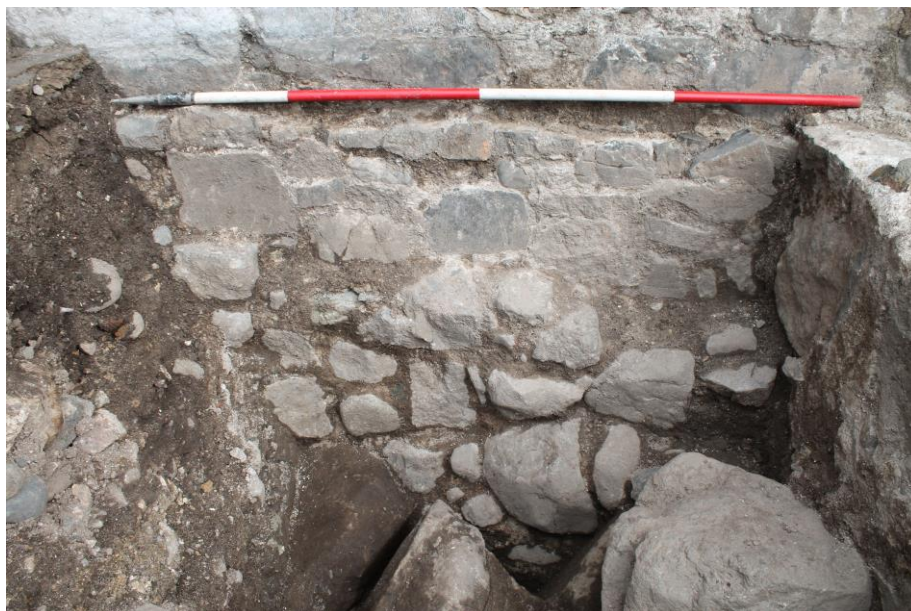
**Plate 11. Inner Ward. Eastern side of Trench 1. Base and footings of the eastern wall of the Inner Ward, Medieval wall C. 106 and bedrock. From west.**

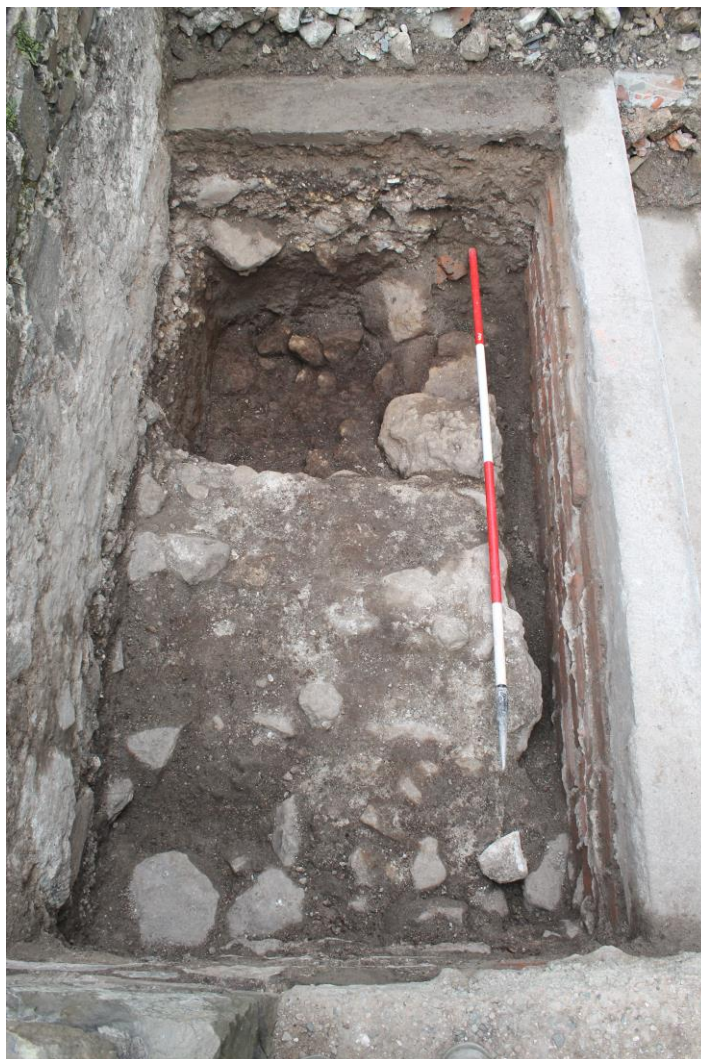
**Plate 12. Inner Ward. Western side of Trench 1. Medieval wall C.135. From south.**

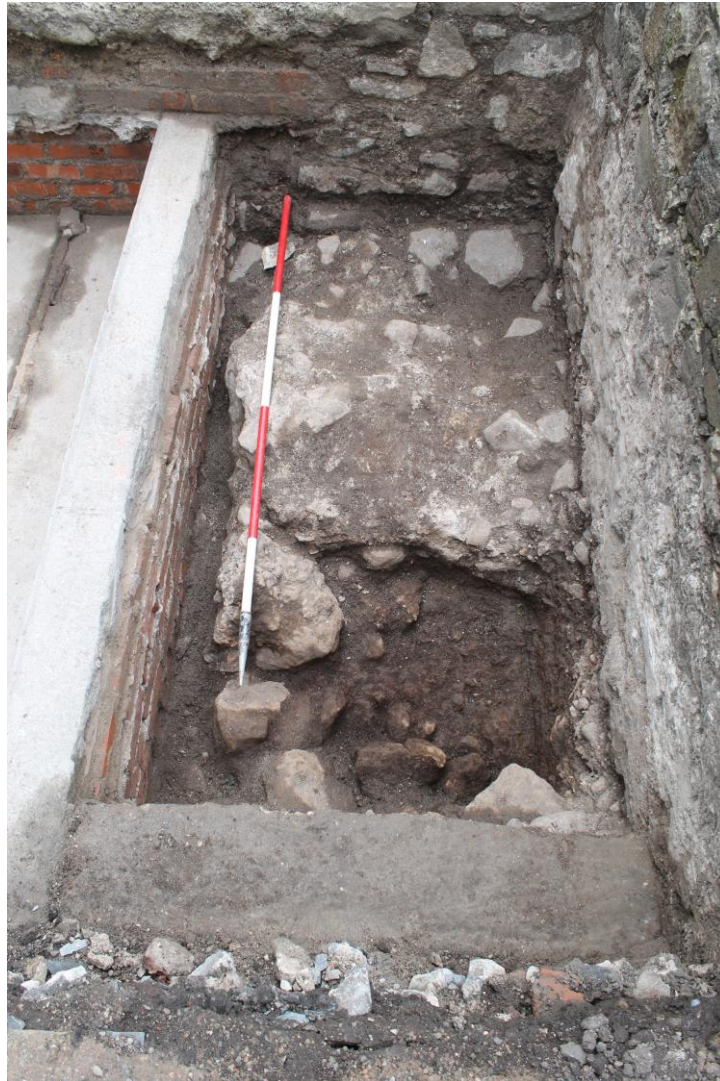
**Plate 13. Inner Ward. Western side of Trench 1. Medieval wall C.135. From north.**

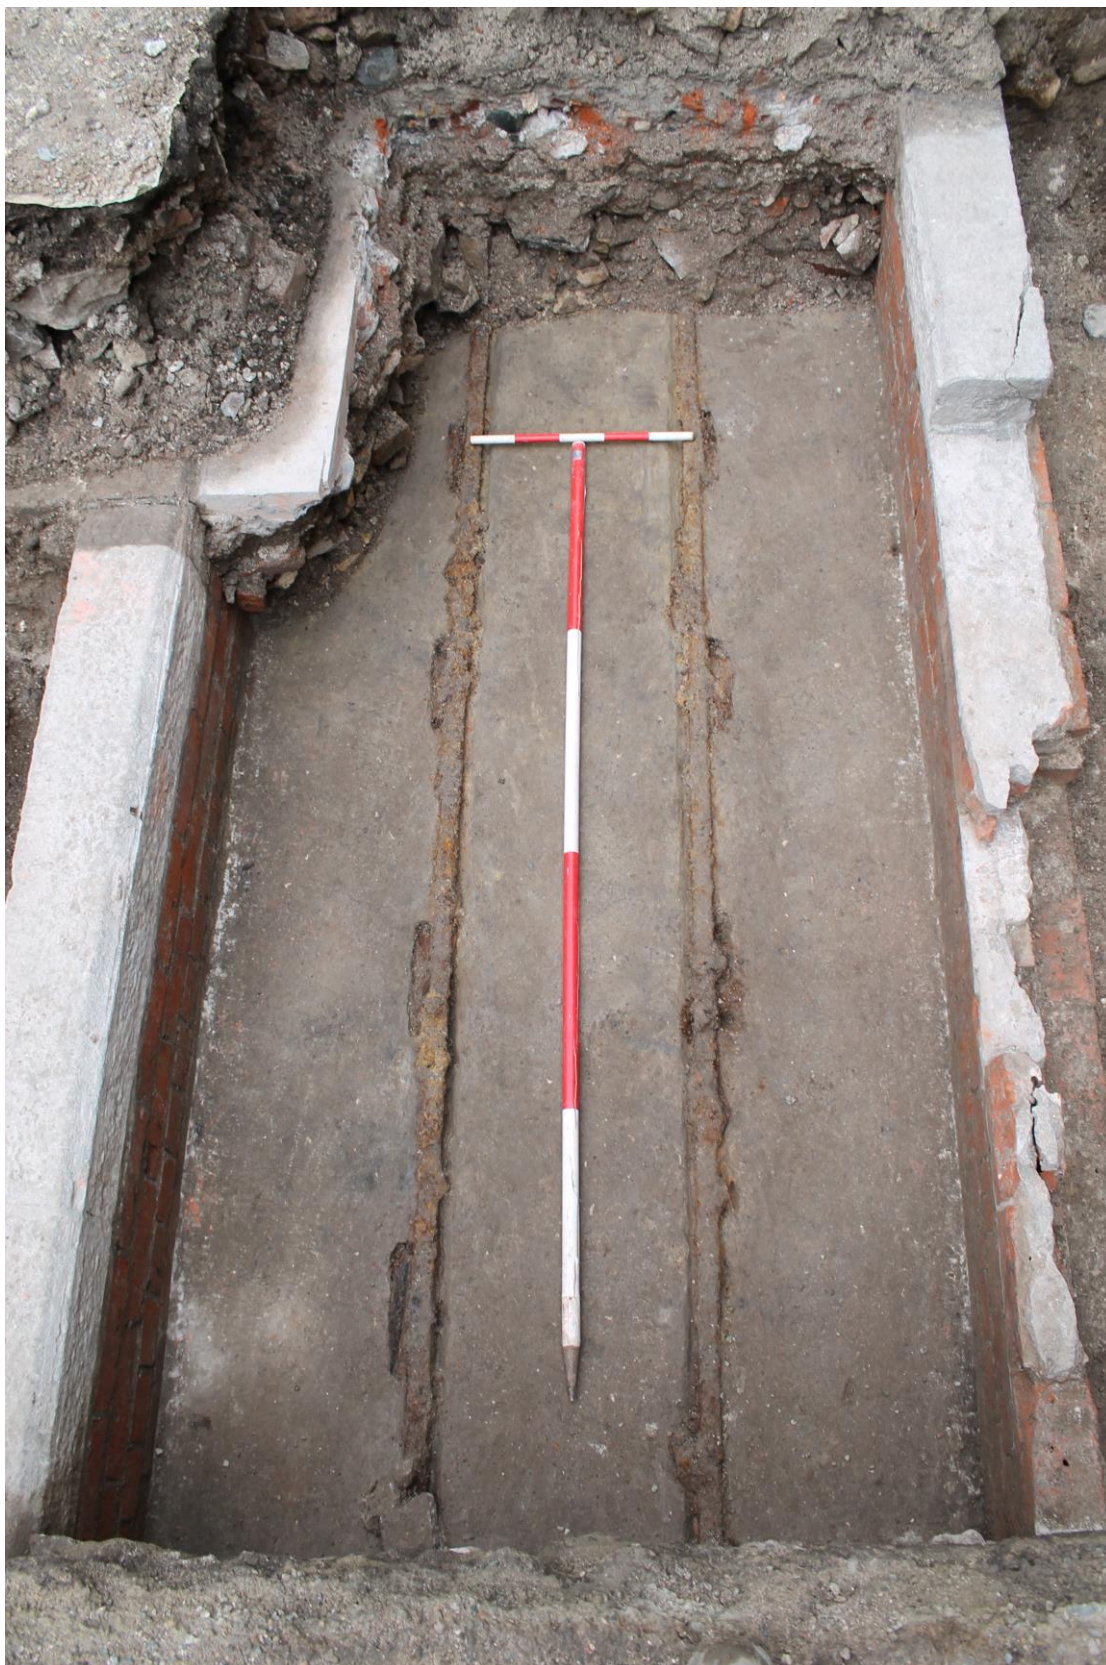
**Plate 14. Inner Ward. Trench 1. Detail of the Victorian railway and later infill layers. From south.**

Above the concrete surface of the infilled Victorian light railway was a thick deposit of rubble (C.105), up to 0.40m thick, and consisting of loose mortar, red brick and small, medium and large stones. It probably represents the demolition of the latest barracks buildings in this part of the castle in the years after the fortification became a State Care monument in 1928.

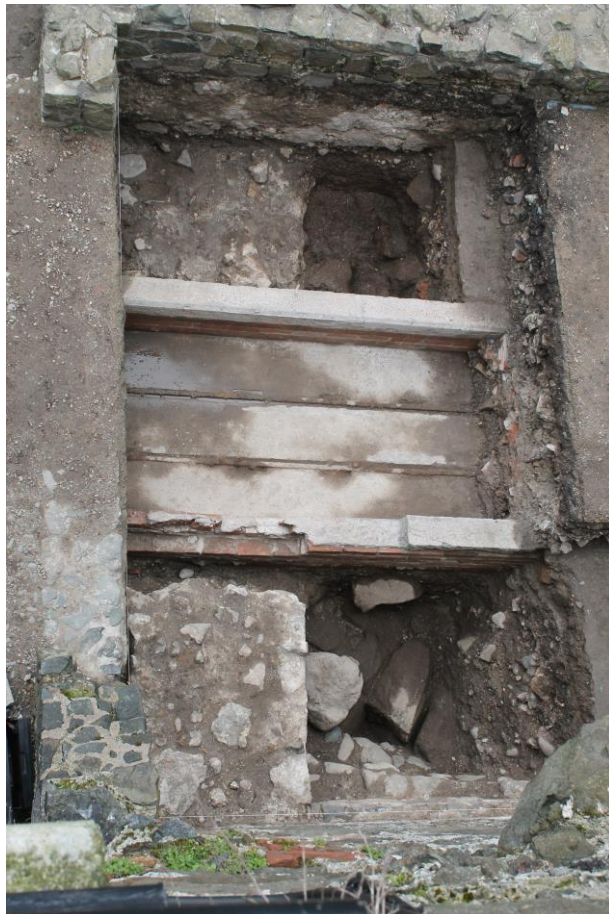
**Plate 15. Inner Ward. Trench 1. The Medieval wall C.106/C.135 crossed by the Victorian railway. From east.**

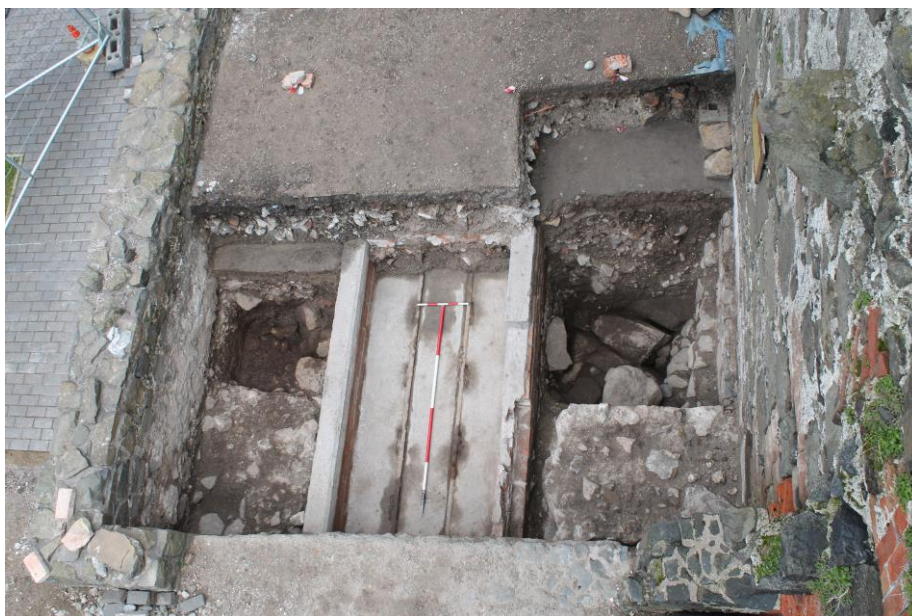
**Plate 16. Inner Ward. Trench 1. The Medieval wall C.106/C.135 crossed by the Victorian railway. From south.**

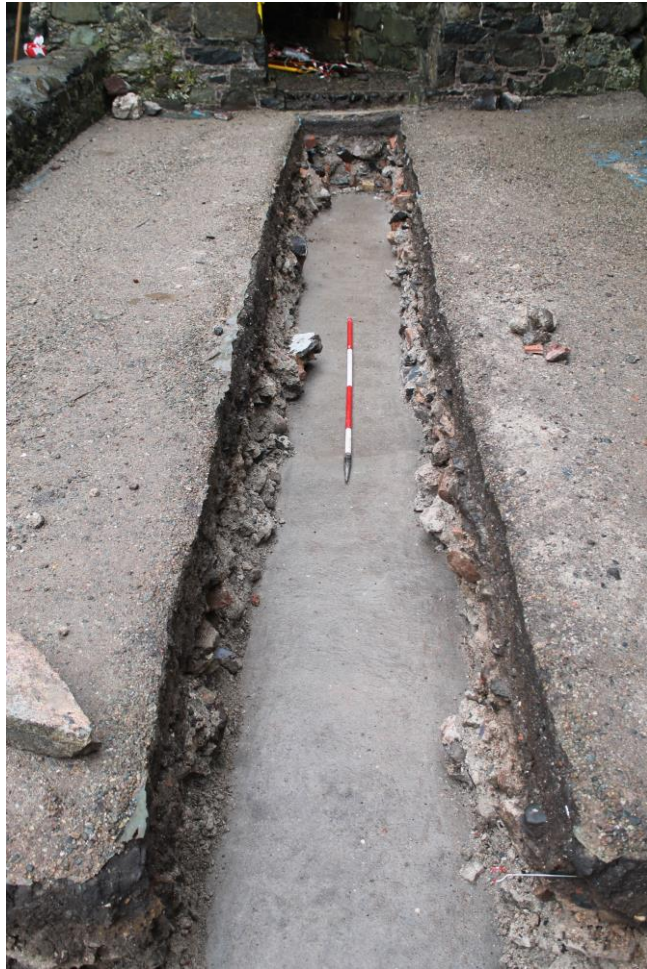
**Plate 17. Inner Ward. Trench 2. Demolition layers and concrete surface C. 210. From south.**

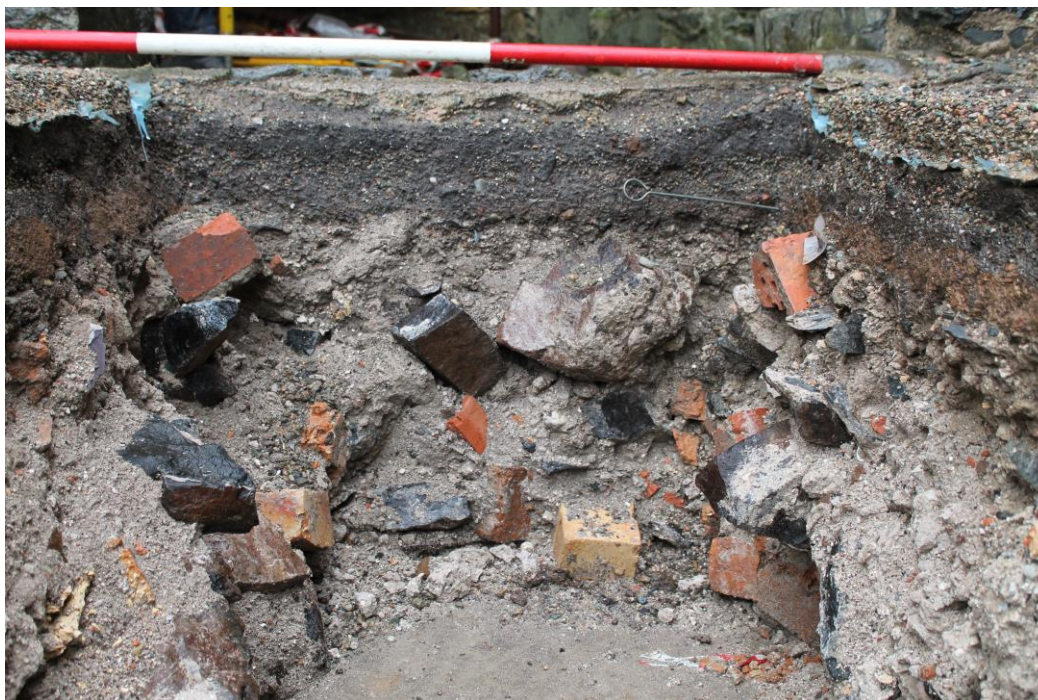
**Plate 18. Inner Ward. Trench 2. South-facing section. Detail of demolition layers and concrete surface C. 210. From south.**

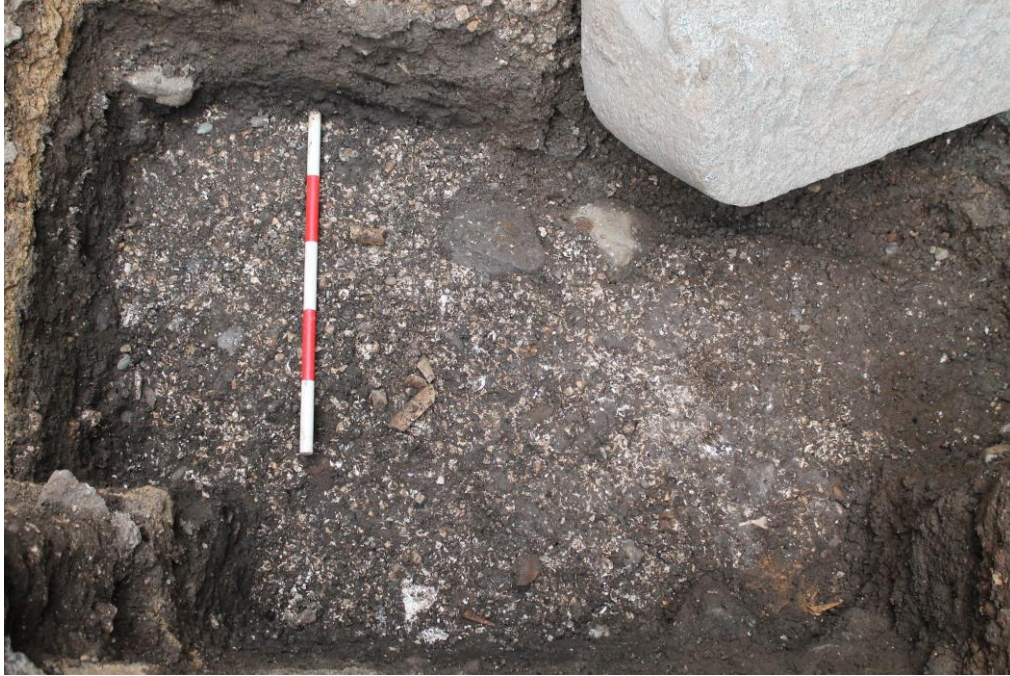
**Plate 19. Inner Ward. Trench 2 Northern Extension. Midden layer C.229. From south.**

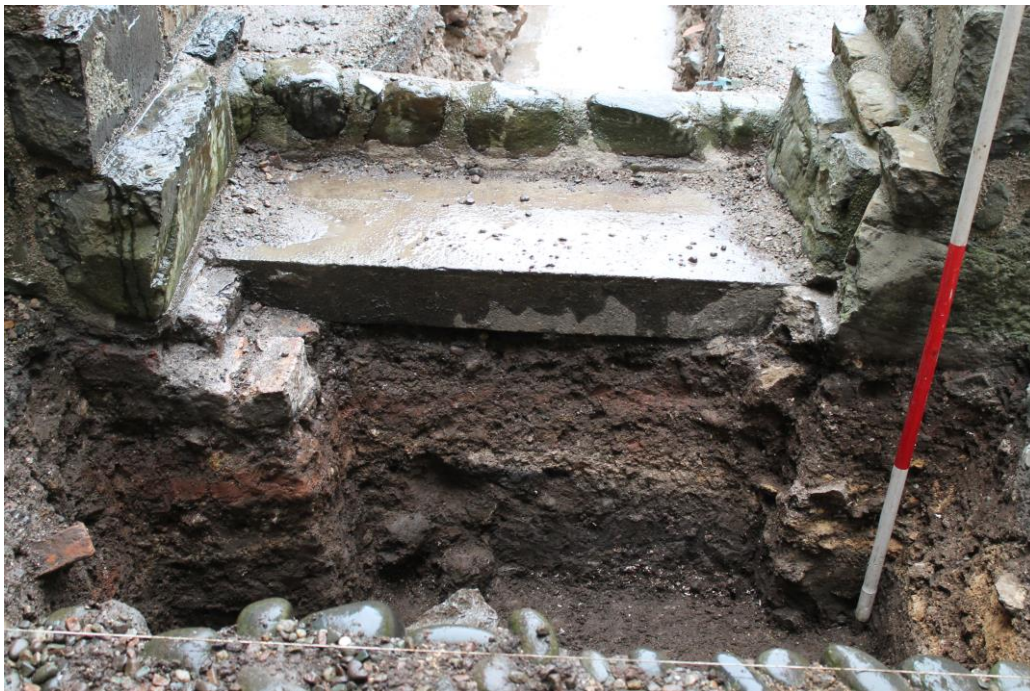
**Plate 20. Inner Ward. Trench 2 Northern Extension. Threshold and shallowly founded northern 'gable' of the store house. From north.**

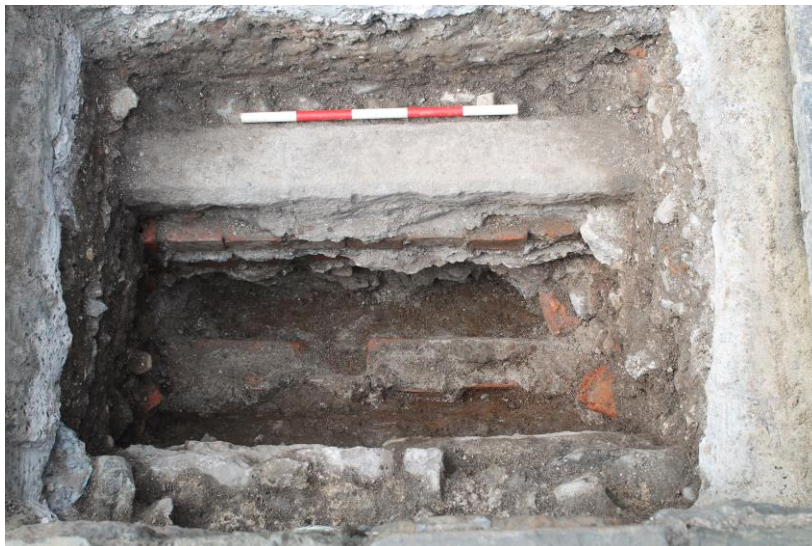
**Plate 21. Inner Ward. Trench 2B. From west showing footings of the west wall of the store house, the east wall of the Victorian railway and the red brick pier structure C.243/ C.246.**

Above the level of the railway were layers of dark brown clay loam containing brick, mortar and slate, granite chippings small stones and pebbles (C.234 and C.235). The rubble content might suggest that these horizons date to the period of the demolition of castle barracks buildings post-1928. More recent horizons above these

included a thick layer of concrete (C.233), and the modern grey brick paving surface of this part of the castle (C.231 and the bedding layer below it C.232).

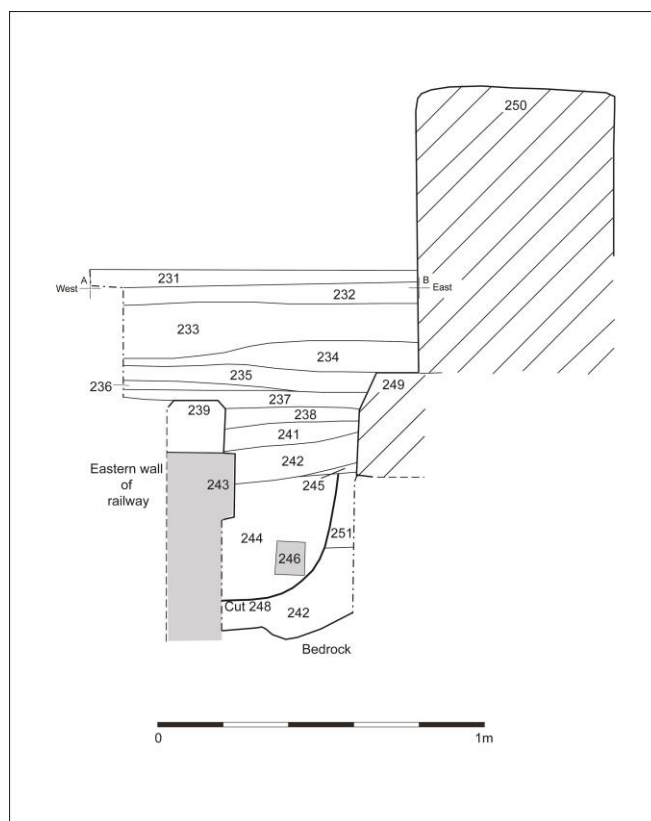
**Fig 14. Inner Ward. Trench 2B. South-facing section.**

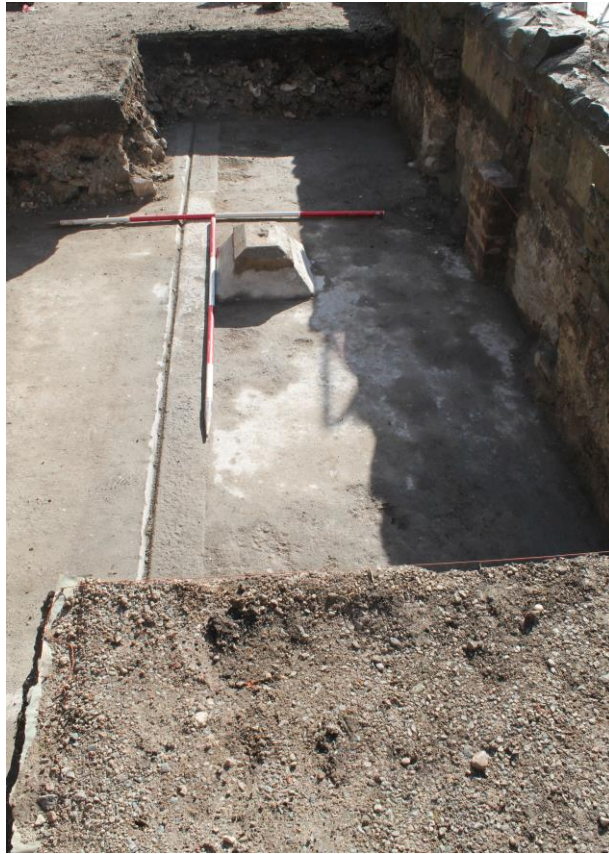
**Plate 26. Inner Ward. Trench 3. Western end. Blocked-up entrance in the west wall of the store house, cement pier C.311 and the line of the Victorian railway. From north.**

The only internal masonry remains associated with the concrete floor within the store house was a rectangular cement pier (C.311), presumably for an internal structural column within the late-18th century building. This was located 0.90m east of the blocked-up entrance in the west wall of the store house and directly in line with its red brick pier. The cement pier base was battered and was 0.66m long by 0.46m wide at

the bottom narrowing to 0.40m x 0.30m at the top. It was 0.38m high and set into the concrete floor C. 308.

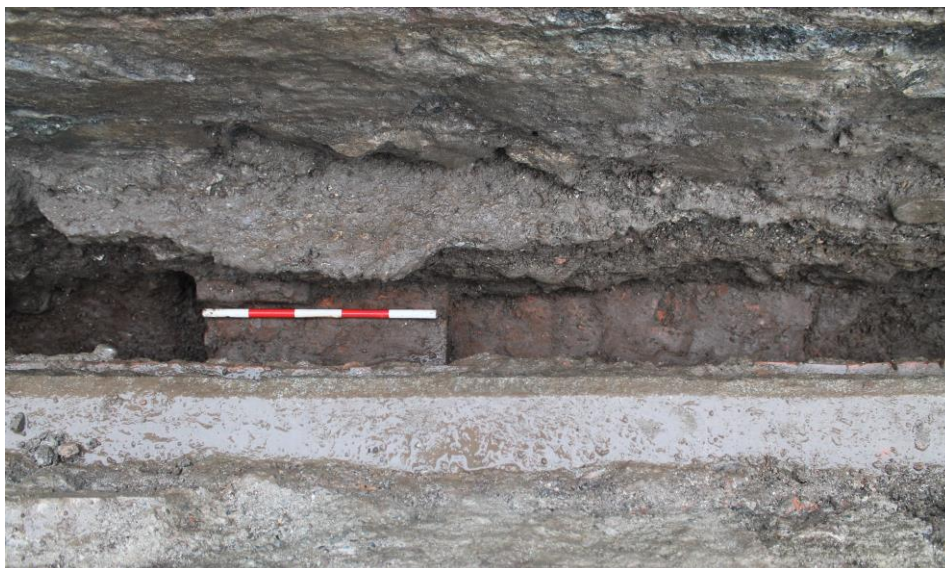
**Plate 27. Inner Ward. Trench 3B. Base of west wall of store house, red brick structure C.350/C.351 and the east wall of the Victorian railway. From west.**

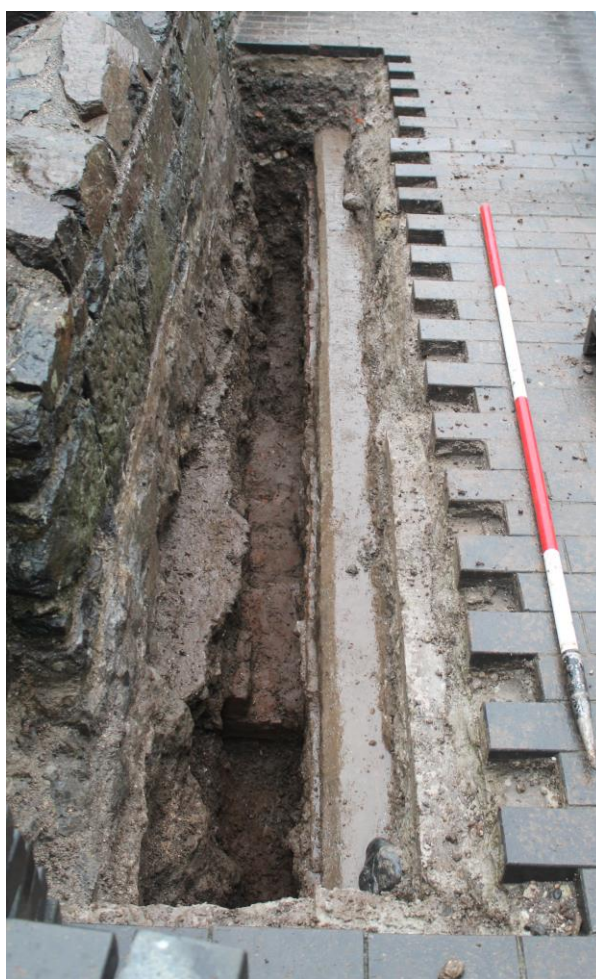
**Plate 28. Inner Ward. Trench 3B. Base of west wall of store house, red brick structure C.350/C.351 and the east wall of the Victorian railway. From north.**

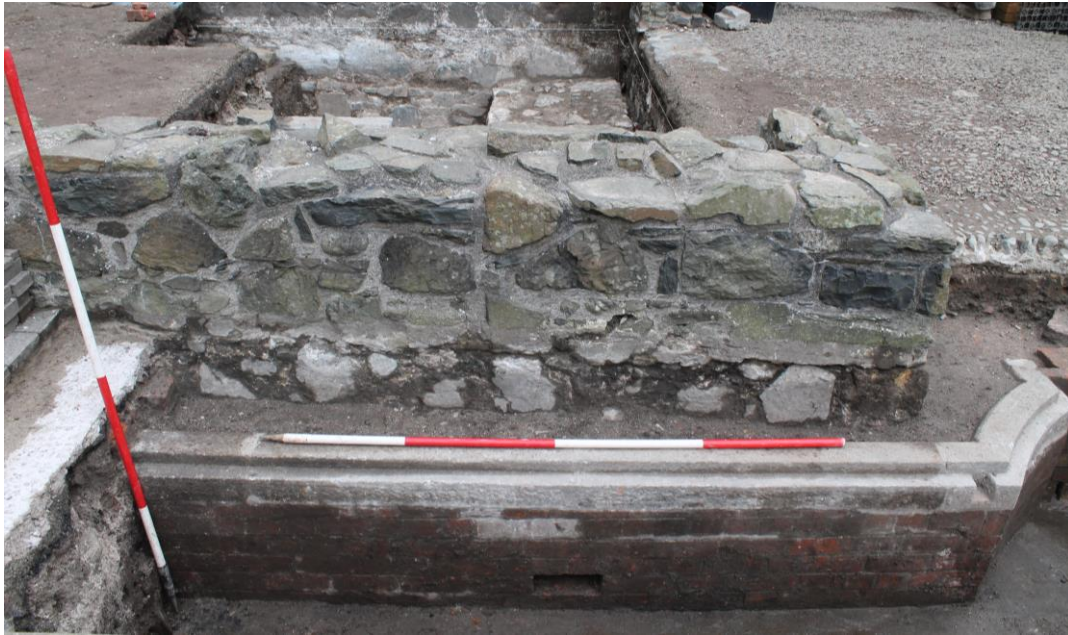
Plate 29. Inner Ward. Trench 9. Eastern walls of Victorian railway, C.920 and C.921. From west.

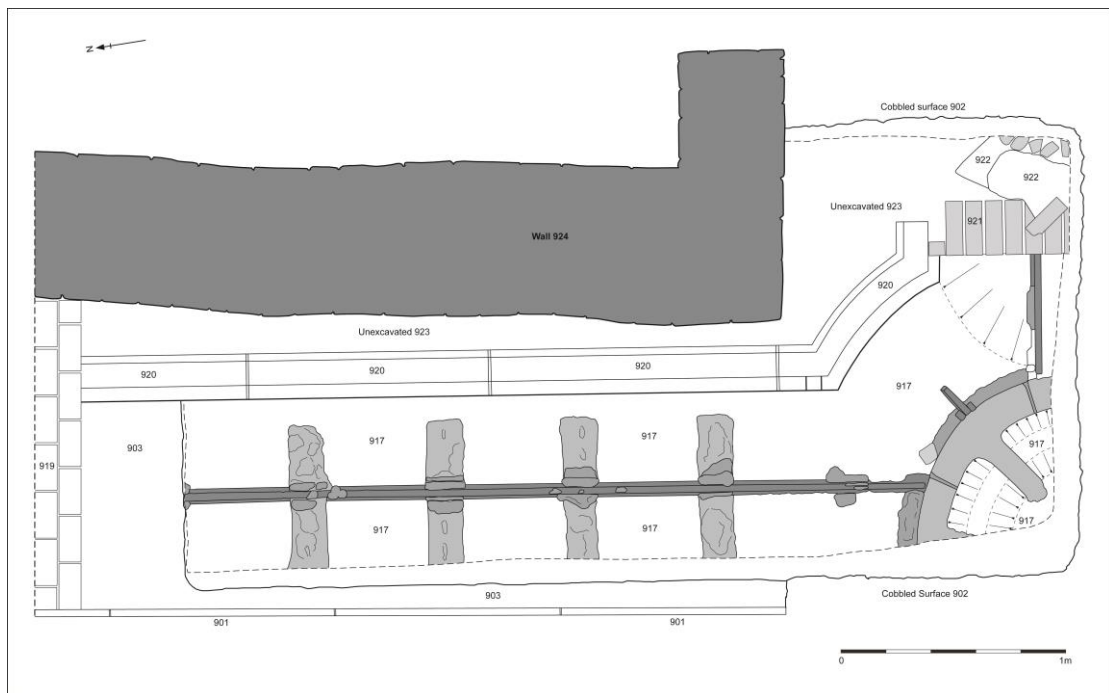
Fig 23. Inner Ward. Trench 9. Plan of the Victorian railway.

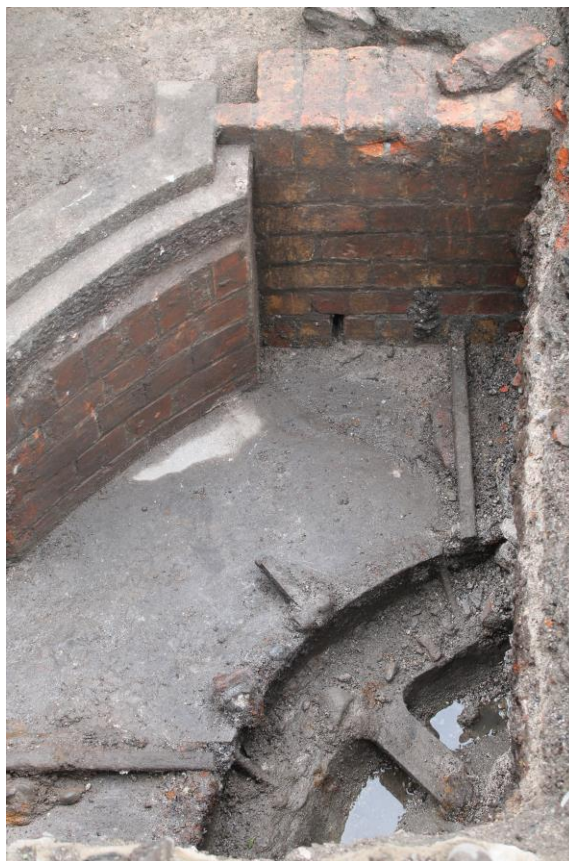
**Plate 30. Inner Ward. Trench 9. Detail of the exposed portion of the turntable of the Victorian railway C.920 and C.921. From west.**

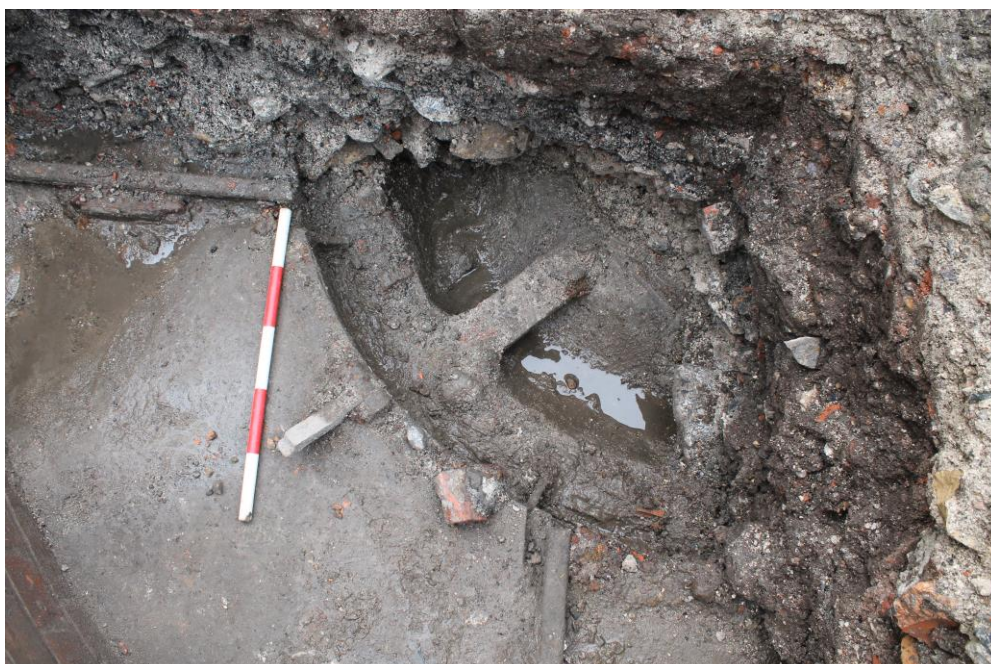
**Plate 31. Inner Ward. Trench 9. Detail of the exposed portion of the turntable of the Victorian railway C.920 and C.921. From north.**

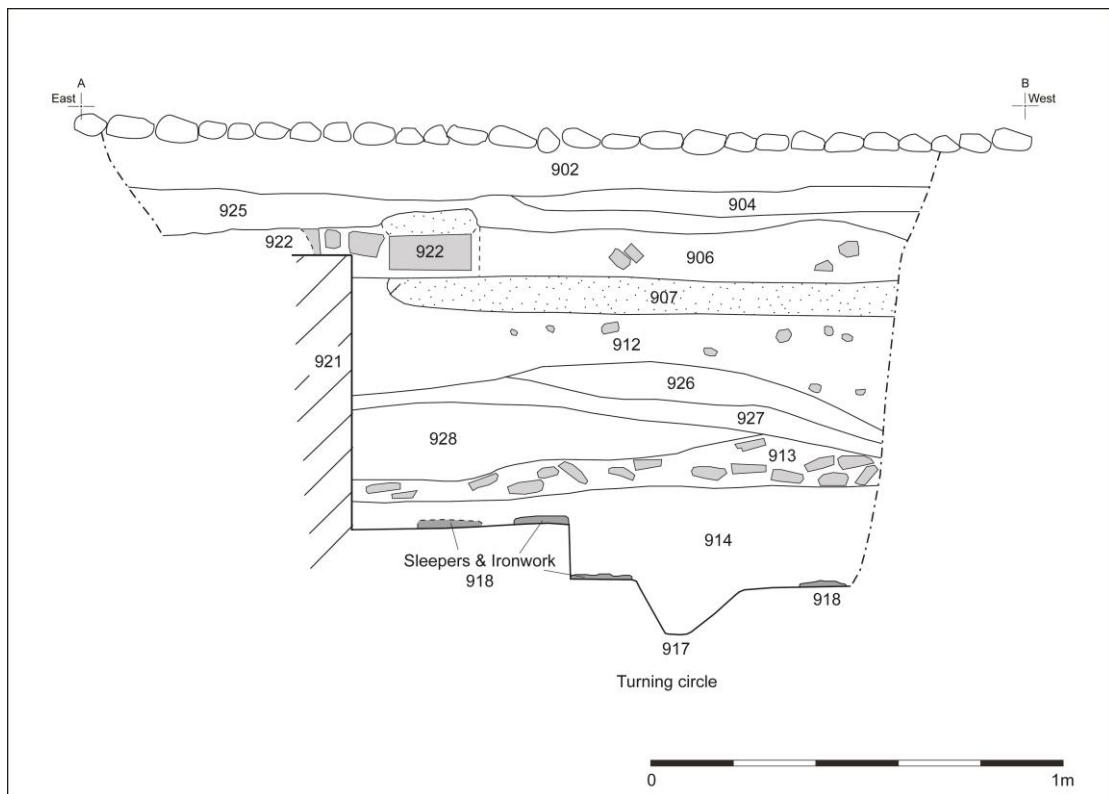
**Fig. 25. Inner Ward. Trench 9. North-facing section of trench.**

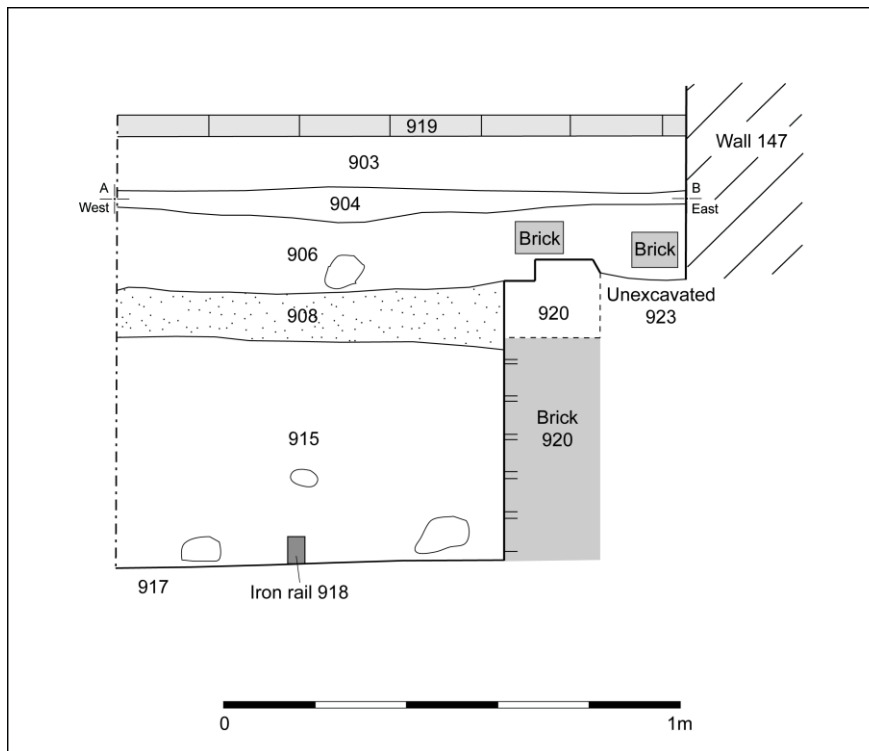
**Fig. 26. Inner Ward. Trench 9. South-facing section of trench.**

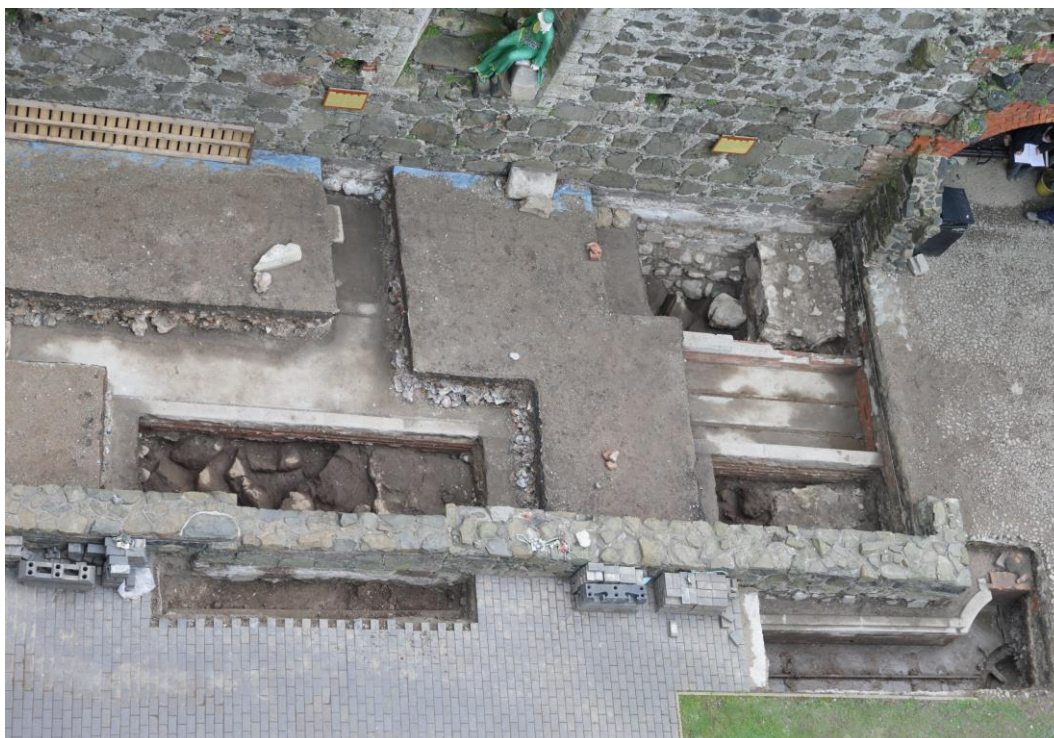
**Plate 32. Inner Ward. Sections of the Victorian railway line visible in Trenches 1, 3, 9 and 3B. It was also located in Trench 2B and 4, not visible in this photograph. From roof of the Keep/ Great Tower.**

The railway line that was uncovered in Trench 9 was a section of line running parallel but outside the store house to that found in Trenches 1 and 3. The railway uncovered in Trenches 1 and 3 was clearly intended to deliver munitions for storage into the building that succeeded the store house. The section of railway line uncovered in Trenches 9, 3B and 2B was intended to take munitions out to buildings located in the Outer Ward.

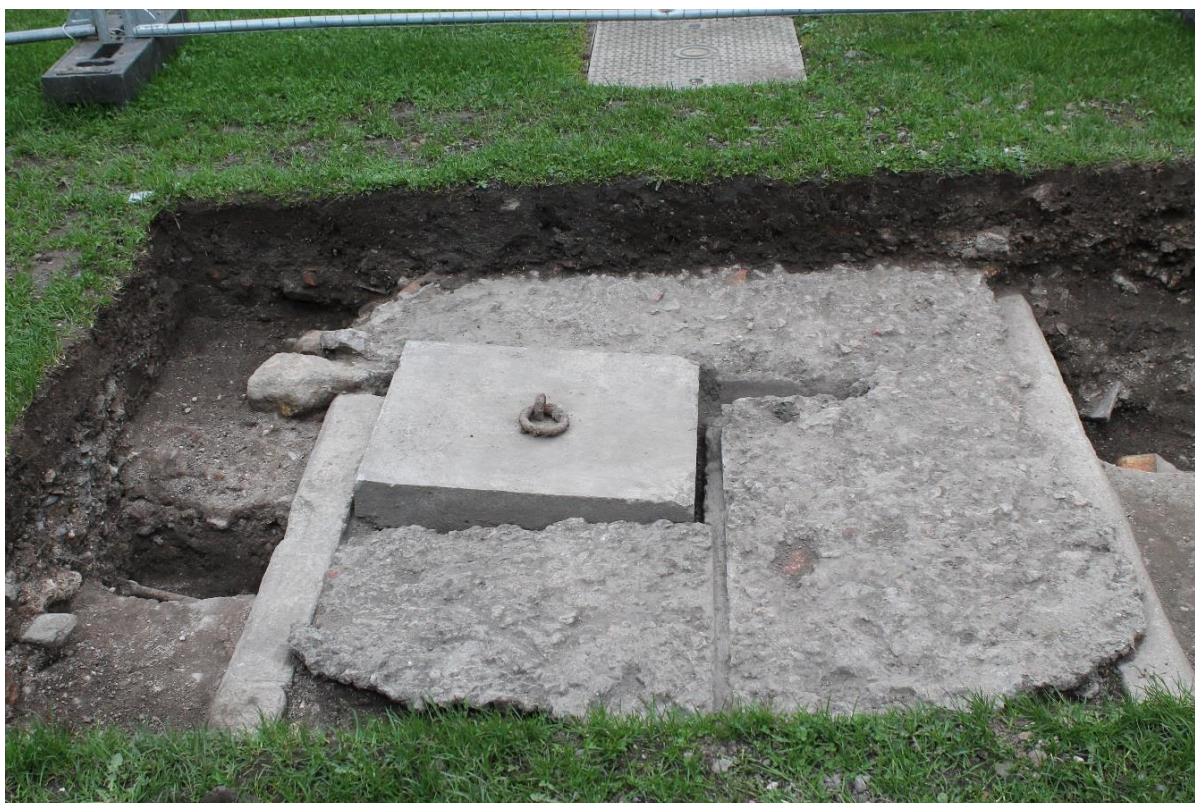
**Plate 33. Inner Ward. Trench 4. The visible granite sleepers of the Victorian railway and the later manhole cover. From east.**

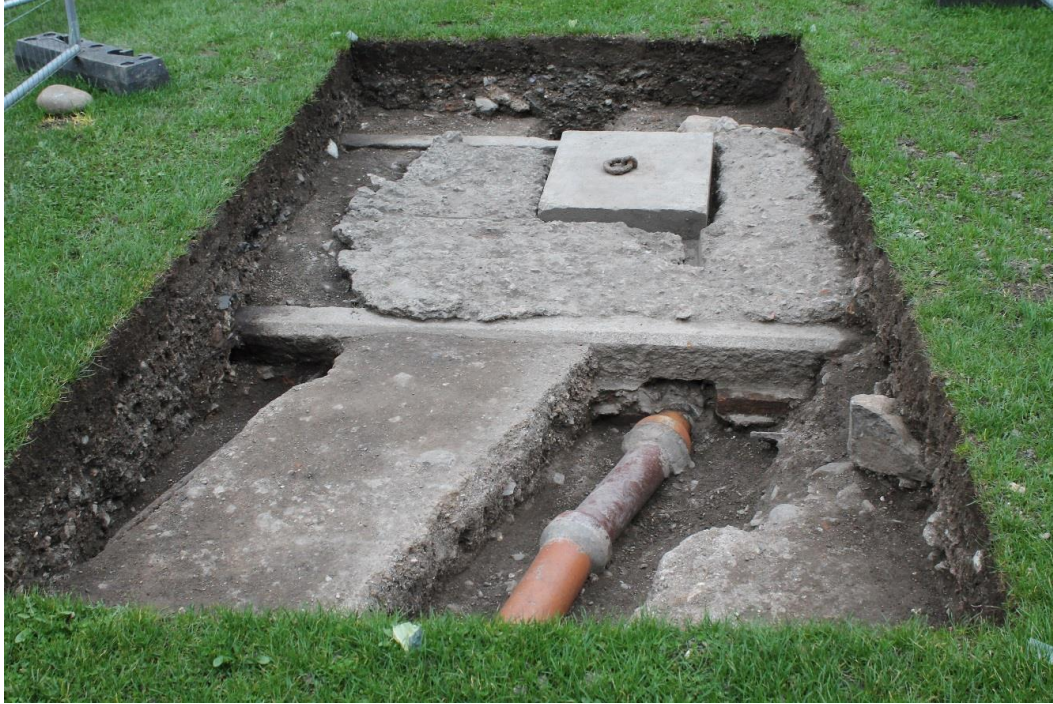
**Plate 34. Inner Ward. Trench 4. Shows the line of the Victorian railway and later service trenches cut through it. From north.**
