**CAF Data Structure Report No. 105**

**Excavations at Carrickfergus Castle,**

**Co. Antrim**

CAF DSR 105

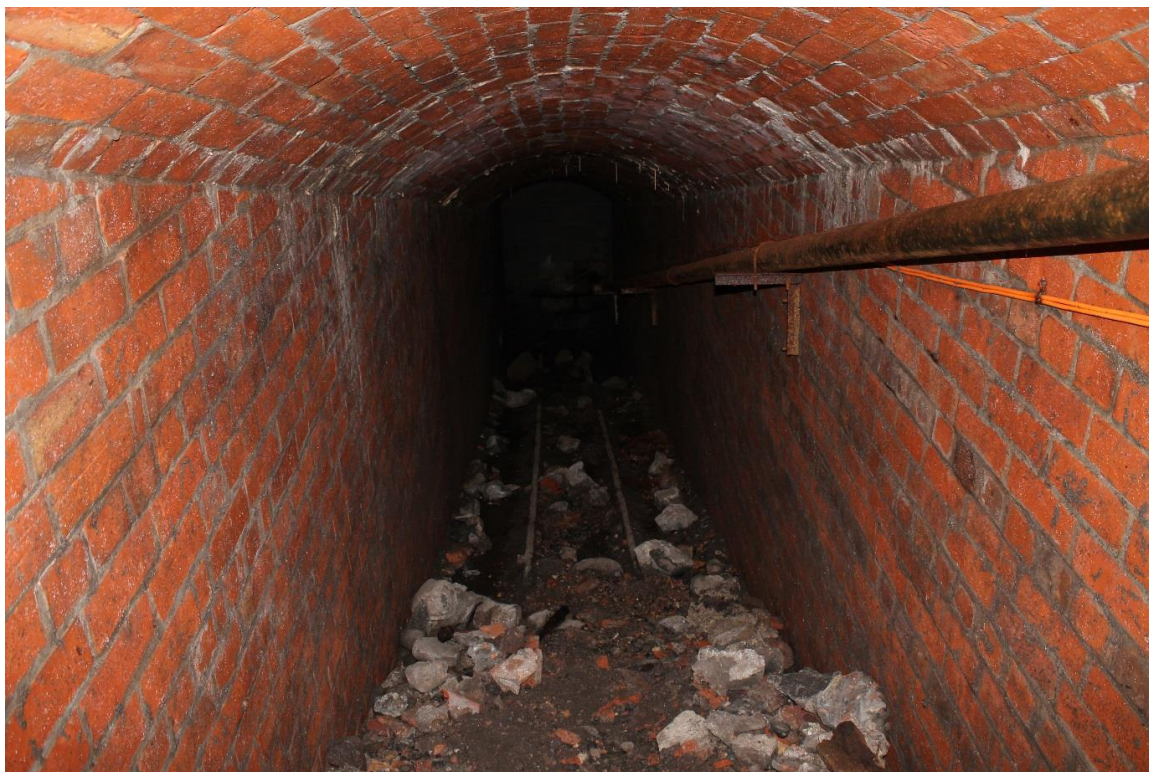
**Plate 35. Inner Ward. The still extant subterranean Victorian railway as seen after being accessed from the manhole cover adjacent/ west of Trench 4. Looking west down the railway tunnel.**

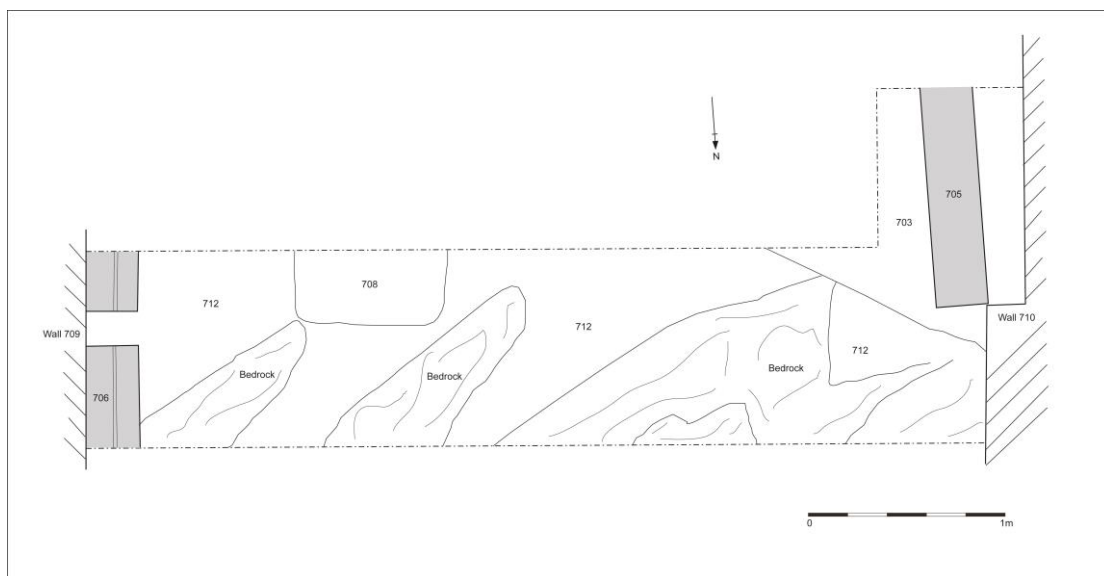
**Fig. 30. Outer Ward. Trench 7. Plan of main features.**

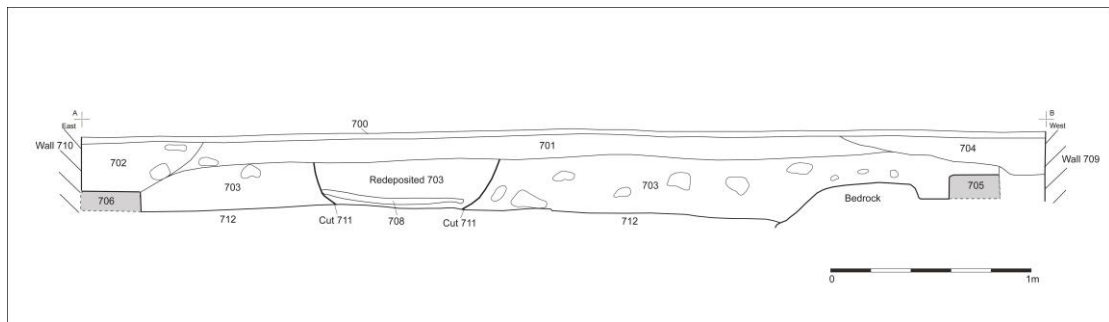
**Fig. 31. Outer Ward. Trench 7. North-facing section.**

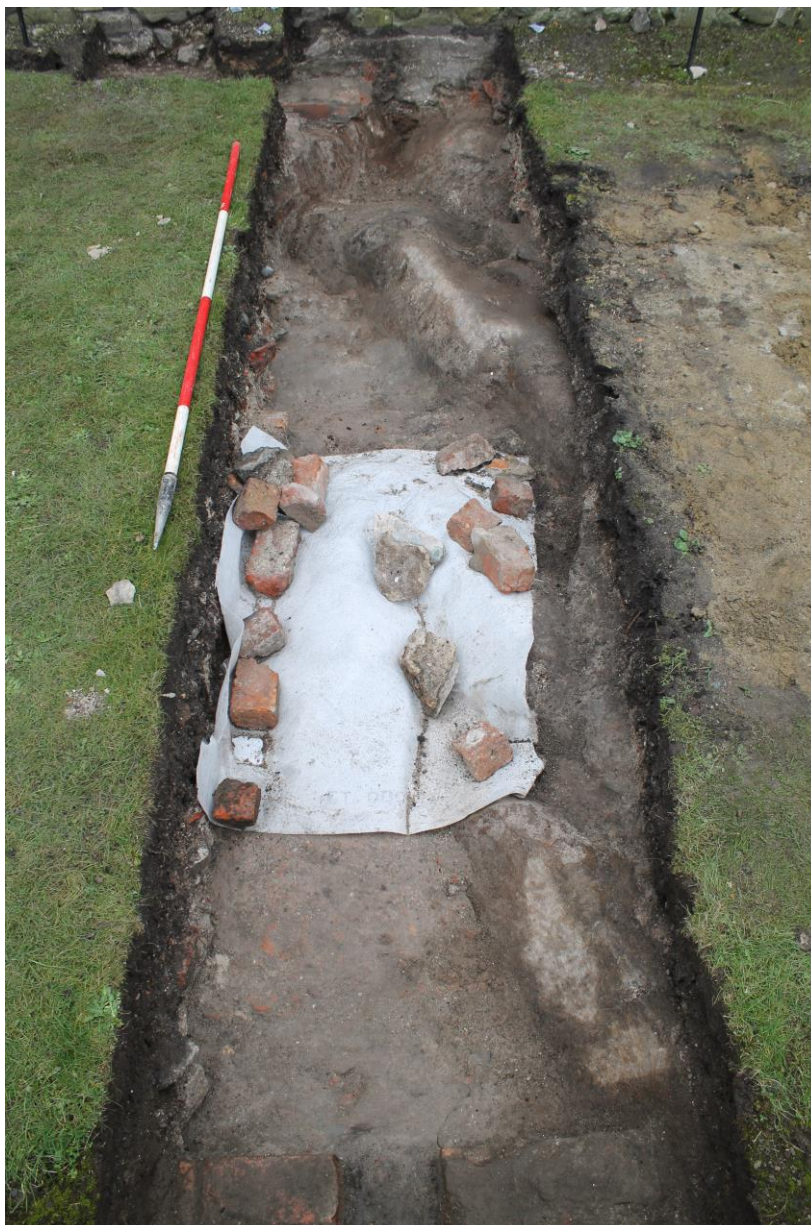
**Plate 37. Outer Ward. Trench 7. From east showing bedrock rising high, the possible pet burial (covered over) and red brick foundations C.705 and C.706.**

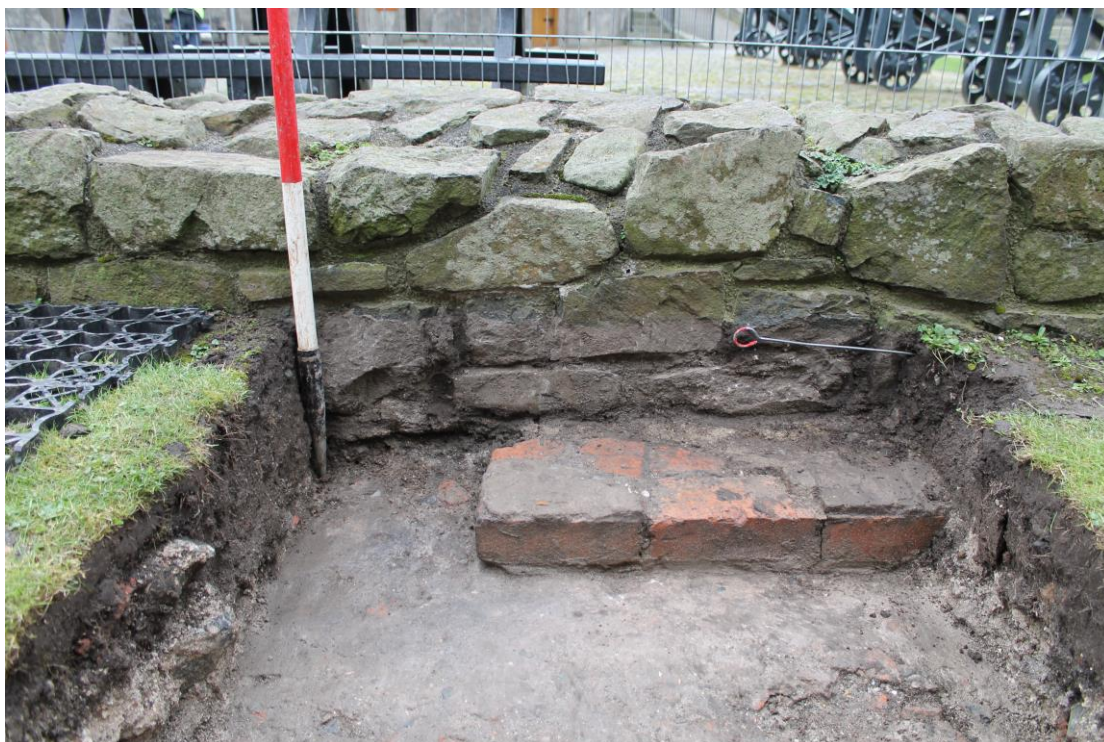
**Plate 38. Outer Ward. Trench 6. From west showing brick foundation C. 606, mortar floor C.605 and the east wall of the barracks building.**

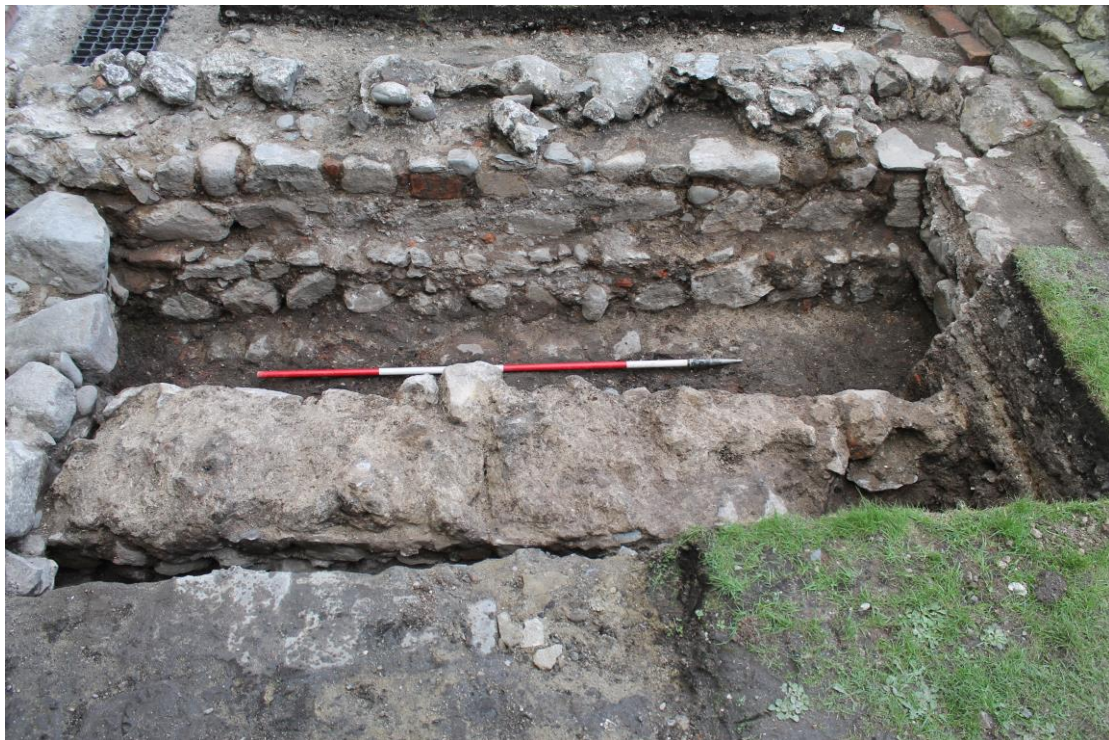
**Plate 39. Outer Ward. Trenches 5 and 8. The southern gable and footings of the barracks building (C.809 and C.818), walls C.510 and C.512. From south.**

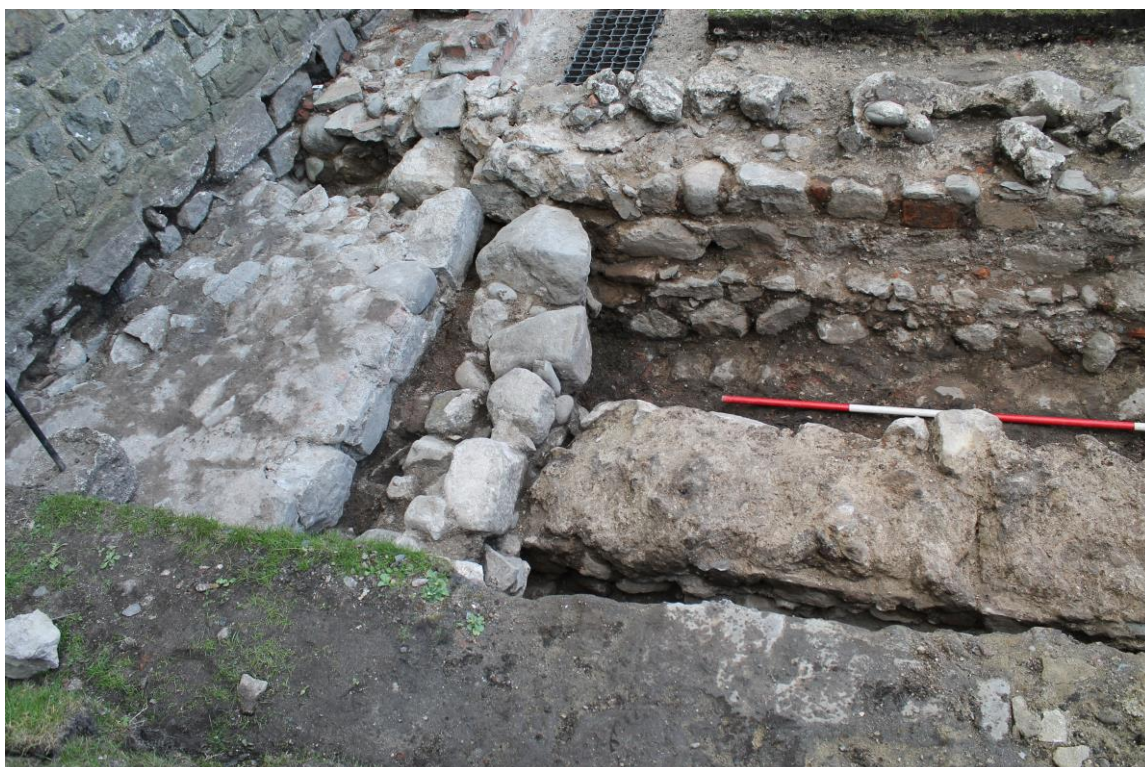
**Plate 40. Outer Ward. Trenches 5 and 8. The southern gable and footings of the barracks building (C.809 and C.818), walls C. 508, C. 510 and C.512. From south-east.**

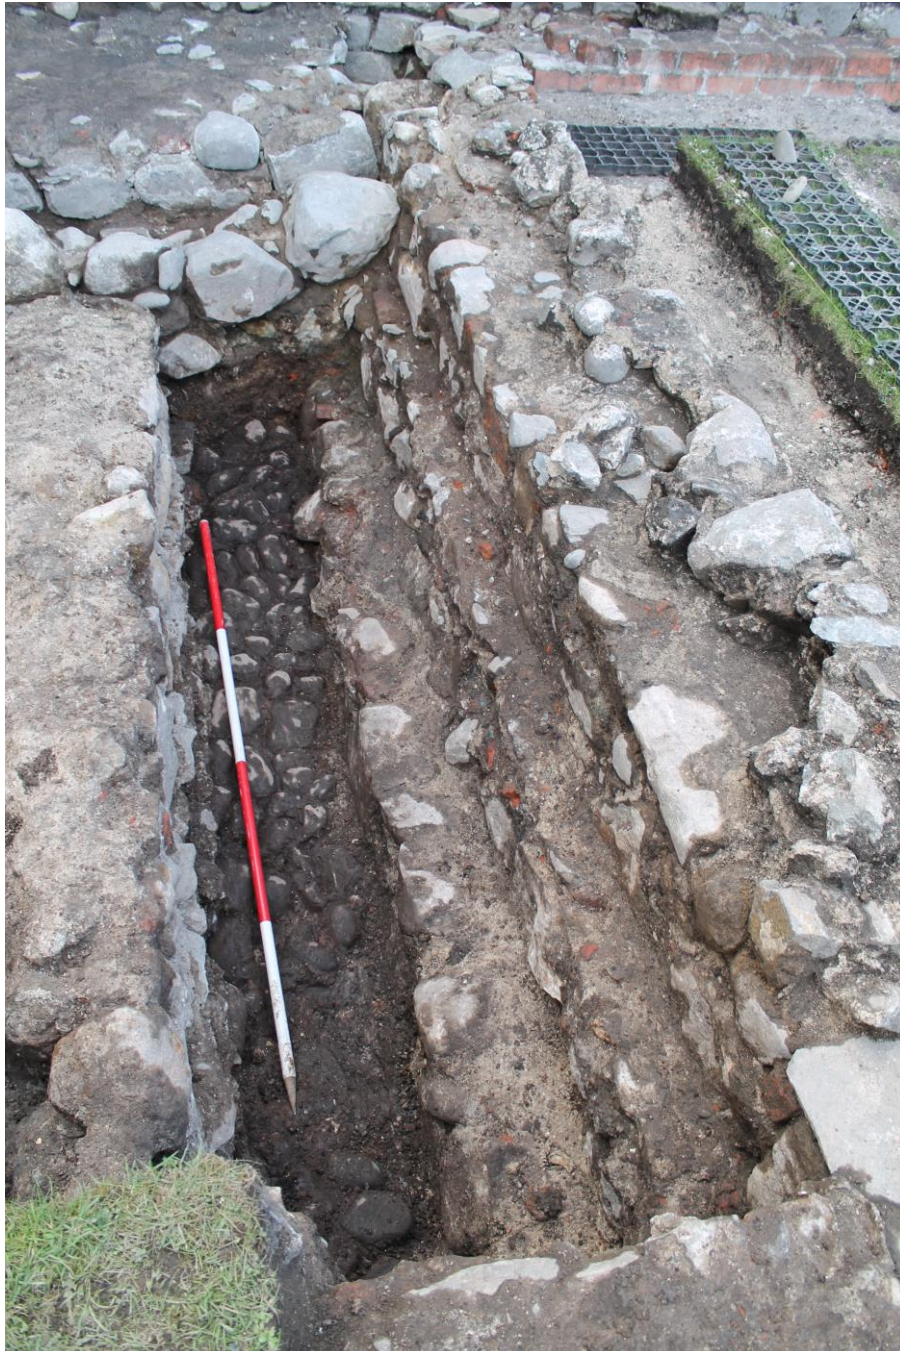
**Plate 41. Outer Ward. Trenches 5 and 8. Wall C.512, cobbles C.819, the southern gable and footings of the barracks building (C.809 and C.818) with later walls C. 508 and C.510 butting against the footings. From east.**

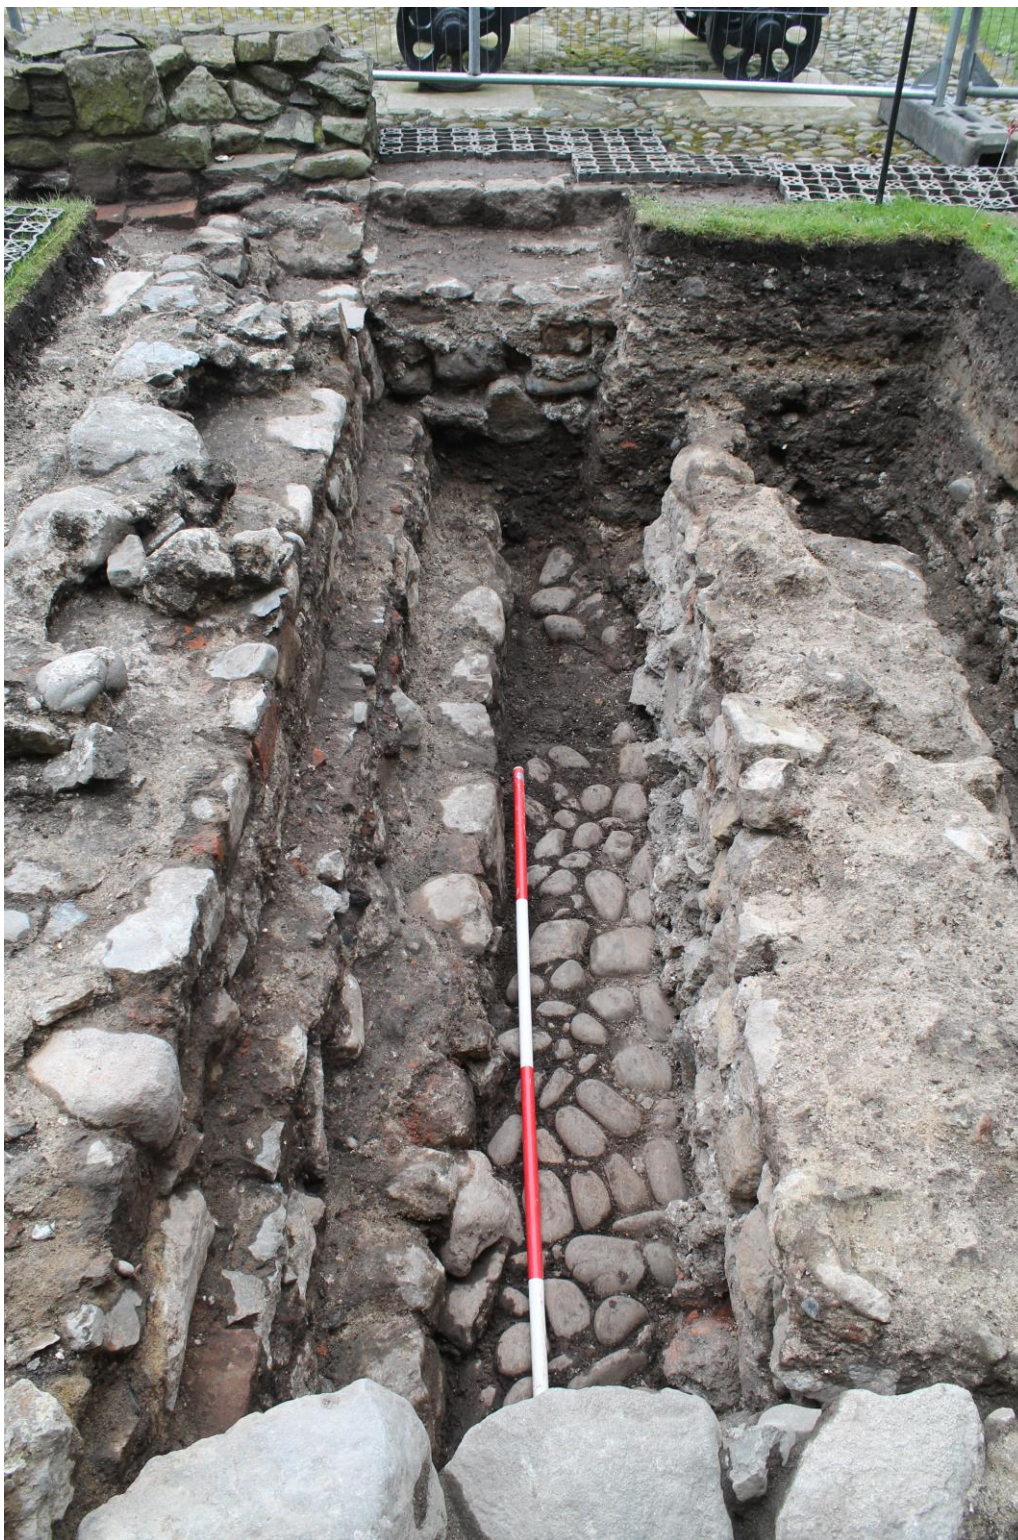
**Plate 42. Outer Ward. Trenches 5 and 8. Wall C.512, cobbles C.819, the southern gable and footings of the barracks building (C.809 and C.818) and the junction with the above-ground east wall of the building. From west.**

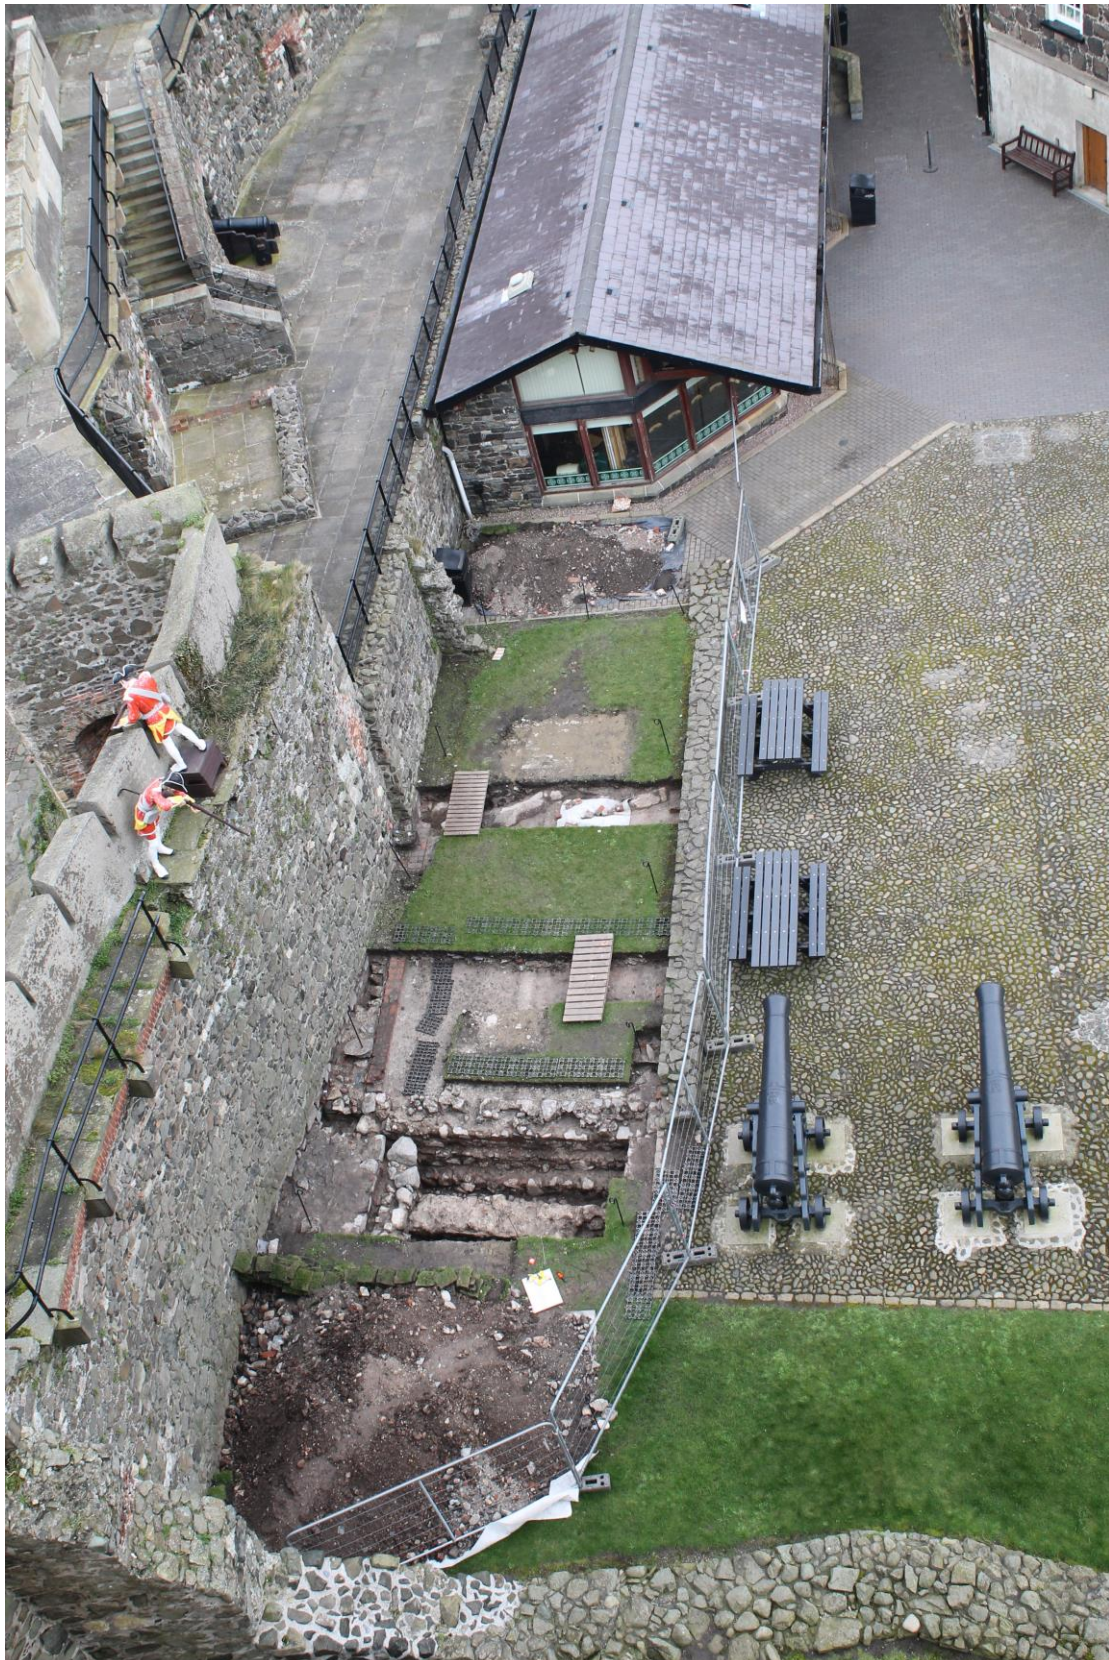
**Plate 43. Outer Ward. Trenches 5-8 from the roof of the Keep/ Great Tower. The wall at the bottom of shot is the Middle Ward wall. From south.**

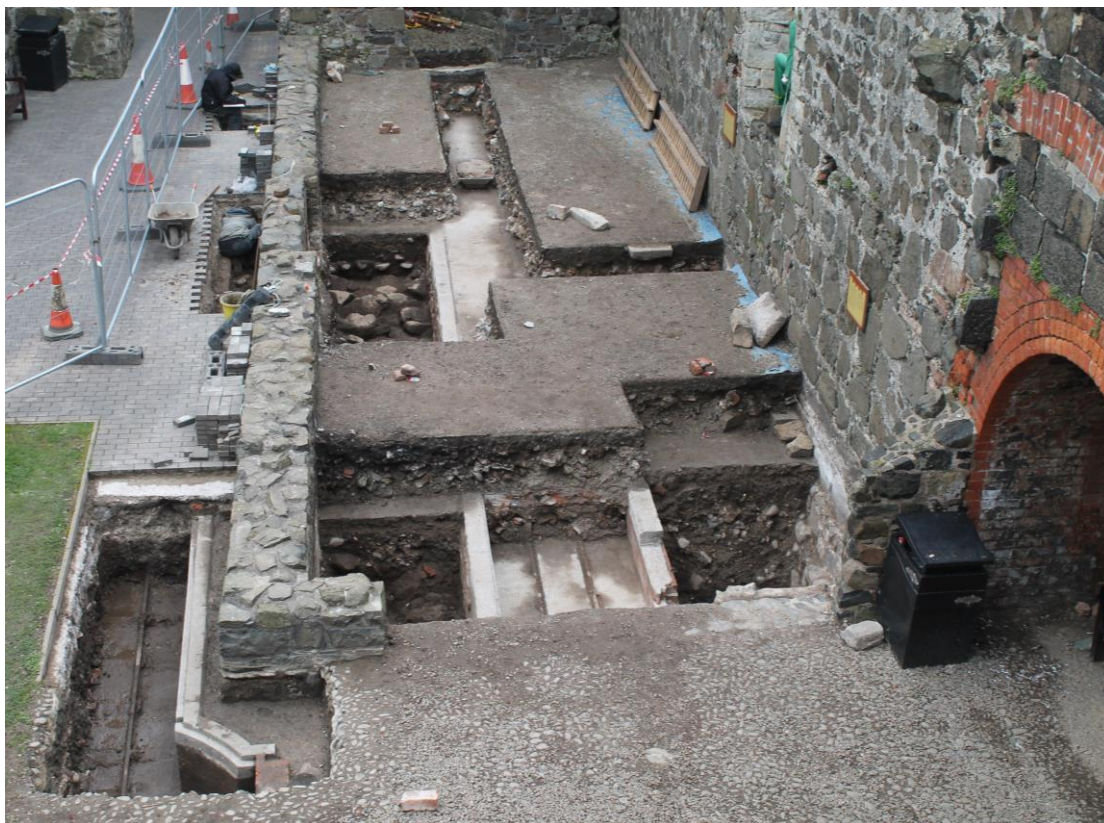
**Plate 44. Inner Ward. The Victorian railway visible in most of the excavated trenches. From south.**

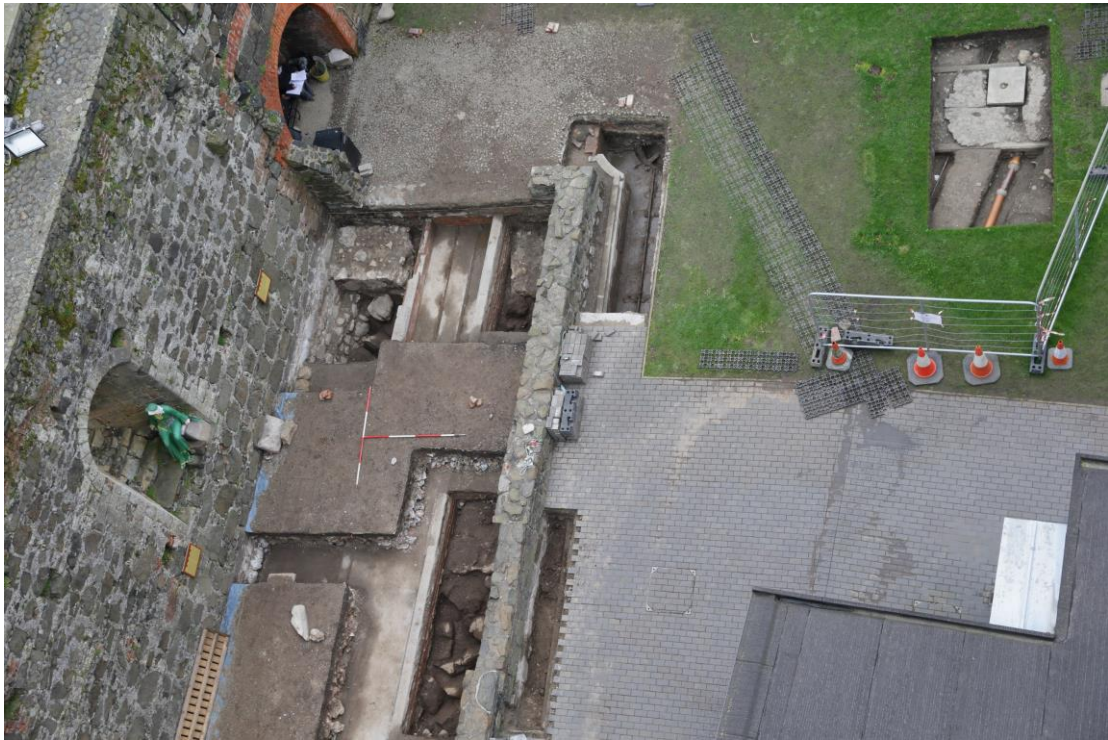
**Plate 45. Inner Ward. The Victorian railway visible and emanating from Trench 4 before it splits into two parallel sections of track and changing direction, as uncovered in the excavated trenches.**
