ULSTER ARCHAEOLOGICAL SOCIETY

Survey Report: No. 41

Survey of Vernacular House at Divis Barn, Divis,
County Antrim
UAS/13/02

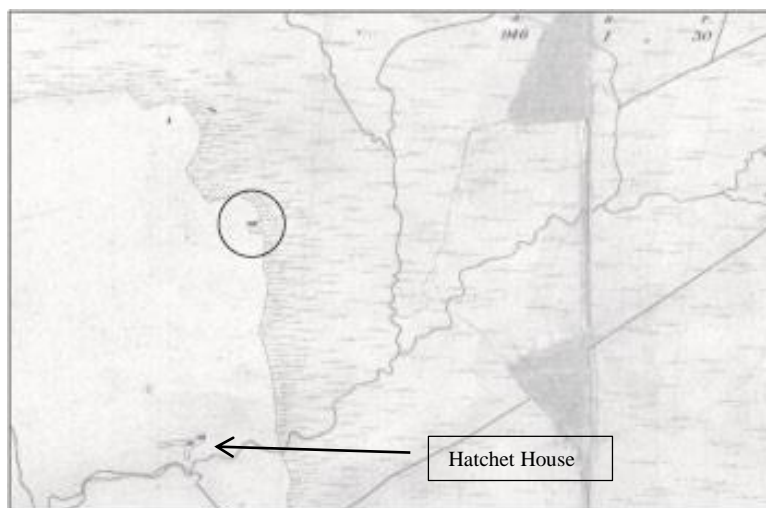
Figure 05: OS County Series Antrim Sheet 56 (part of) 1833

There is a vernacular house marked on the 1833 Ordnance Survey (OS) County Series Antrim Sheet 60 (circled in Figure 05). This is located approximately at the location of the present *Divis Lodge* unoccupied farmhouse. The vernacular house known as the *Hatchet House* is also marked on the map, along with an adjacent building, of which no trace remains at ground level. There is an area of improved grassland indicated to the west of the *Divis Lodge* vernacular house.

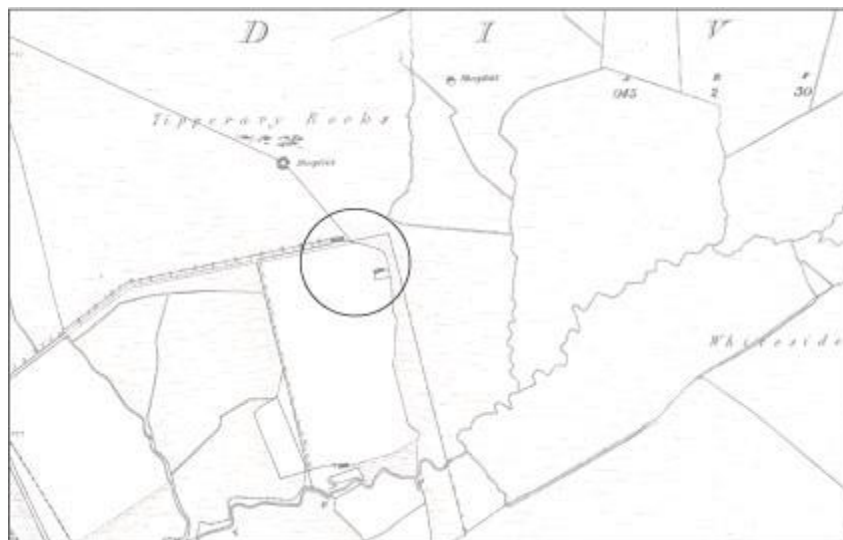
Figure 06: OS County Series Antrim Sheet 60 (part of) 1857

The vernacular house is also shown on the 1857 revision (circled on Figure 06), along with the monument currently known as the *Divis Cashel*, annotated as a *sheepfold* 275 metres to the north-west. This map also shows the position of several field boundaries in the immediate area, indicating a more formal pattern of land use.

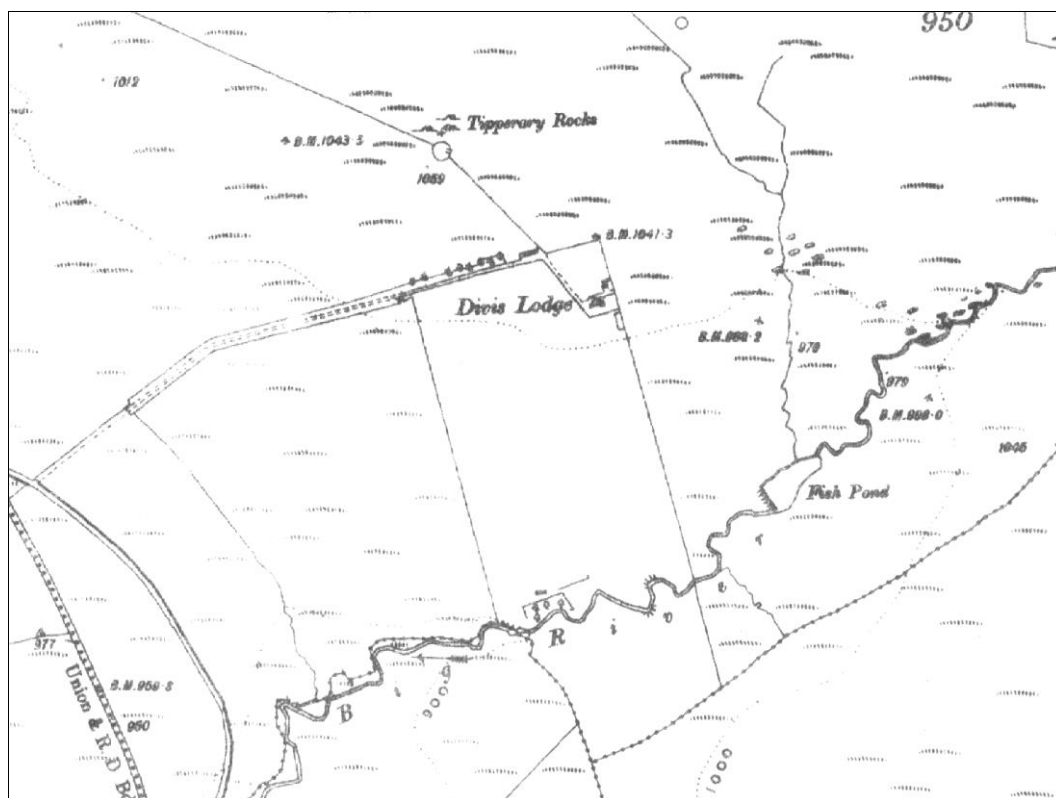
Figure 07: OS County Series Antrim Sheet 60 (part of) 1901, with *Divis Lodge* now annotated

The 1901 revision (Figure 07) annotates Divis Lodge, but not the sheepfold (*Divis Cashel*), although this is marked as a circular enclosure. The distinction between improved grassland in the area of *Divis Lodge* and unimproved grassland in the remainder of the site serves to reinforce the suggestion that this plot of land was being actively farmed by the residents of *Divis Lodge* at this time.

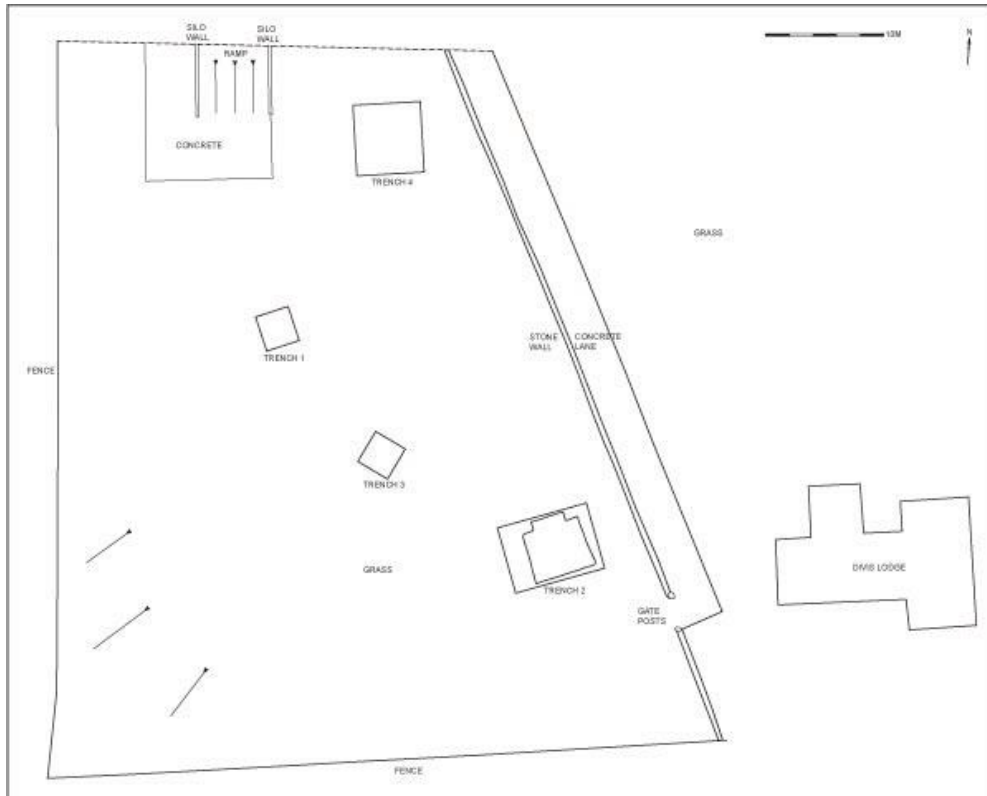
Figure 08: Plan of site, showing excavation trenches

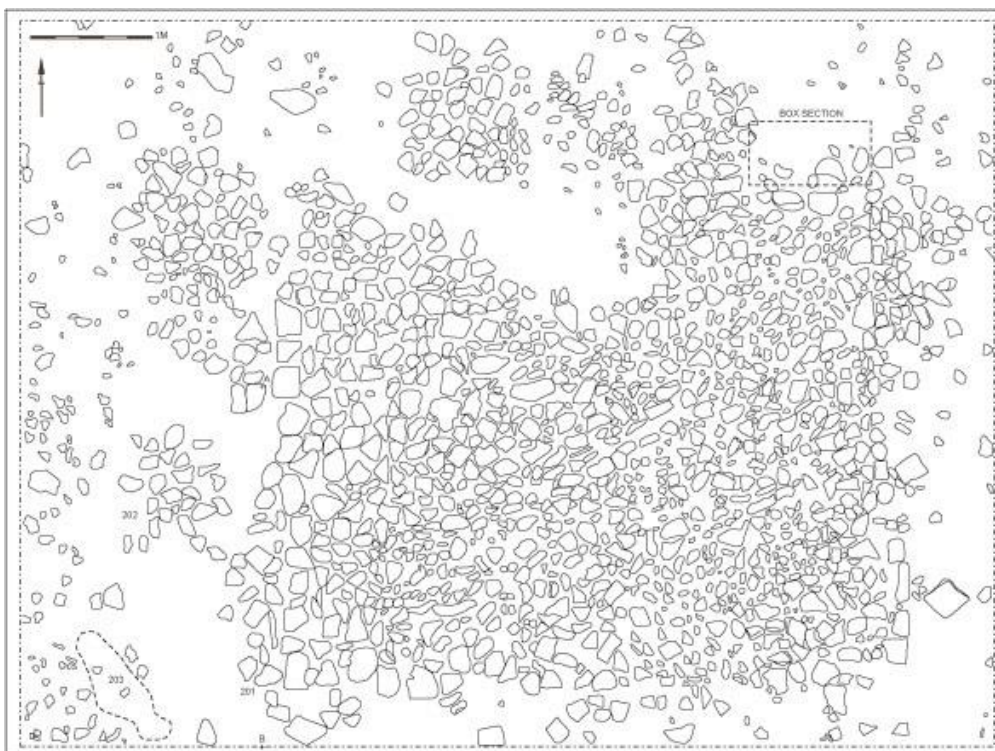
Figure 09: Post-excitation plan of Trench 2, with stone platform of vernacular house

The trench was initially extended to 4m by 4m in an attempt to determine the extent of the stone platform C201, with subsequent extensions before this was achieved. The final dimensions of the trench were 8m in length east/west and 6m in width north/south. The stone platform C201 had a maximum length of 5m [16 feet 4 inches] east/west and a maximum width of 4.3m [13 feet 9 inches] north/south, with a centrally-placed external outshot to the north, 3m [9 feet 10 inches] east/west and 0.8m [2 feet 7 inches] north/south. A number of the stones had a distinct alignment, or facing, at the east and west perimeter of the structure, but this was less evident at the south and entirely absent at the north.

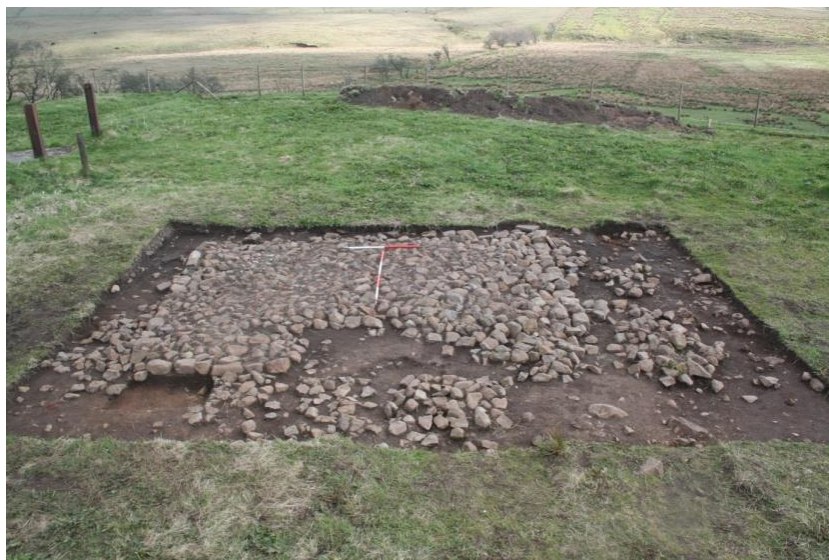
Figure 11: The vernacular house platform, fully exposed, looking south

There was no evidence of walls or wall foundations around the perimeter of stone platform, suggesting that it was either just a purpose-built platform, or more likely that the walls of the building were made from building materials, such as timber or clay, that had either been removed or had completely decayed. A box-section (1m in width, 0.5m in depth and 0.3m in depth, aligned east/west) was excavated at the north-eastern corner of the feature to look for evidence of foundation cuts, foundation courses or residual construction materials, but no such evidence was found. The box section did reveal a layer of mid-brown clayey loam immediately beneath the stony layer, approximately 0.2m in thickness. This was observed to rest on the sub-soil and was interpreted as being either a clay floor or a clay base for the stony layer. Further excavation would be required here in order to be more definitive.

The stone platform was disturbed at the centre of the northern edge, leaving a sub-rectangular gap, 1m in width and 2.25m length, aligned east/west. The soil in this area was heavily flecked with charcoal and it is possible that a hearth stone had been removed from this area to leave the gap. Behind this, to the north, a further sub-rectangular platform was uncovered. This was 1.25m in width and 2.8m in length and aligned east/west. This was interpreted as being an extension, or outshot, in order to provide a fire-resistant support for a chimney flue.

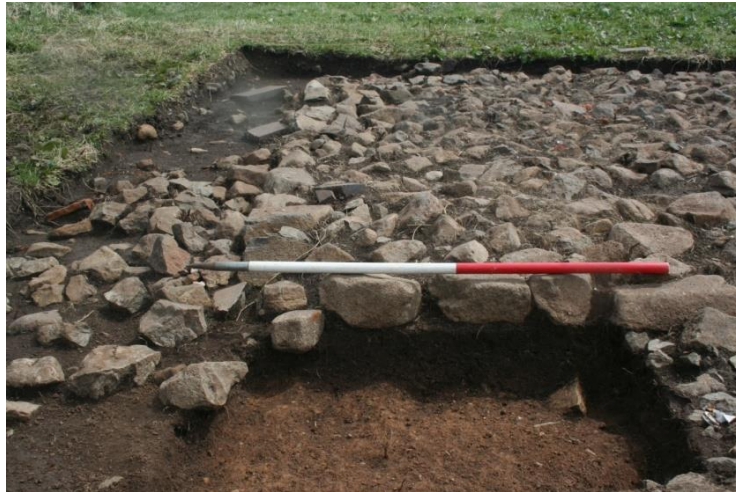
To the west of the excavation trench, three irregular groups of stones were uncovered immediately below the sod layer. These were interpreted as being residual deposits following the demolition of the building. A deposit of greyish-brown gravelly clay was uncovered to the east. This deposit was rich in charcoal and fragments of coal and coke. It was interpreted as being the residue from a fire, probably dumped there from elsewhere, as there were no indications of in-situ burning in the immediate area. Finds from the topsoil around the stony deposits included fragments of brick pottery and slate, with some metal objects and possible slag.

Figure 12: Section at north-east of vernacular house, looking south [scale 1m]

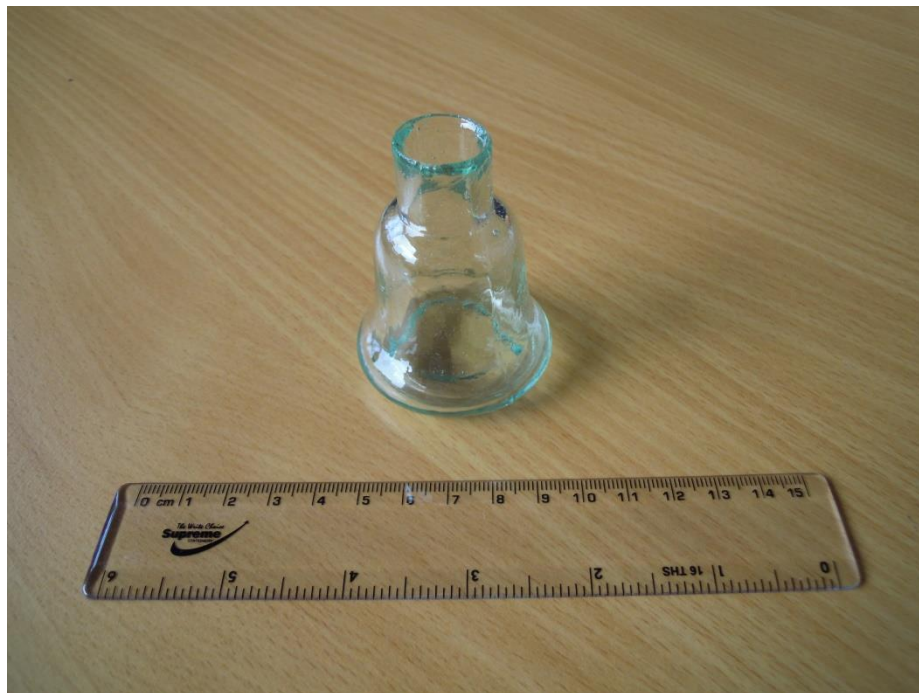
Trench 2 was initially to be located at the south-east corner of the excavation site over an area where several worked flints had been observed. However, following the results of the geophysical survey and observations of visible regularly-placed stones, the location of the trench was realigned slightly to the north-west of its original location. Initially 3m by 3m in size, the sod layer was removed to reveal a layer of topsoil, which extended across the trench. When this was excavated at the eastern part of the trench, a stony platform was revealed. The topsoil was found to contain animal bone, fragments of brick, clay pipe, glassware, mortar and plastic. Also found were two sherds of pottery, provisionally dated to the seventeenth century (Ruairí Ó Baoill pers. comm.). Also recovered were some fragments of metalworking slag, quartz, slate, tiles and a water-rolled stone. Of particular interest was a complete glass bottle, probably an ink pot (Figure 13).

Figure 13: Glass ink pot recovered from vernacular house

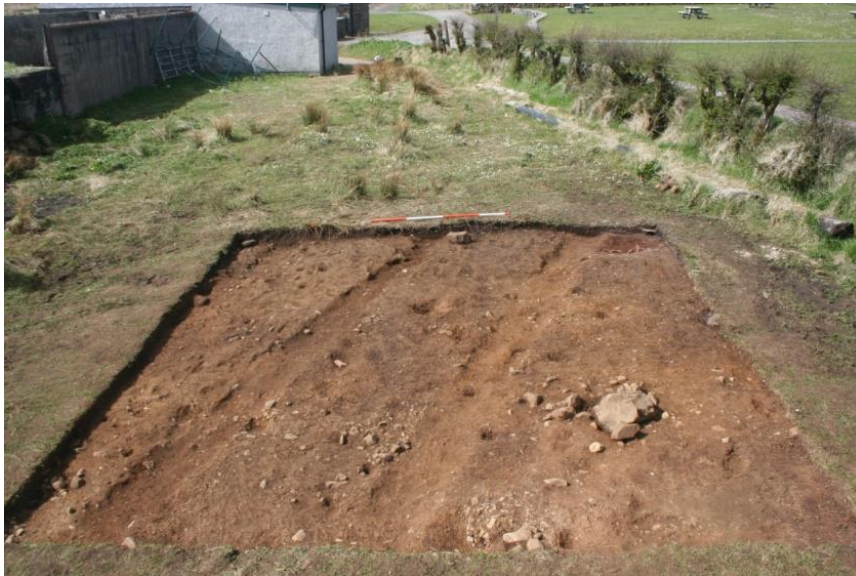
Evidence for spade cultivation, in the form of shallow furrows, was uncovered in Trenches 1, 3 and 4. These were all aligned north-east/south-west and were presumably contemporary with each other. It was unclear if the ridge and furrow cultivation trenches were associated with the vernacular building, or with the later *Divis Lodge* farm. Further excavation would be required in the area of Trench 2 in order to investigate the relationship between the cultivation trenches and the vernacular house.

Figure 14: Evidence of spade cultivation furrows in Trench 4 (scale 2m)
