ULSTER  
ARCHÆOLOGICAL  
SOCIETY

# Survey Report

Reference: **Survey Report No. 57**

**‘Richardson’s House’**

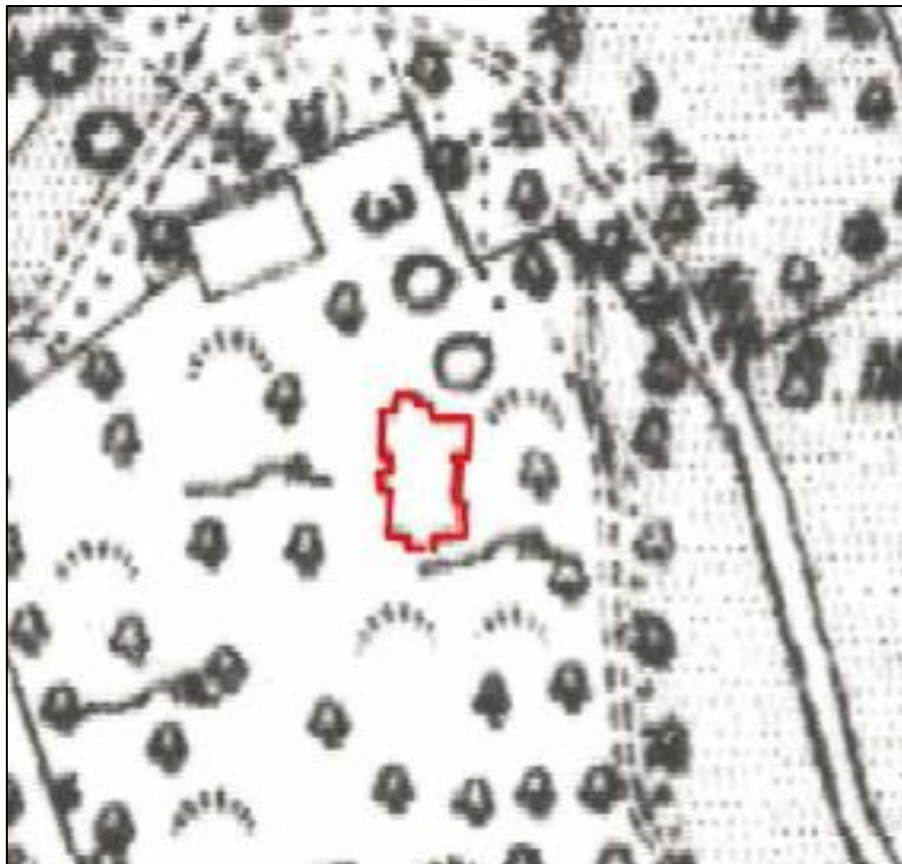
Though this 'layout' of the building depicted is derived from an Ordnance Survey 6 inch map it nevertheless clearly depicts an irregular shaped outline which would appear to suggest the foundations of the 'in-progress' building, which was visible at the time the map was being surveyed (Figure 5). Interestingly, a further rectangular shaped outline is also shown on this 1906 map, lying to the north-north-west of the building foundations and while no physical evidence for any walls or foundations were noted of this possible building within the area, being largely covered by vegetation at the time of survey, it is possible this may represent a secondary structure possibly one that was also in process of being built aside from the Richardson's proposed new house and can be hypothesised that was similarly abandoned. If this hypothesis is correct, such an 'office' or outbuilding may have been designed to serve an ancillary function to the new house. The existence and association between the two buildings can only be ascertained and confirmed through a future program of targeted research excavation or ground truthing of the site.

Figure 5: Detail from Ordnance Survey, County Series, Armagh, 3<sup>rd</sup> Edition (part of) 1909 showing outline of Richardson's House site (shown in red outline) and possible ancillary building shown as rectangular shaped outline to its north-north-west.

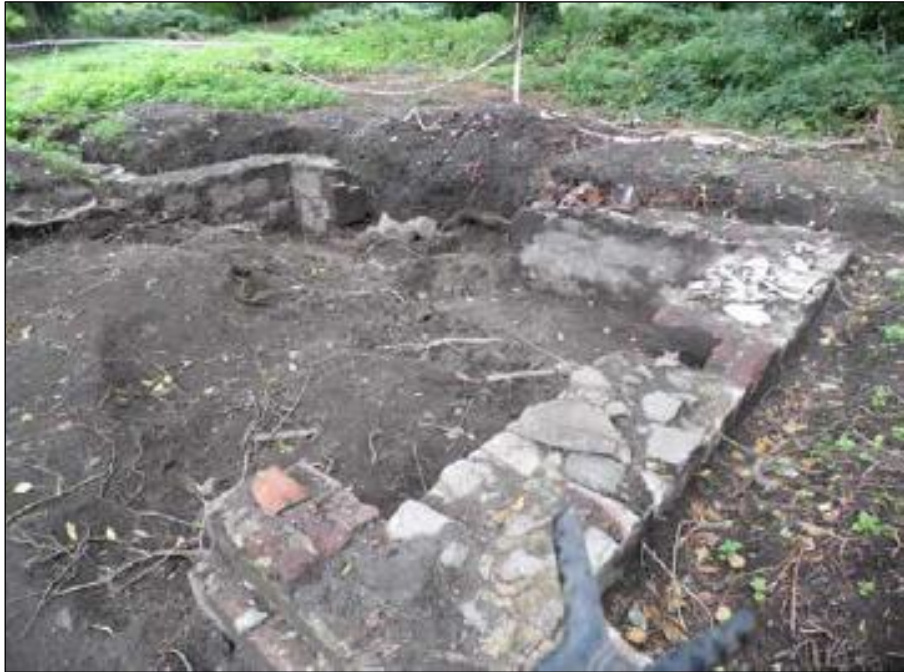
*Pl 1: View of exposed northwest corner wall foundations. (M. Conway, NT)*

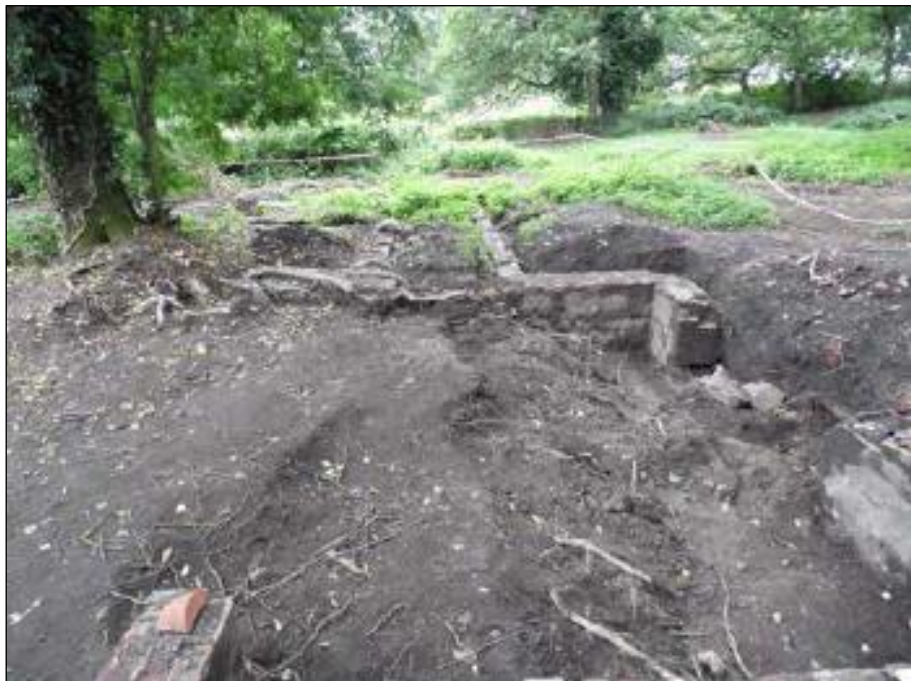
*Pl 2: View south along the west side of exposed wall foundations (M. Conway, NT)*

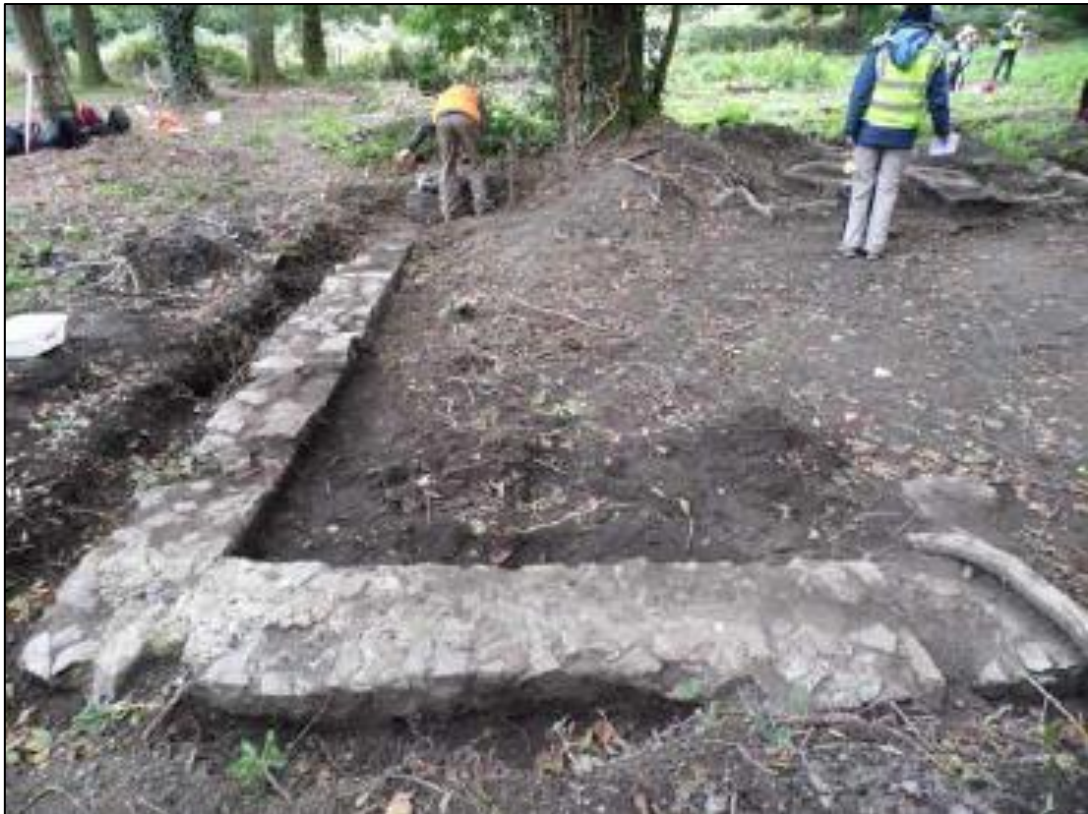
*Pl 3: View from north of the east side of the North compartment showing tree roots covering the line of the south wall (W4), (M. Conway, NT)*

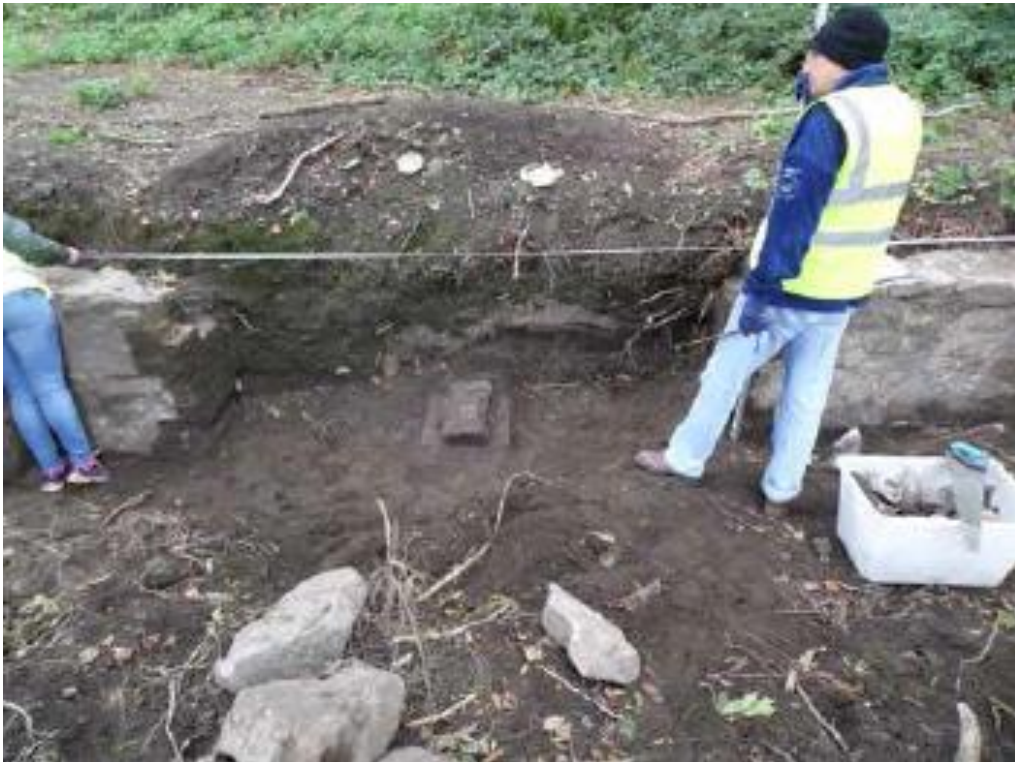
*Pl 4: West opening in North compartment from east showing remains of central brick pier (M. Conway, NT)*

An opening in the west wall was located 2.75m south of the northeast corner of the foundations, between the south end of W1 and the north end of W2, both of which had brick facing set into the opening (Figure 7). Measuring 2.65m north-south by 0.6m west-east the west opening contained the lower footing of a centrally placed brick pier measuring 0.6m west-east by 0.45m north-south (Figure 6, Plate 4).

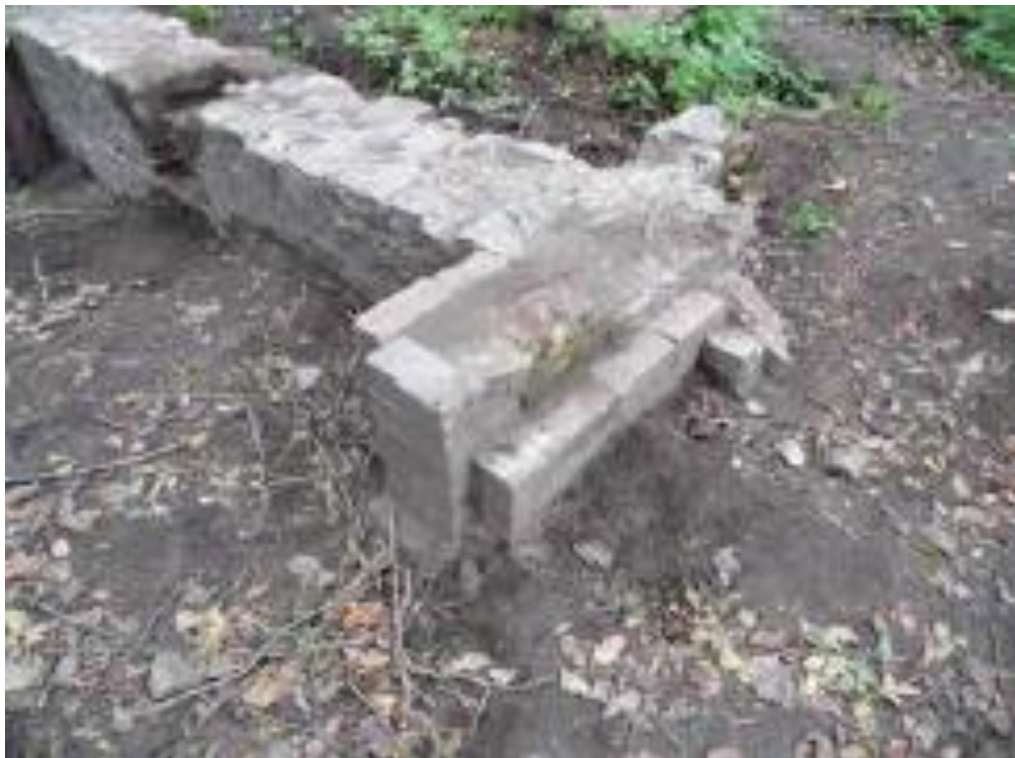
*Pl 5: Detail of north opening west side taken from southeast showing brick pier addition at wall W1 (M. Conway, NT)*

An opening in the north wall was located 4.7m from the northeast corner, forming a gap between walls W1 and W3 (Figure 7, Plate 5). This opening measured 1.45m west-east by 1.0m north-south and with attached brick piers extending south from both W1 and W3. A

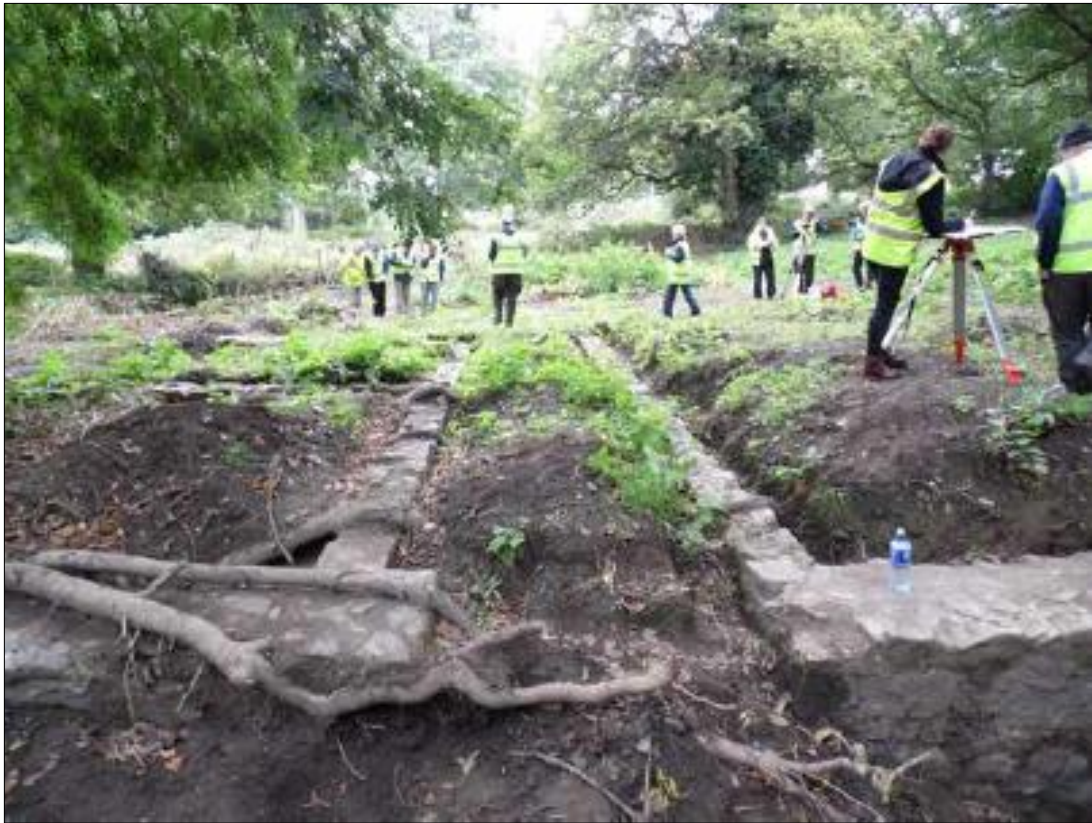
*Pl 6: View south through the opening located in south end of North compartment into the narrow passage or compartment (M. Conway, NT)*

An opening in the south wall of the North compartment was located 2.20m from the inner southwest corner of W2 (Figure 7, Pl 6). This opening measured 1.35m west-east by 0.6m north-south and presented into a narrow rectangular walled arrangement measuring 4.3m north-south by 1.55m west-east, characterised by random rubble walls 0.3m wide on the west (W5) and south (W7) and 0.4m wide on the east (W6).

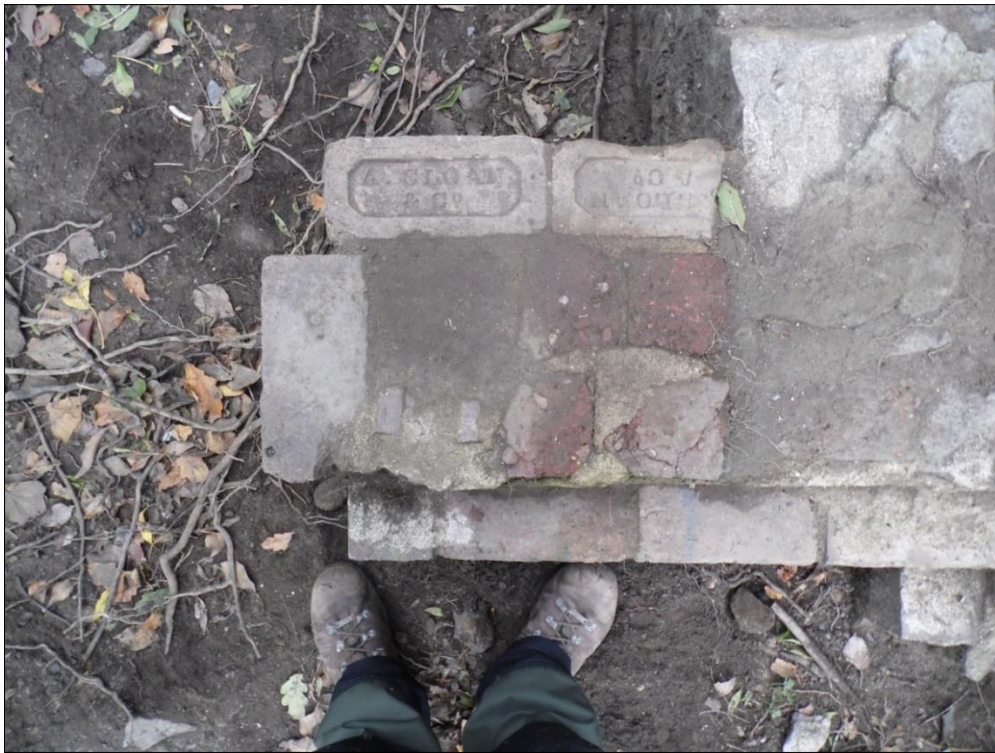
In general, the stone used in the foundations would appear to be locally sourced material and one can presume that the common bricks used in the openings were also locally produced or sourced. The only stamped brick that was identified during recording of the foundations was that found within the brick pier at the east end of wall W1. Here two stretcher bond bricks of pressed type were stamped A. Sloan & Co (see Pl.7). This is

clearly from the Andrew Sloan & Co., fire-brick and tilemaker, Bridge End, Ballymacarrett, and is a company listed in local trade directories from 1852 to 1877 (information George Rutherford).

Pl.7: Detail top of brick pier, east end of wall W1, showing bricks by 'A. Sloan & Co.' (M. Conway, NT)

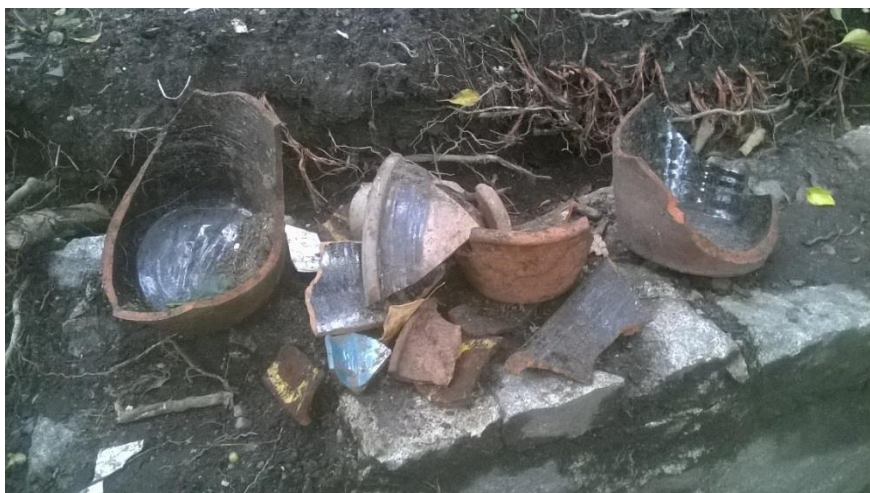
Pl.8: Selection of mainly ceramics found at the site. (M. Conway, NT)

Table 1 below provides a short inventory of the ceramics, tile, brick, glass and bone objects that were recovered from disturbed ground within the foundations (see Pl.8). This report does not present detail on the finds, however it can be said that in date, particularly in the ceramics, the artefacts broadly span the late 19<sup>th</sup> to early 20<sup>th</sup> century and therefore are contemporary to the phase of the building work. One can presume as the house was not completed, the finds simply represent the dumping of local refuse into the site as part of filling-in and could have been generated by any of the occupied buildings within the demesne or from the village.
