Survey Report

Reference: **Survey Report No. 34**

**Survey of World War II
Pillbox, Murlough, County
Down**

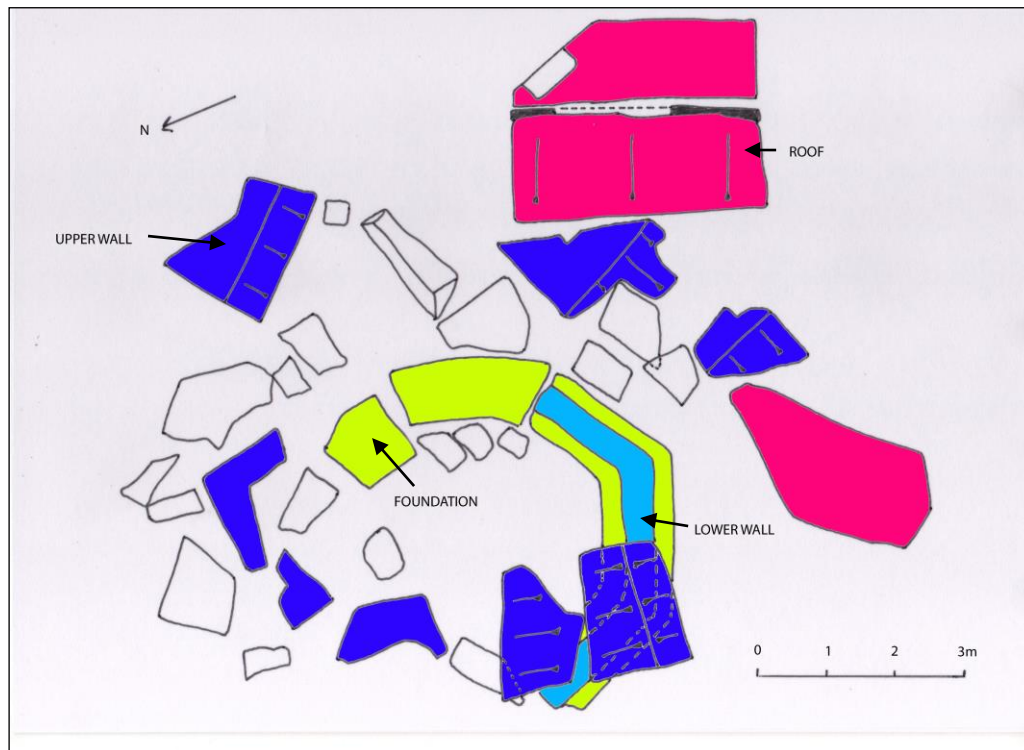
Figure 6: Plan of Murlough Pillbox

Plan drawings were completed, using data obtained from a field survey. Measurements were obtained by using the method of tapes and off-sets. A detailed plan at 1:50 scale was completed on site by recording these measurements on drafting film secured to a plane table and backing up the data on a field notebook for subsequent reference. Field plans were later transferred to a computer-based format for printing.

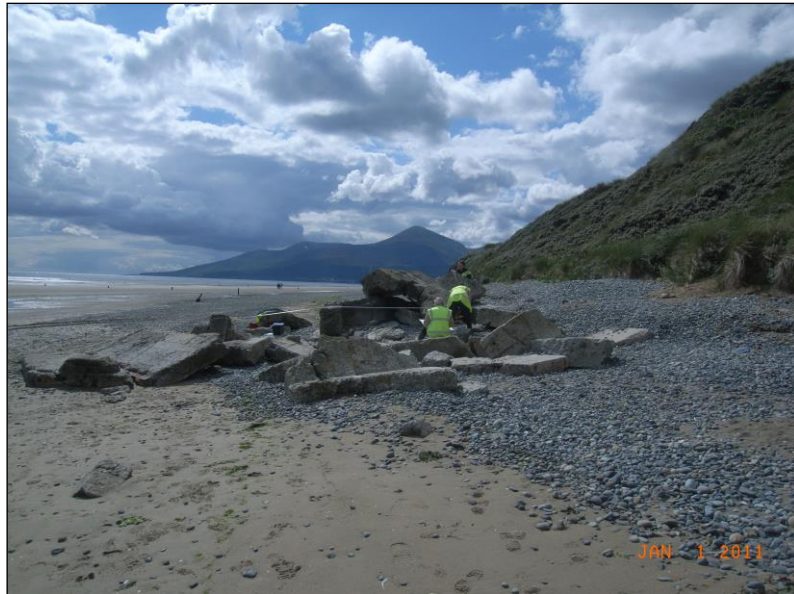
Figure 7: View of Pillbox remains, with Mourne Mountains to the south

visible remains are 0.75m maximum height above the level of the sand. From the scattered remains it appears that it was constructed in sections, with a strip foundation at its base, constructed from corrugated iron shuttering, into which concrete was poured. The lower wall on top of the base has a shaped moulding at the upper external face and the upper wall measures about 2m in height. Finally, the concrete roof, some 0.3m thick, is set in place, giving an overall height of approximately 3.35m.

This Pillbox at Murlough is comprehensively damaged, with every wall section shattered and its roof lying inverted to the south, strongly suggesting that it was destroyed by explosives. This was most likely carried out by the military during the

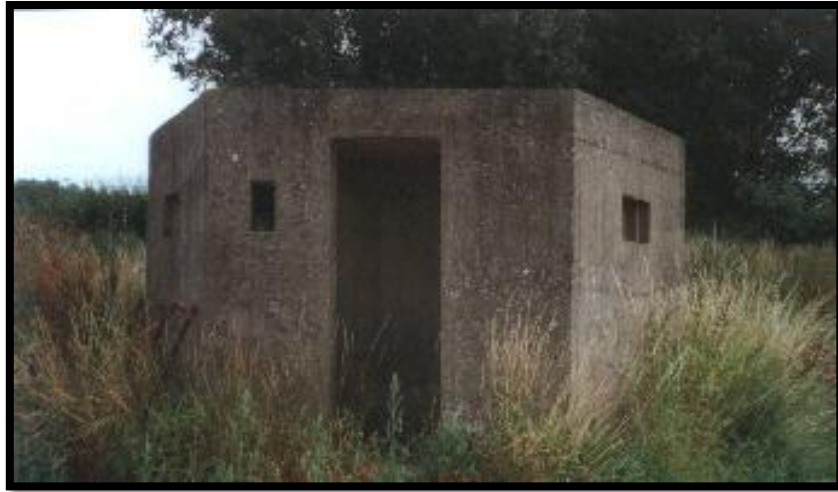
Figure 10: Concrete Type 22 at Newport, Shropshire, www.pillbox-study-group.org.uk

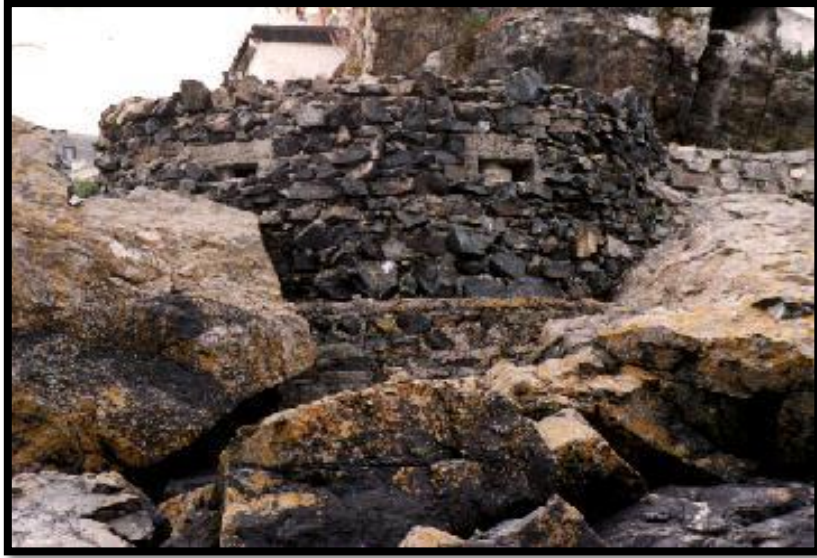
Figure 12: Type 22 Pillbox overlooking Porthminster Beach, St.Ives,Cornwall,
www.pillbox-study-group.org.uk

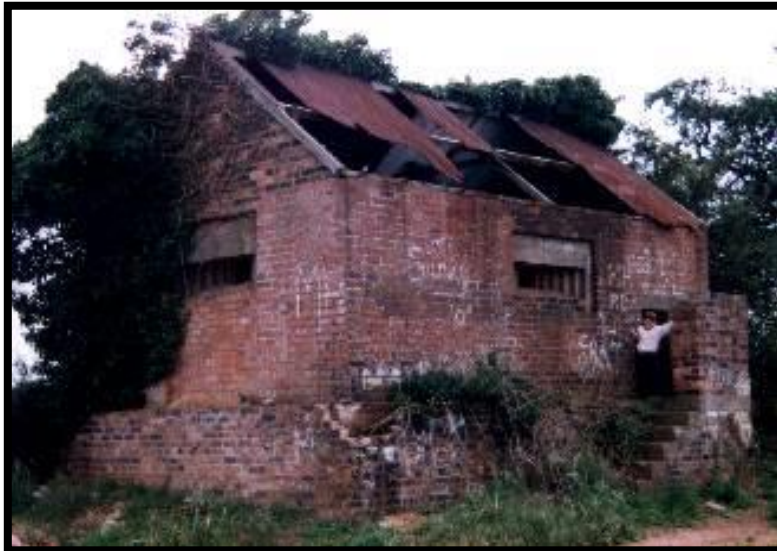
Figure 13: Large Pillbox at High Ercall, Shropshire, disguised as a house,
www.pillbox-study-group.org.uk

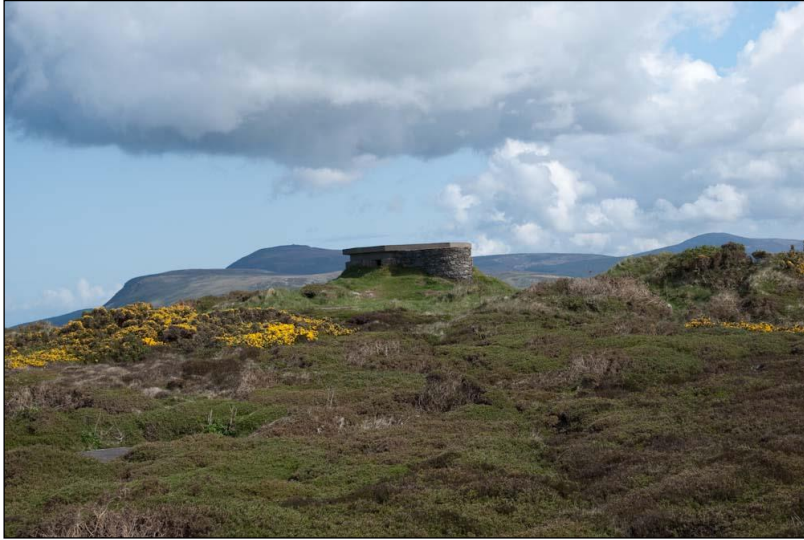
Figure 14: Nine-sided Pillbox on the Isle of Man, www.pillbox-study-group.org.uk

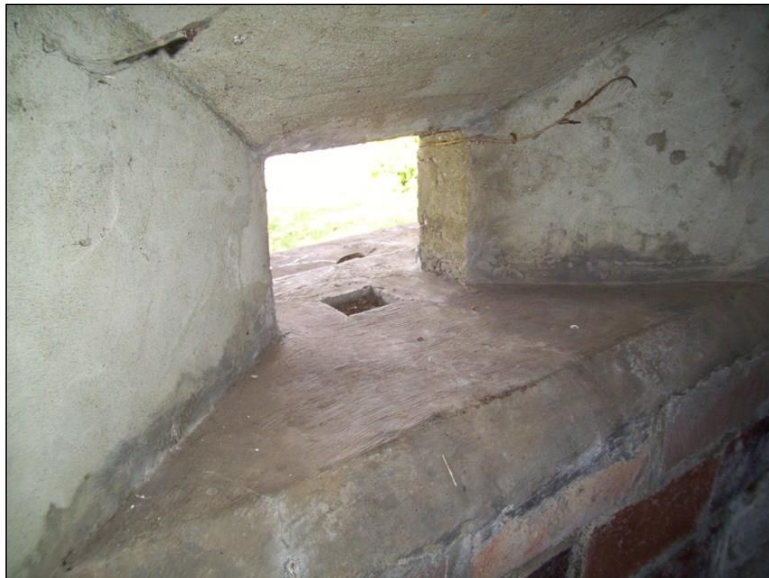
Figure 15: Inside a Type 22 Pillbox in Elstead, Surrey, complete with concrete loop-hole tables, www.pillbox-study-group.org.uk

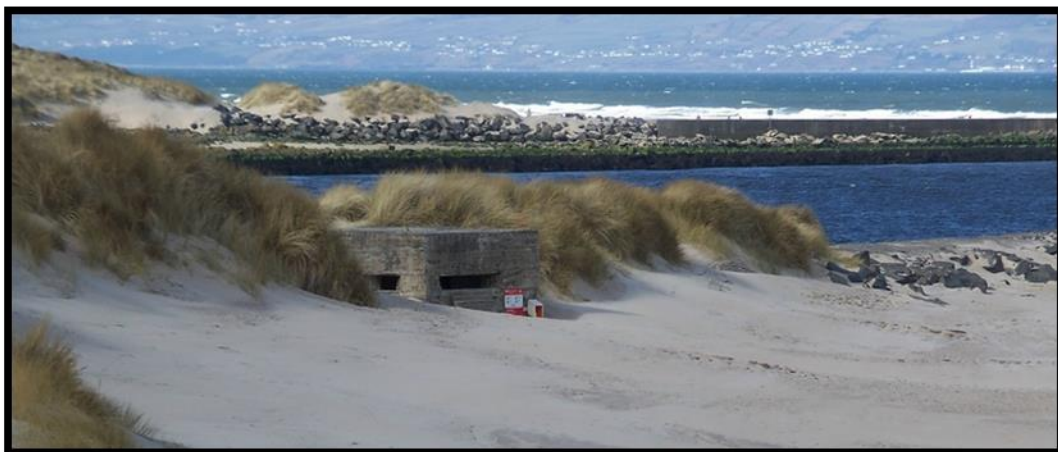
Figure 16: Pillbox on western side of Portstewart Strand, to protect the Bann estuary
 Courtesy of Andy Glenfield, *The Second World War in Northern Ireland* at
www.ww2ni.webs.com

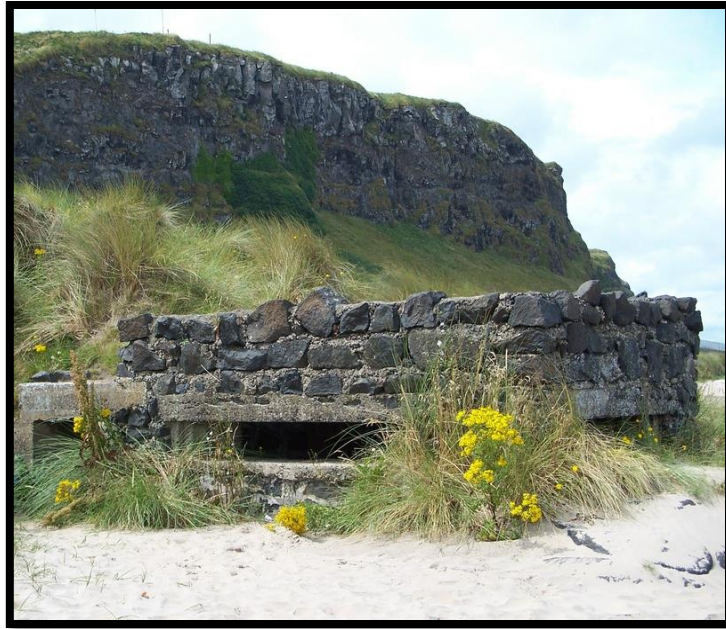
Figure 18: Downhill Pillbox, with basalt blocks as additional camouflage Courtesy of Andy Glenfield, *The Second World War in Northern Ireland* at www.ww2ni.webs.com

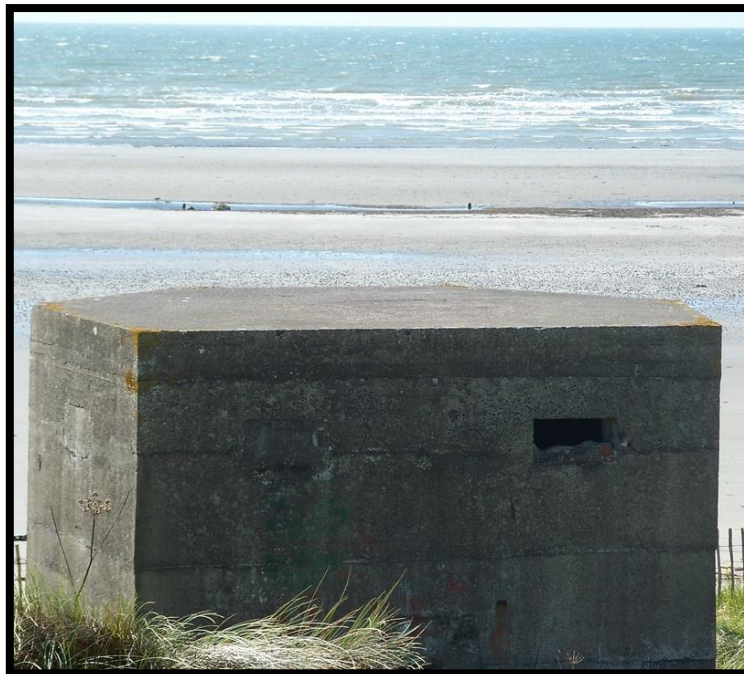
Figure 19: Tyrella Beach Pillbox Courtesy of Andy Glenfield, *The Second World War in Northern Ireland* at www.ww2ni.webs.com

Tyrella Beach is in close proximity to the Army's Abercorn Barracks along the coast at Ballykinler. Such defences would be useful in preventing any planned airborne landing by enemy forces.

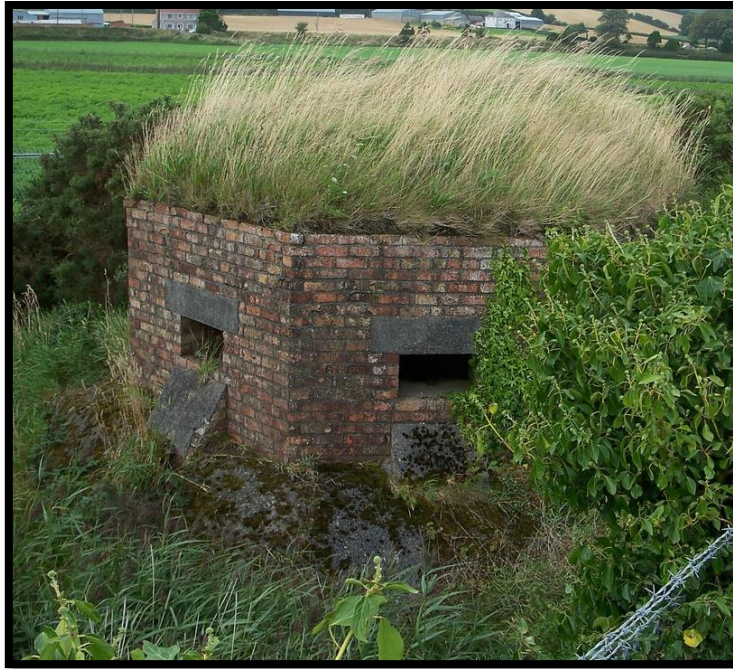
Figure 20: Comber Pillbox, Courtesy of Andy Glenfield, *The Second World War in Northern Ireland* at www.ww2ni.webs.com

The Pillbox at Comber is located on the shore of Strangford Lough and has been sited to afford excellent views of the lough. The grass roof provides interesting and effective camouflage.

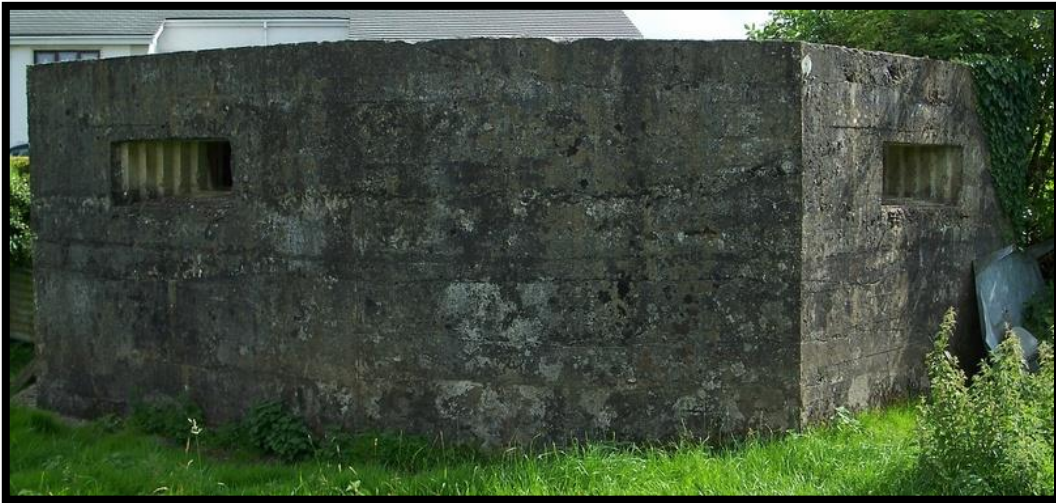
Figure 22: Bleary Pillbox, where the River Bann provides an effective defence line,
 Courtesy of Andy Glenfield, *The Second World War in Northern Ireland* at
www.ww2ni.webs.com

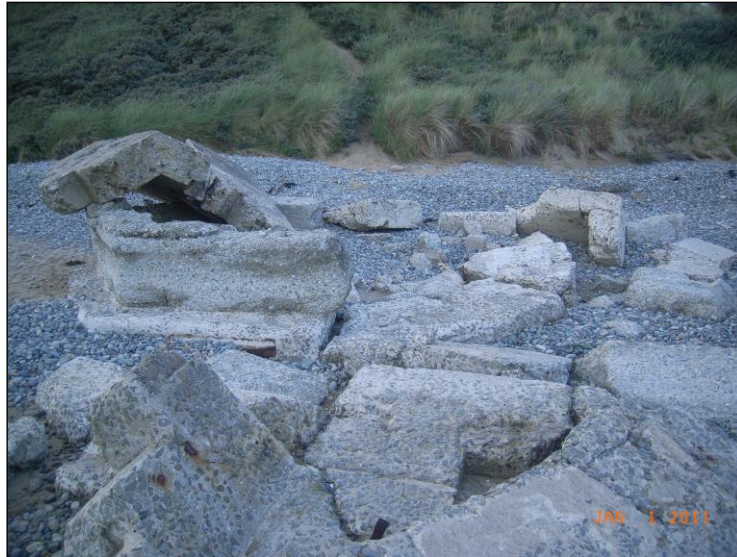
The remains of this Pillbox, which lie on the beach at the southern end of the sand dunes, are spread over an area of approximately 11m east/west and 12m north/south. There are about twenty-five visible fragments above the level of the sand and it is possible that more may be buried. These fragments of concrete range in size from 4m in length by 3m in width and 0.3m in depth to 0.5m in length by 0.4m in width and 0.3m in depth.

Figure 24: Scattered fragments of Murlough WWII Pillbox

recent civil disturbances in Northern Ireland, to prevent its use by terrorists to attack the nearby Ballykinler Army Camp, which lies to the east.

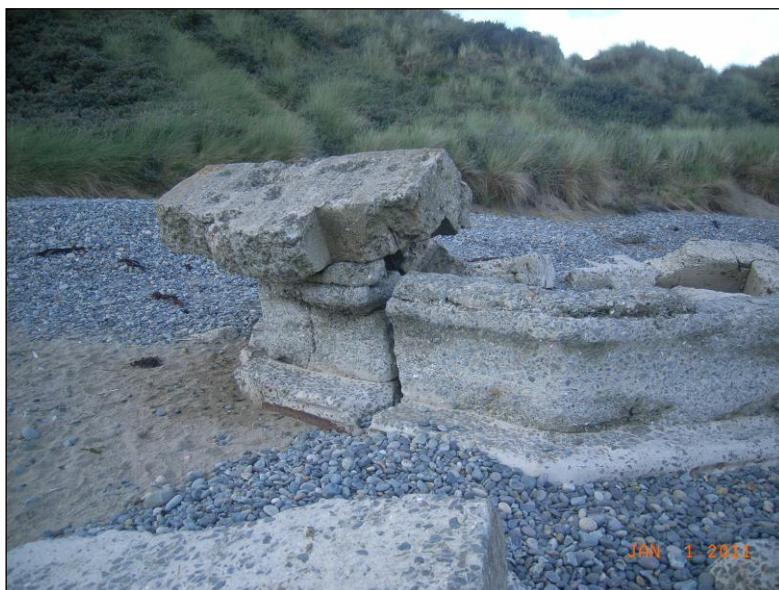
Figure 25: Elements of Pillbox still in situ

To the north-west of the debris field, some elements of the Pillbox remain relatively undisturbed, as evident above. From this we can tell it was hexagonal in shape and its internal width measures about 4m, with walls between 30cm and 40cm thick. The

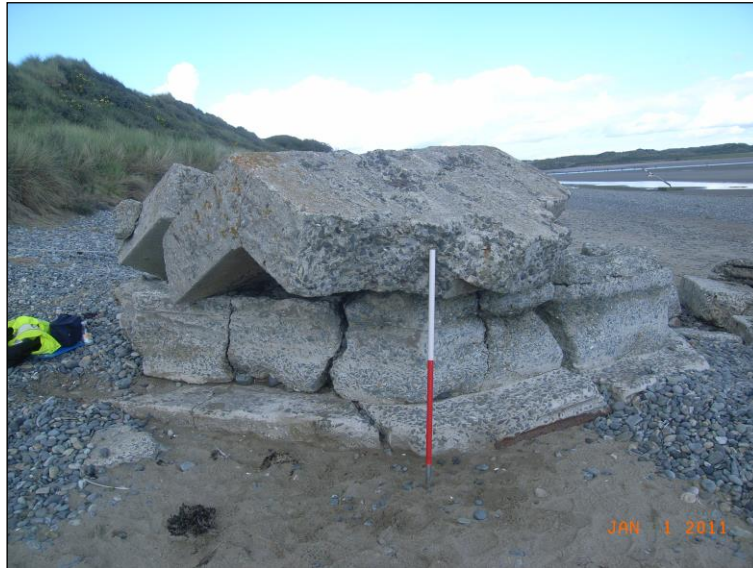
Figure 26: Evidence for sectional construction

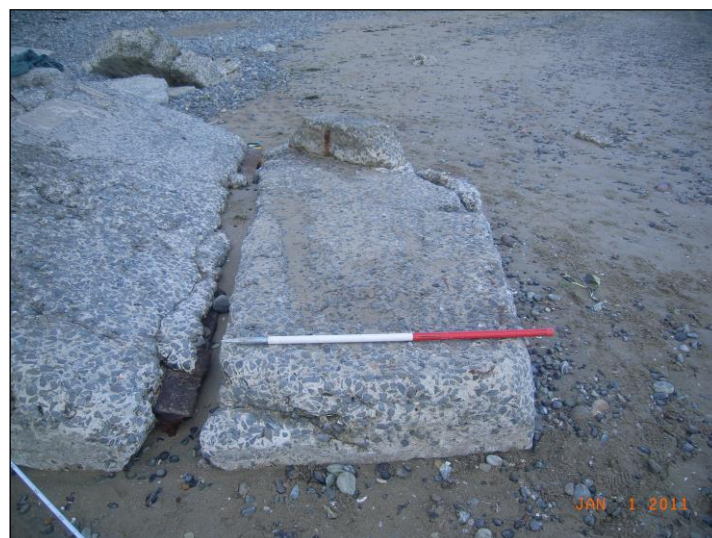
The roof appears to be cast in three sections, supported by what appears to be re-used metal rails, perhaps from railway lines. Its overall external measurement is approximately 5.5m in diameter. Although the entrance to the Pillbox is not visible, it seems likely that it would be at the rear of the structure and facing the sand dunes. It is important to remember that over the years the sand dunes have been eroded to the north, leaving the Pillbox further out on the beach.

Figure 27: Metal rails used as roof supports

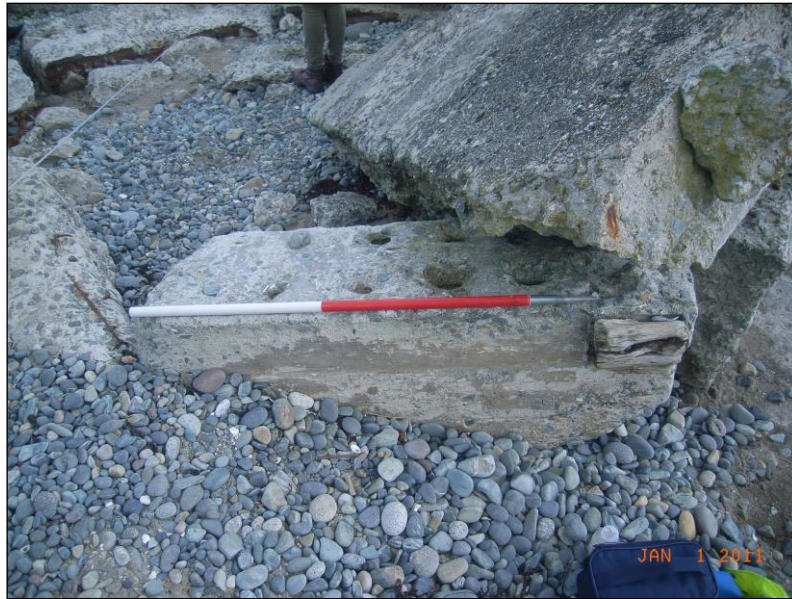
The upper face of several sections of the lower wall display evidence of regularly placed sockets and also stone pegs, some of which are still in situ. These were obviously used to provide a secure joint.

Figure 28: Ten regularly placed sockets with some stone pegs still in situ

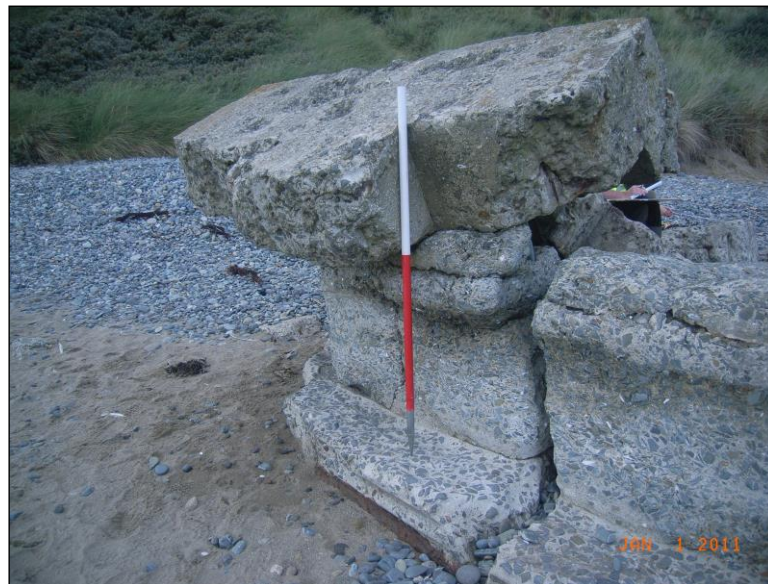
Elements of gun loopholes are visible from some fragments of the upper wall of the Pillbox.

Figure 29: Indent of partial gun loophole

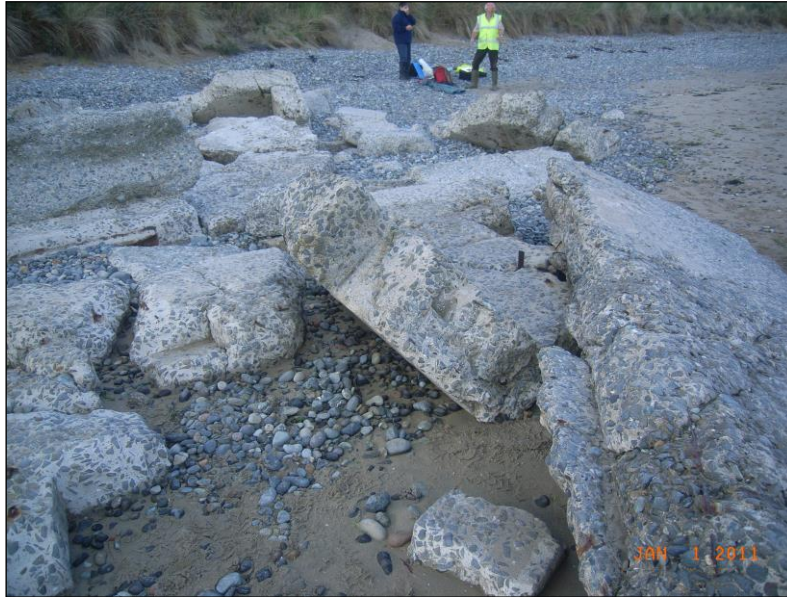
The entire structure is constructed of angular stones, which vary from 3cm to 6cm in diameter and were set into a concrete matrix. Some evidence exists for the use of corrugated iron shuttering in constructing its foundations. However, the presence of angular stones and not beach-rolled pebbles in the fabric of the other structural

components indicates that these were not constructed on the beach, but were transported to the site and erected, using a pre-fabricated design.

Figure 30: Angular stones set into concrete matrix

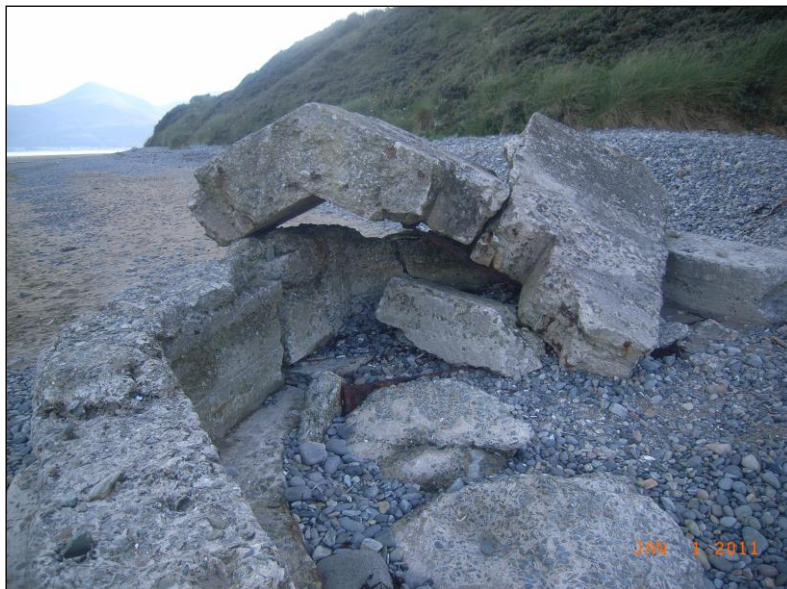
Within the remains of the Pillbox were a number of iron items, some partially buried in the debris. It is difficult to determine accurately their function.

Figure 31: Iron/metal items within the Pillbox structure
